Re: Cape Decision Lighthouse - Timber Tramway Hazardous Condition  
WJE No. 2015.1826

At your request, Wiss, Janney, Elstner Associates, Inc. (WJE) has performed a limited condition assessment of the timber boathouse foundation that was subject to fire in 1989. During the week of May 18, 2015, Mr. Zeno Martin of WJE was onsite documenting conditions for repair planning, and met with you and others. An item of immediate concern, and as discussed with you onsite, is that the timber tramway and boathouse foundation (Figure 1) have deteriorated to such an extent that we strongly suggest these structures no longer be used to carry people or equipment until significant structural repair occurs.

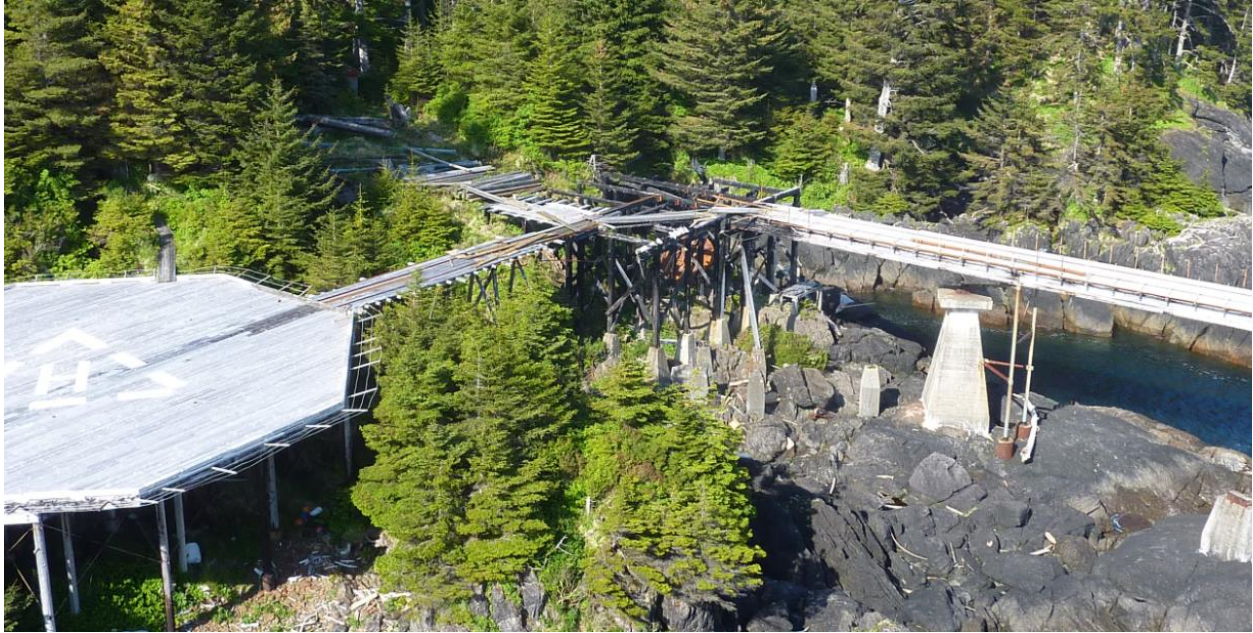
*Figure 1. Helipad, tramway, boathouse foundation and pier (left to right).*

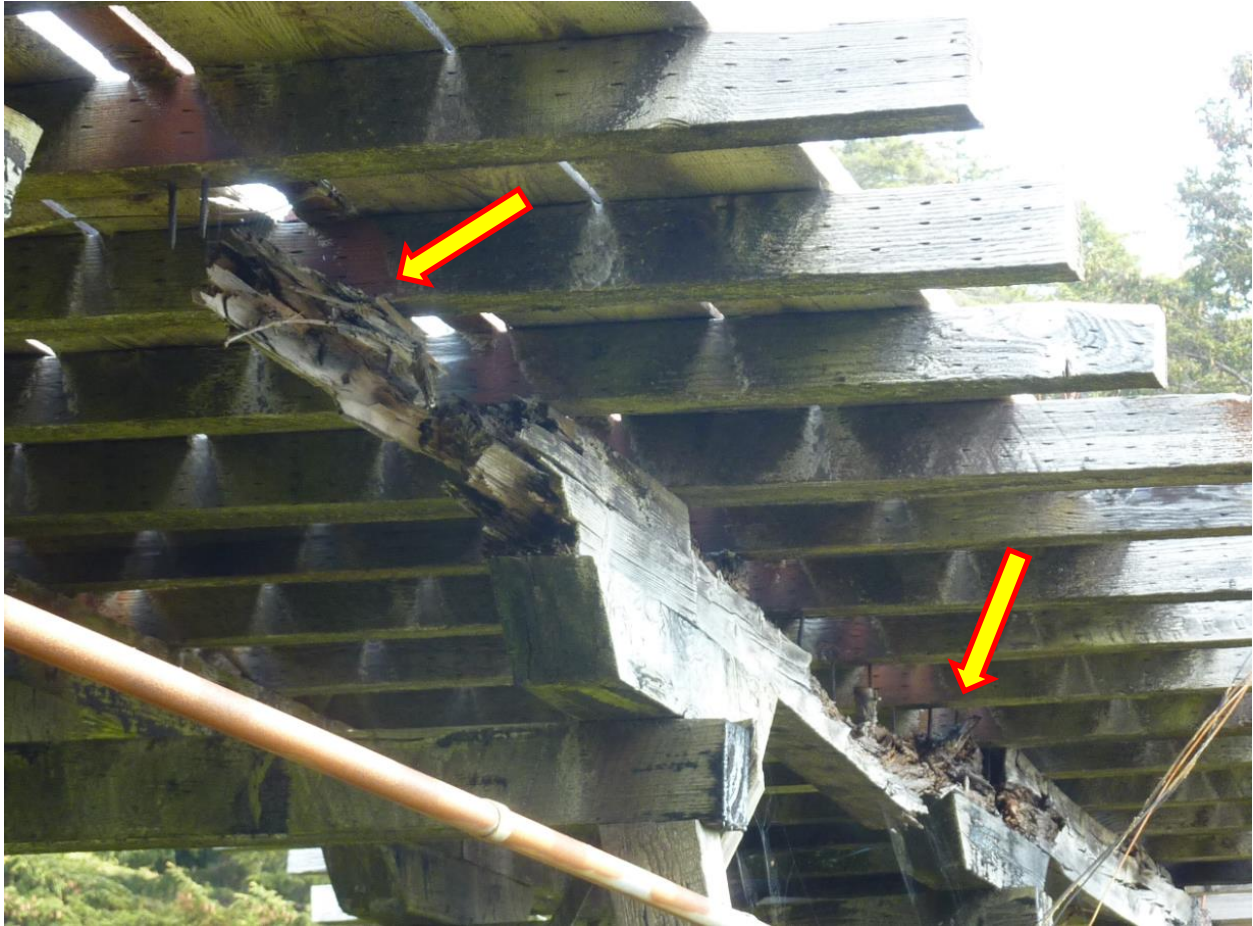
- Advanced wood decay in non-fire damaged portions of tramway joists (Figure 2)
- At some charred areas, wood material cannot resist aggressive probing (Figure 3)
- Organic growth through char (Figure 4)

Late stages of fungal decay at many of the timber structural elements is obviously present and, as a result, significant strength loss of the wood material has occurred and will continue to occur. Due to the extensive char and wood decay, we reiterate our strong opinion that these structures no longer be used to carry people or equipment until significant structural repair occurs.

*Figure 2. Joists supporting the tramway deck have lost integrity due to wood decay.*

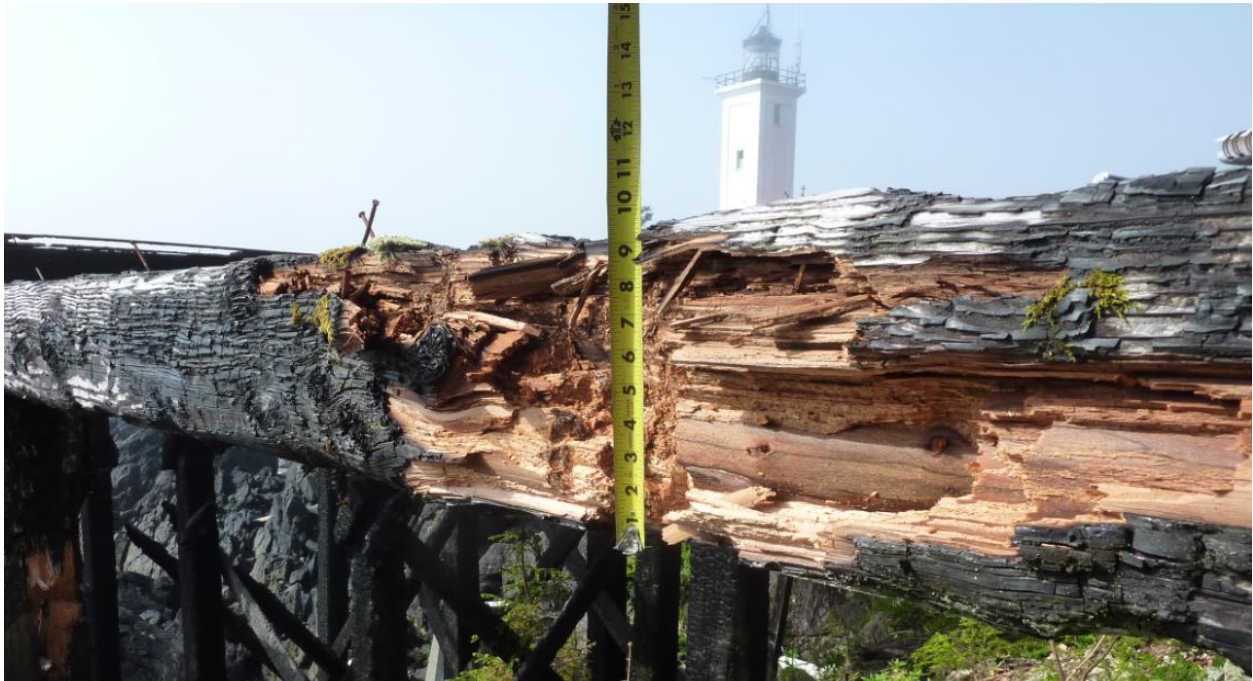
*Figure 3. Wood material has lost integrity due to decay.*

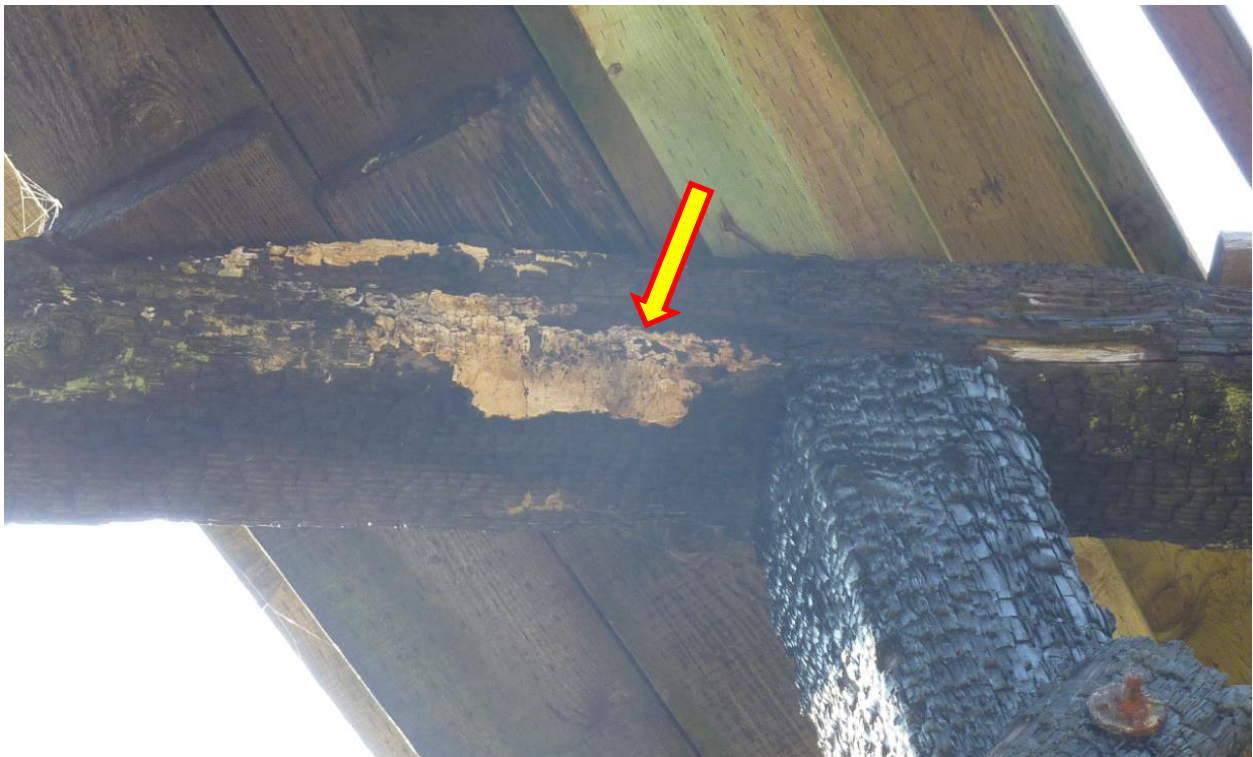
*Figure 4. Organic growth on underside of 12x12 timber beam supporting temporary plank decking above.*
