CAPE DECISION LIGHTHOUSE SOCIETY (CDLS)

CONSERVATION CONDITION ASSESSMENT OF THE
CAPE DECISION LIGHTHOUSE
CUPOLA AND LANTERN ROOM

JULY 07-10, 2019

REPORT BY:
NICOLE PETERS, CONSERVATOR
PETERS ART CONSERVATION SERVICES, LLC

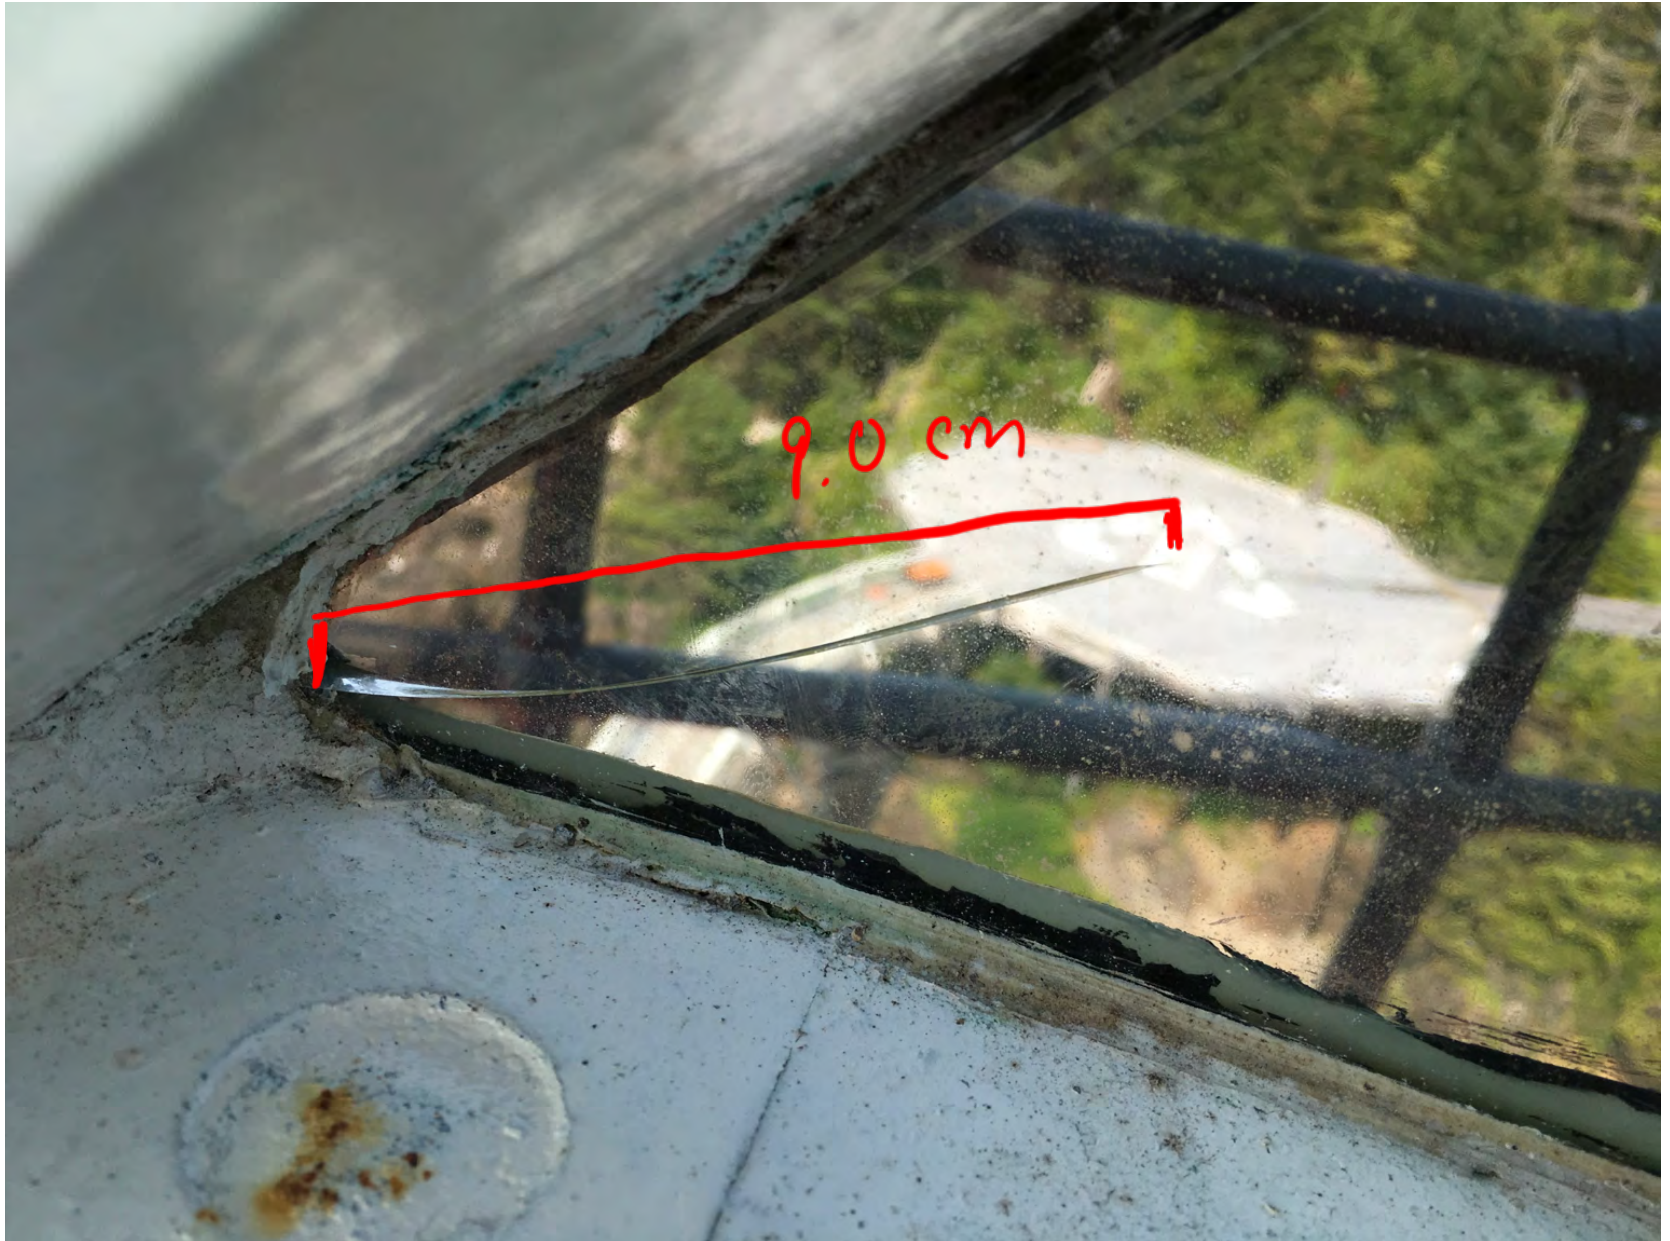
Section 1:

Detail of the crack in the window pane in Section 1. The crack currently spans approximately 9 cm in length.

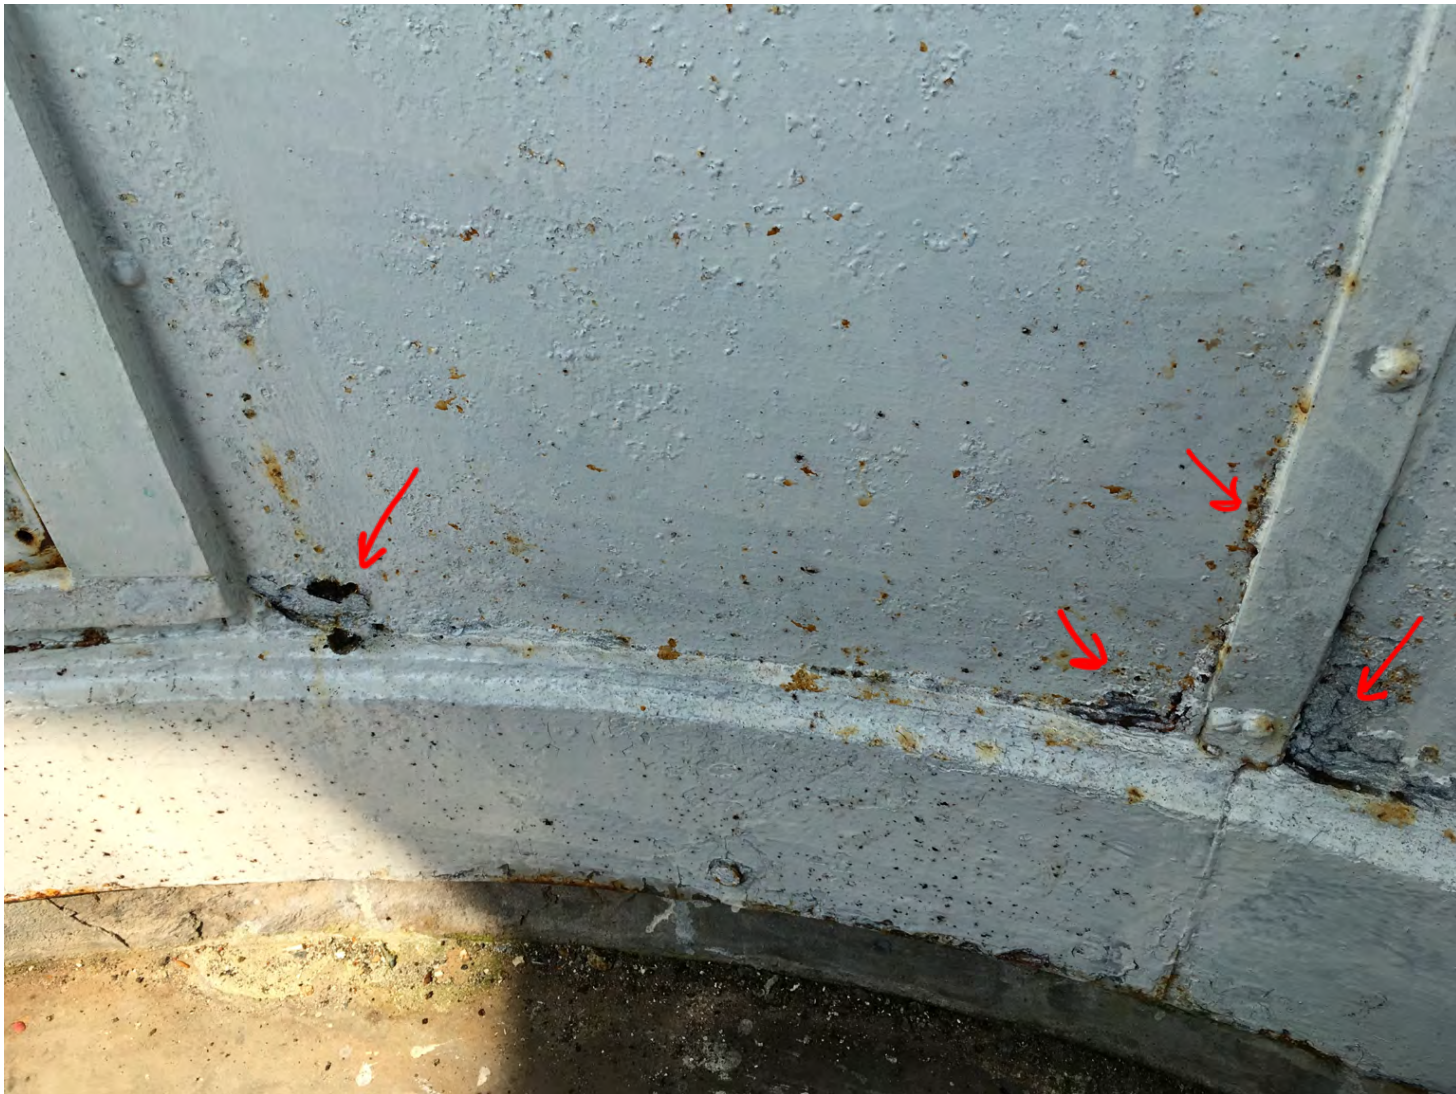
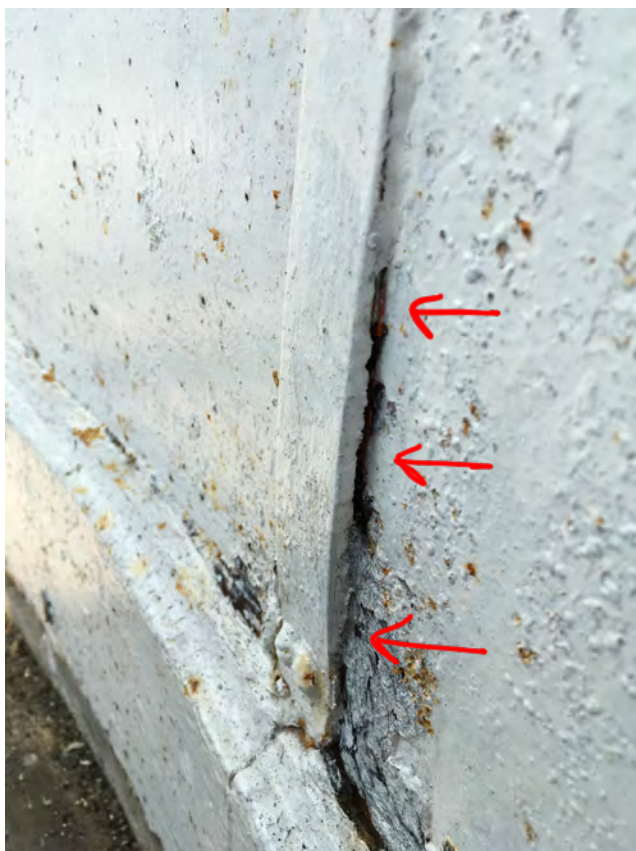
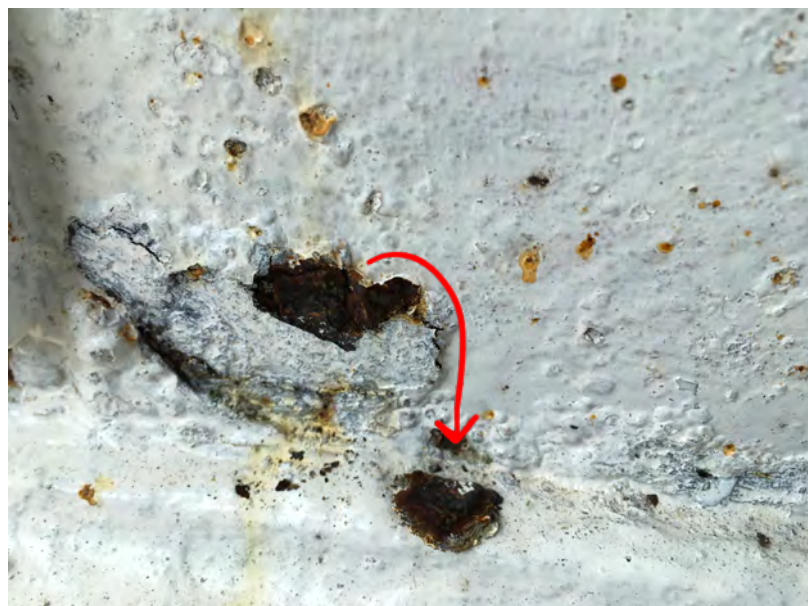
Section 1 (cont.)

Arrows indicating areas of failing paint coating. Areas of missing paint, corrosion penetration, and active spalling were noted during site visit.

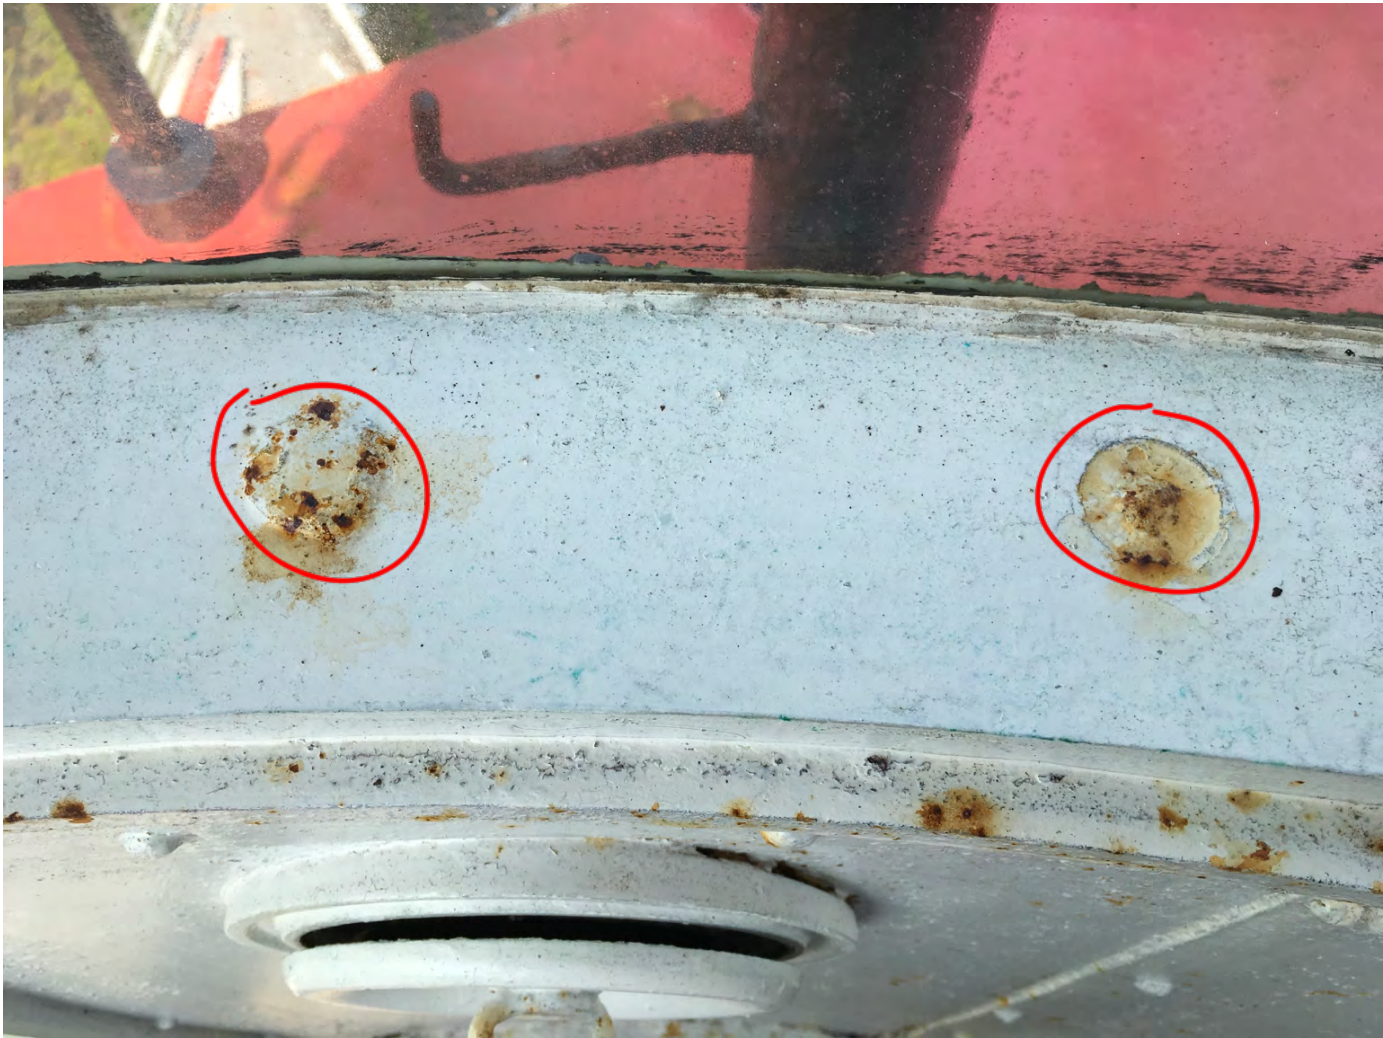
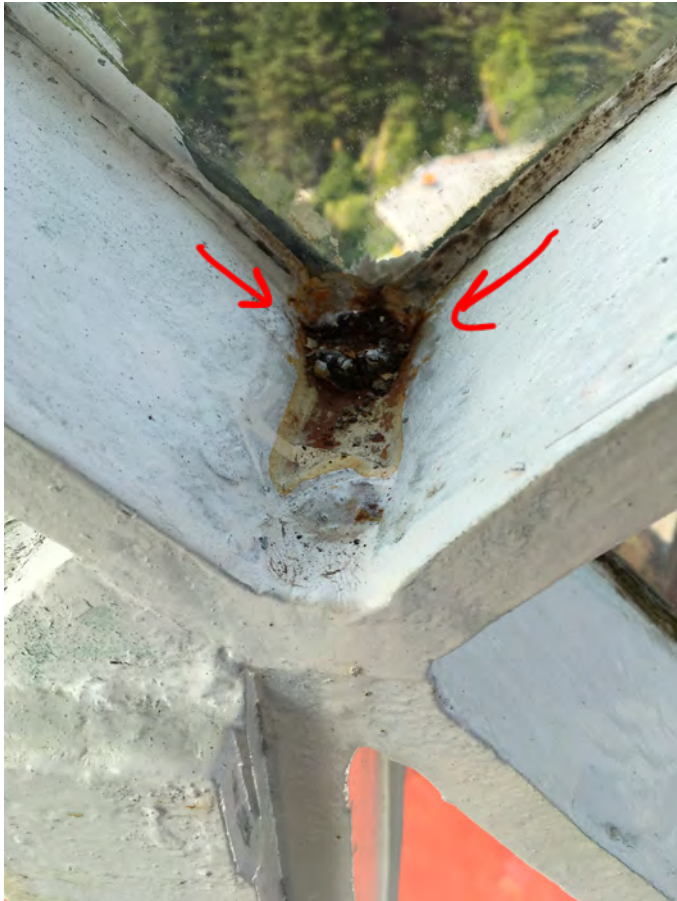
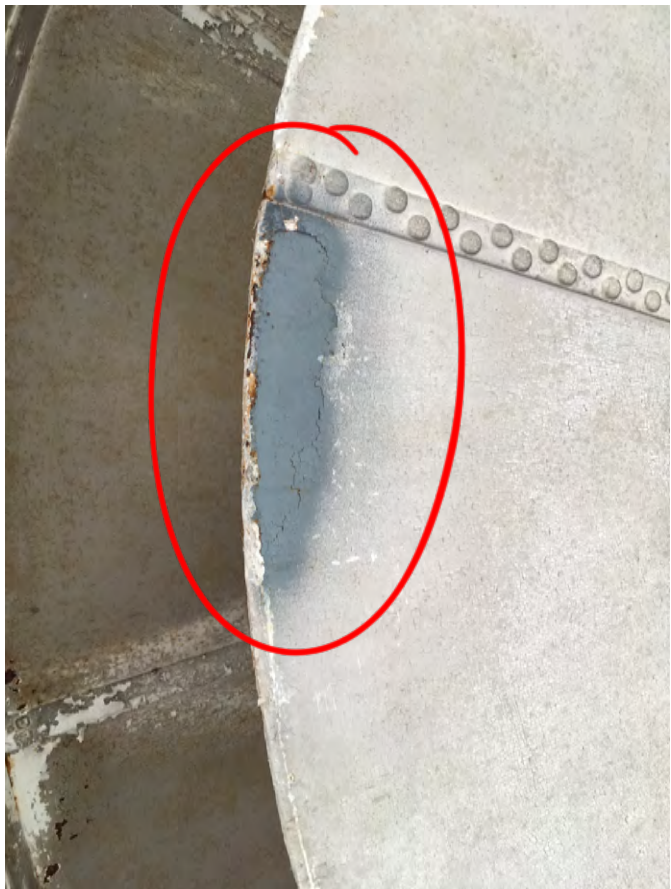
Section 1 (cont.)

Top: galvanic corrosion of ferrous hardware. Bottom right: Rust-oleum(?) coating application on ceiling liner. Bottom left: severe degradation and corrosion of ferrous hardware due to galvanic corrosion.

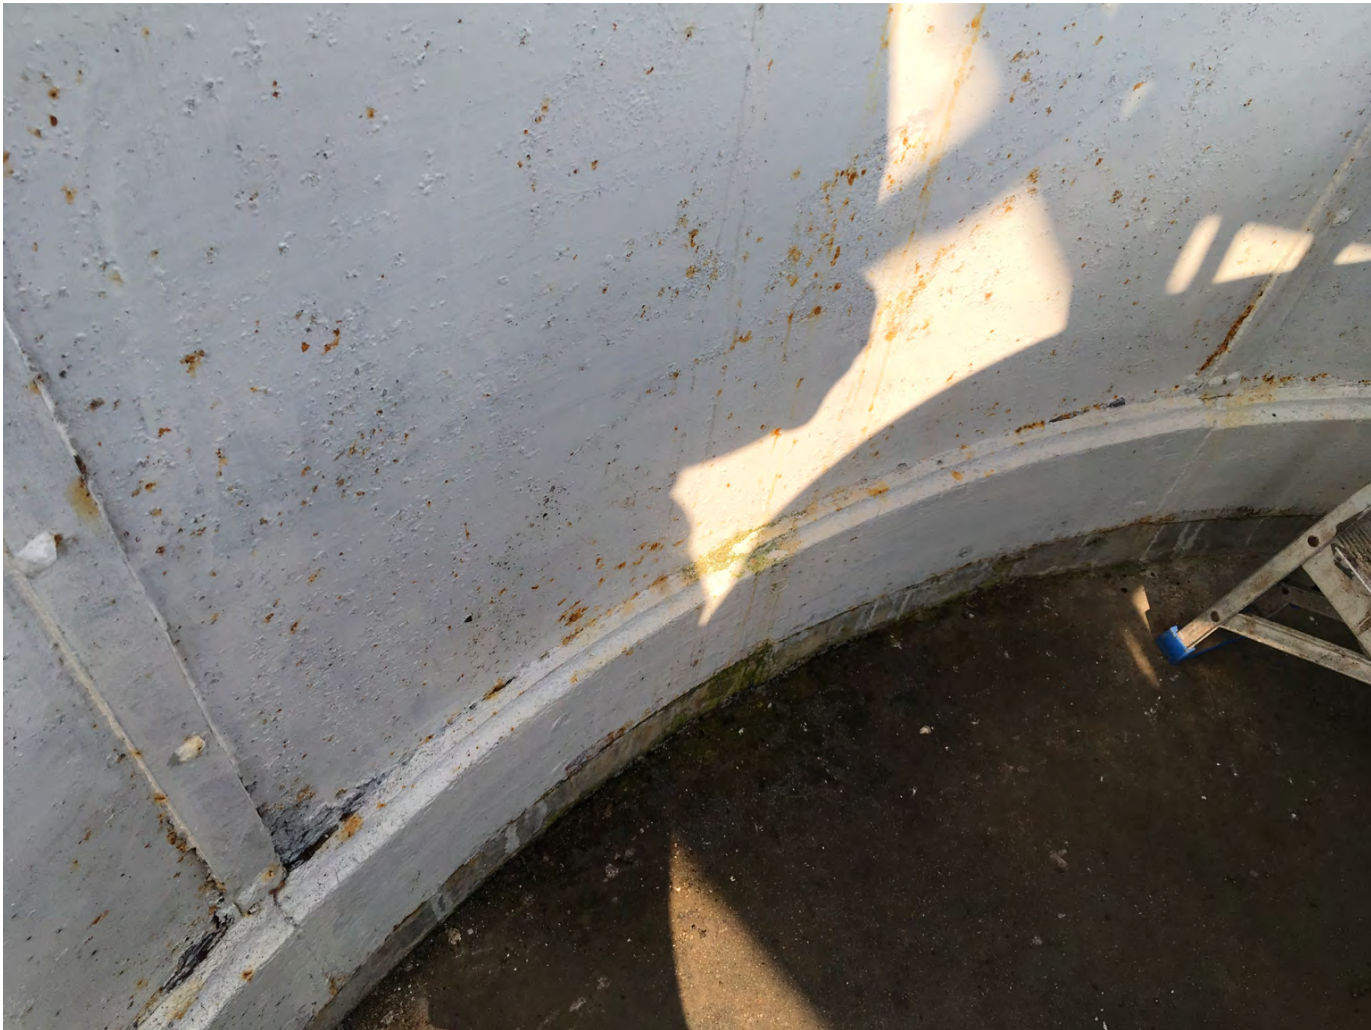
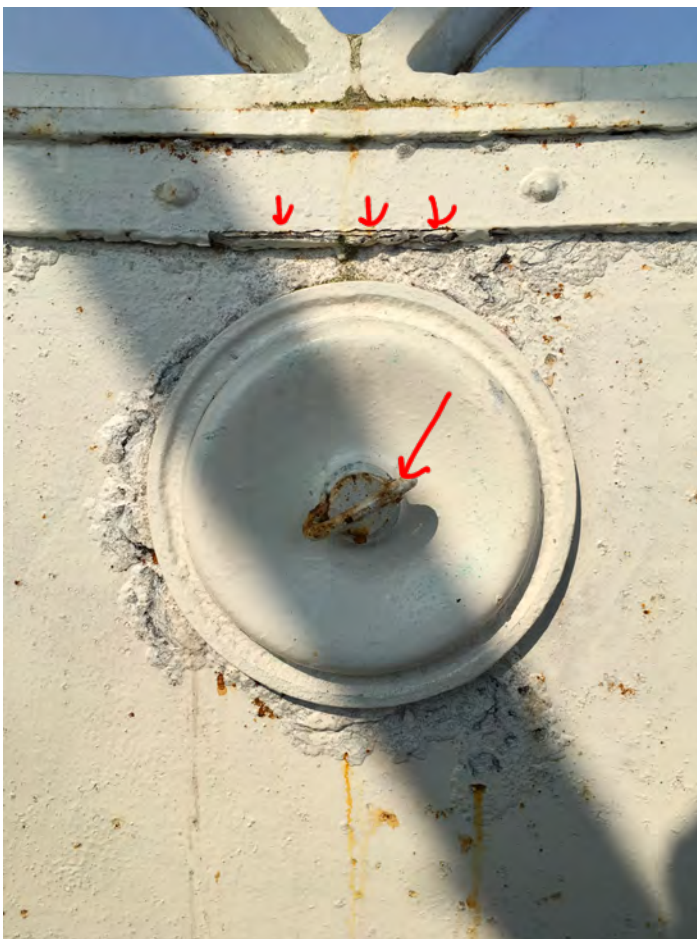
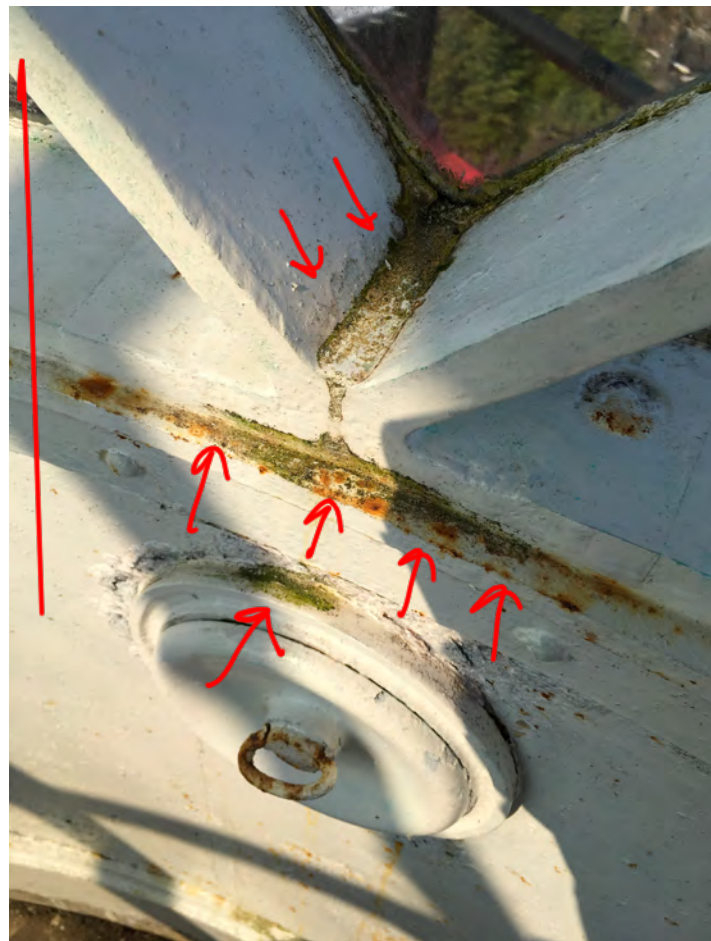
Section 2:

Top: Detail of iron corrosion sporting beginning to penetrate through paint coating. Bottom right: Biological growth forming on top of grime/organic deposits. Bottom left: Detail of damage to vent handle: handle had been torqued too hard and is bent. Detail of delaminated iron structure just above.

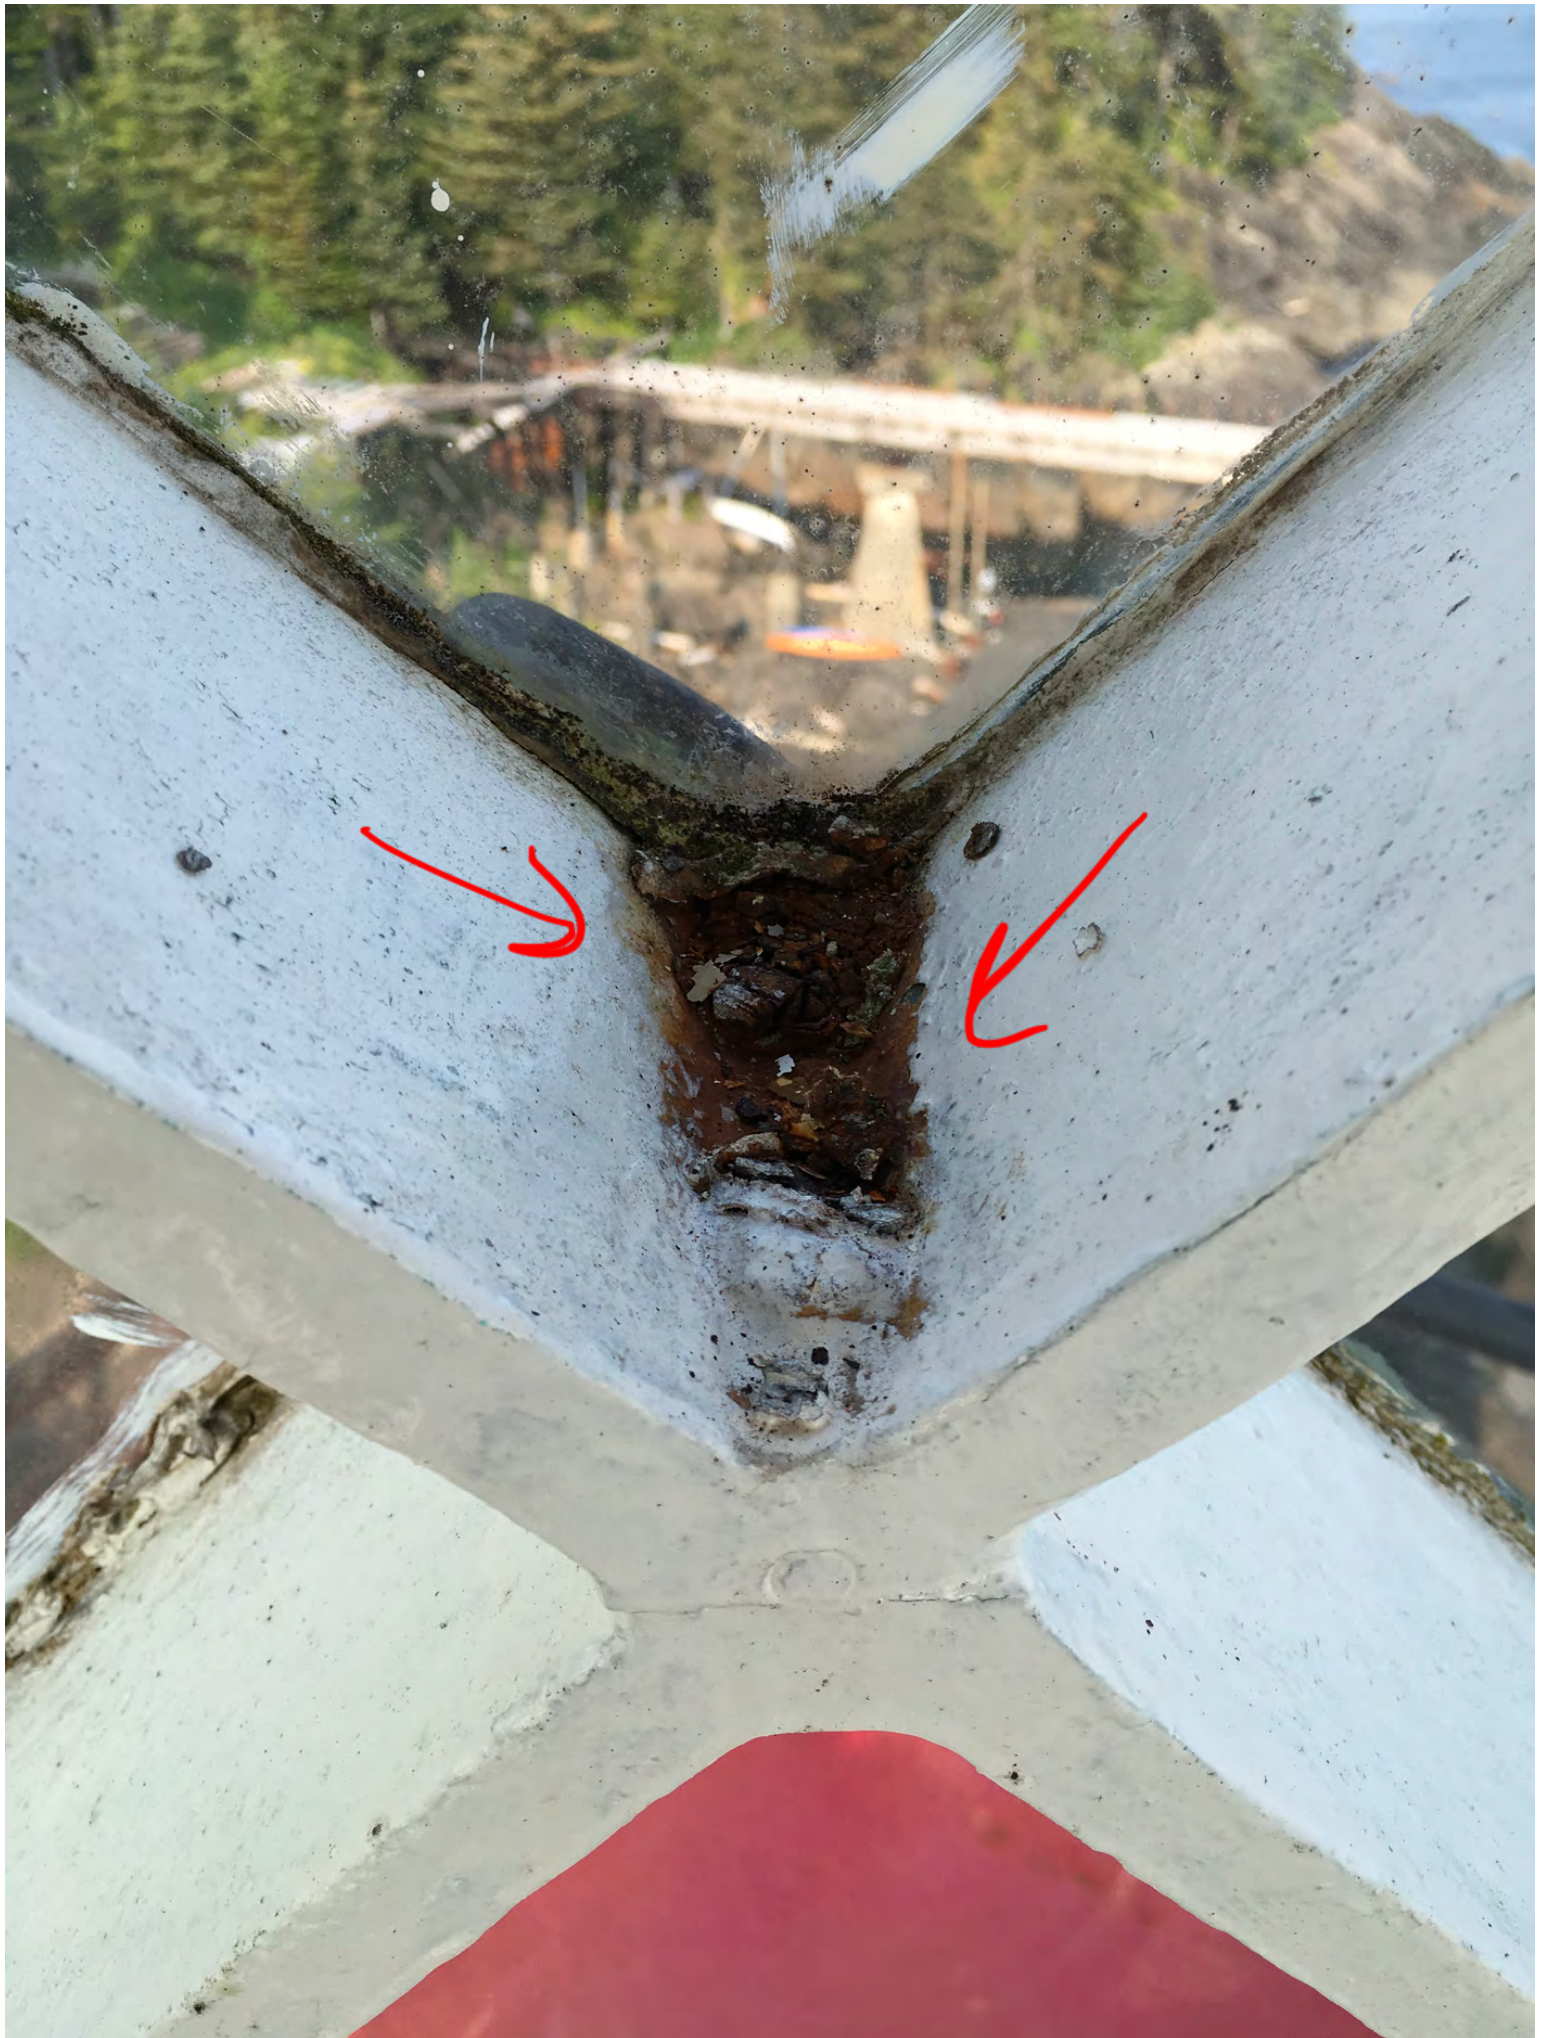
Section 2 (cont):

Galvanic corrosion of ferrous hardware.

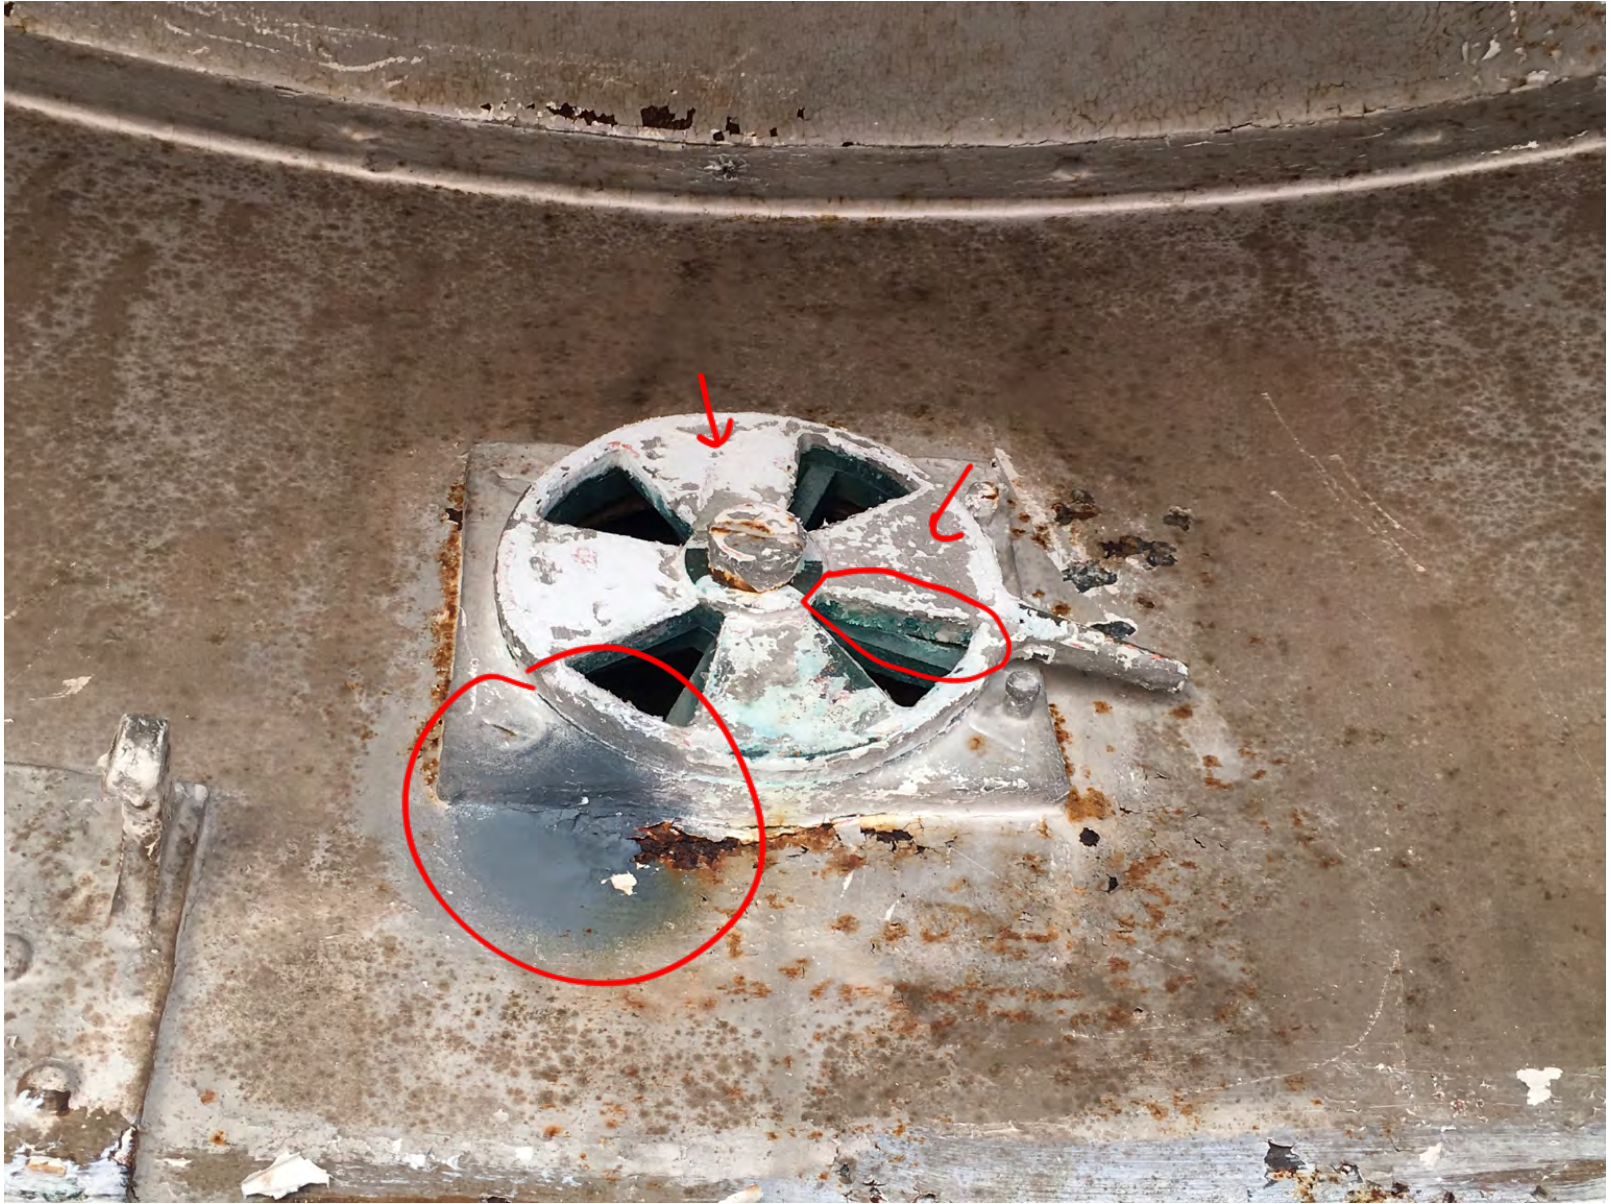
Section 2 (cont):

The vents throughout the lantern room require a great deal of attention. This image details the Rust-oleum(?) application, flaking original paint/coating, and advanced cuprous corrosion.

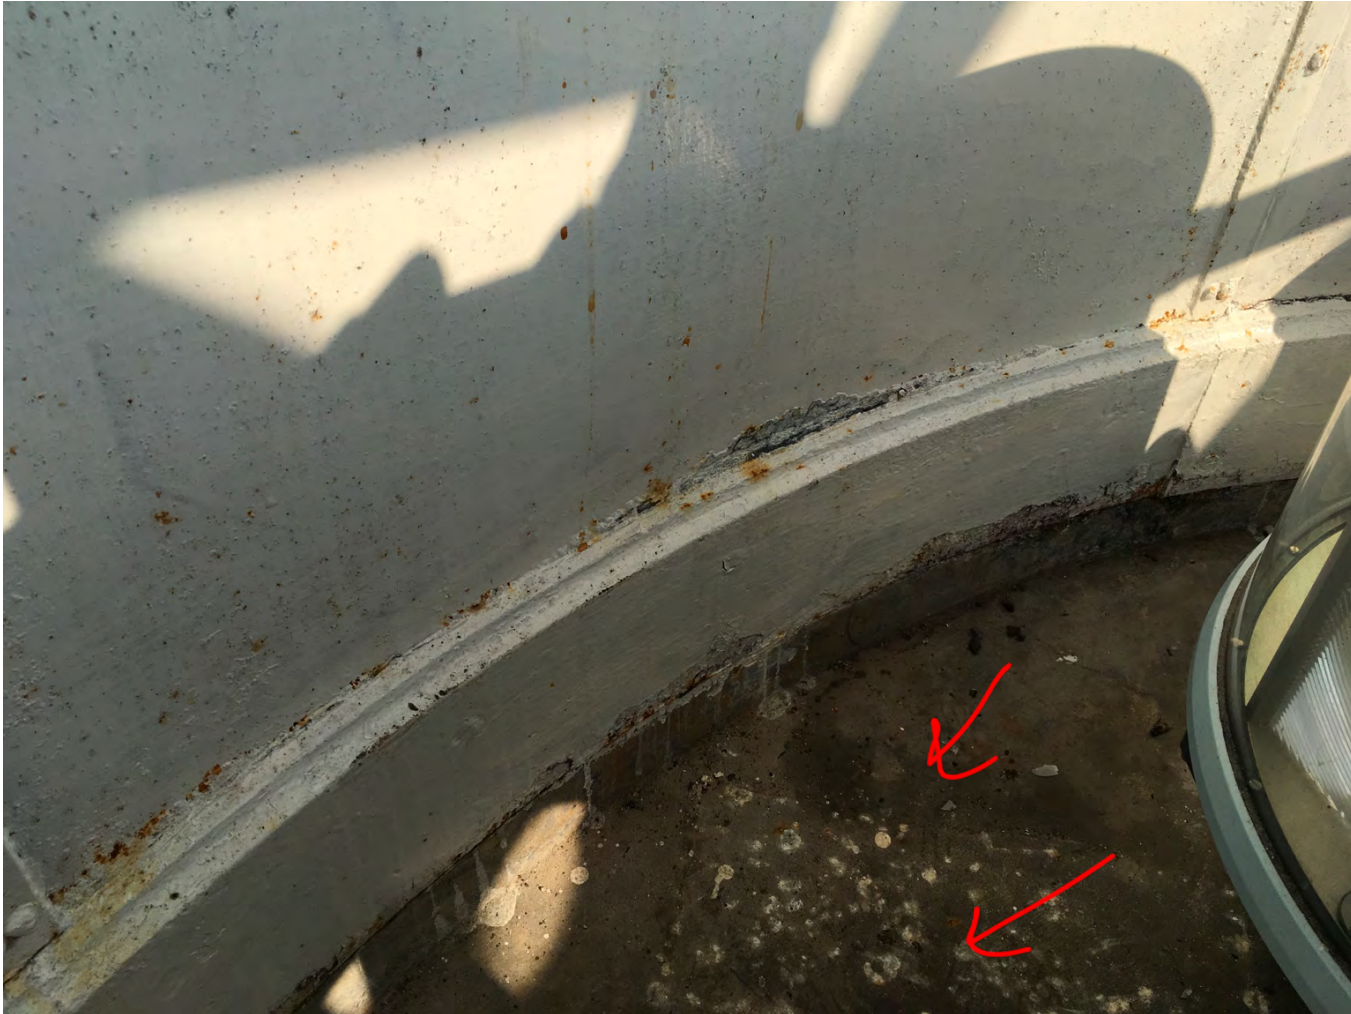
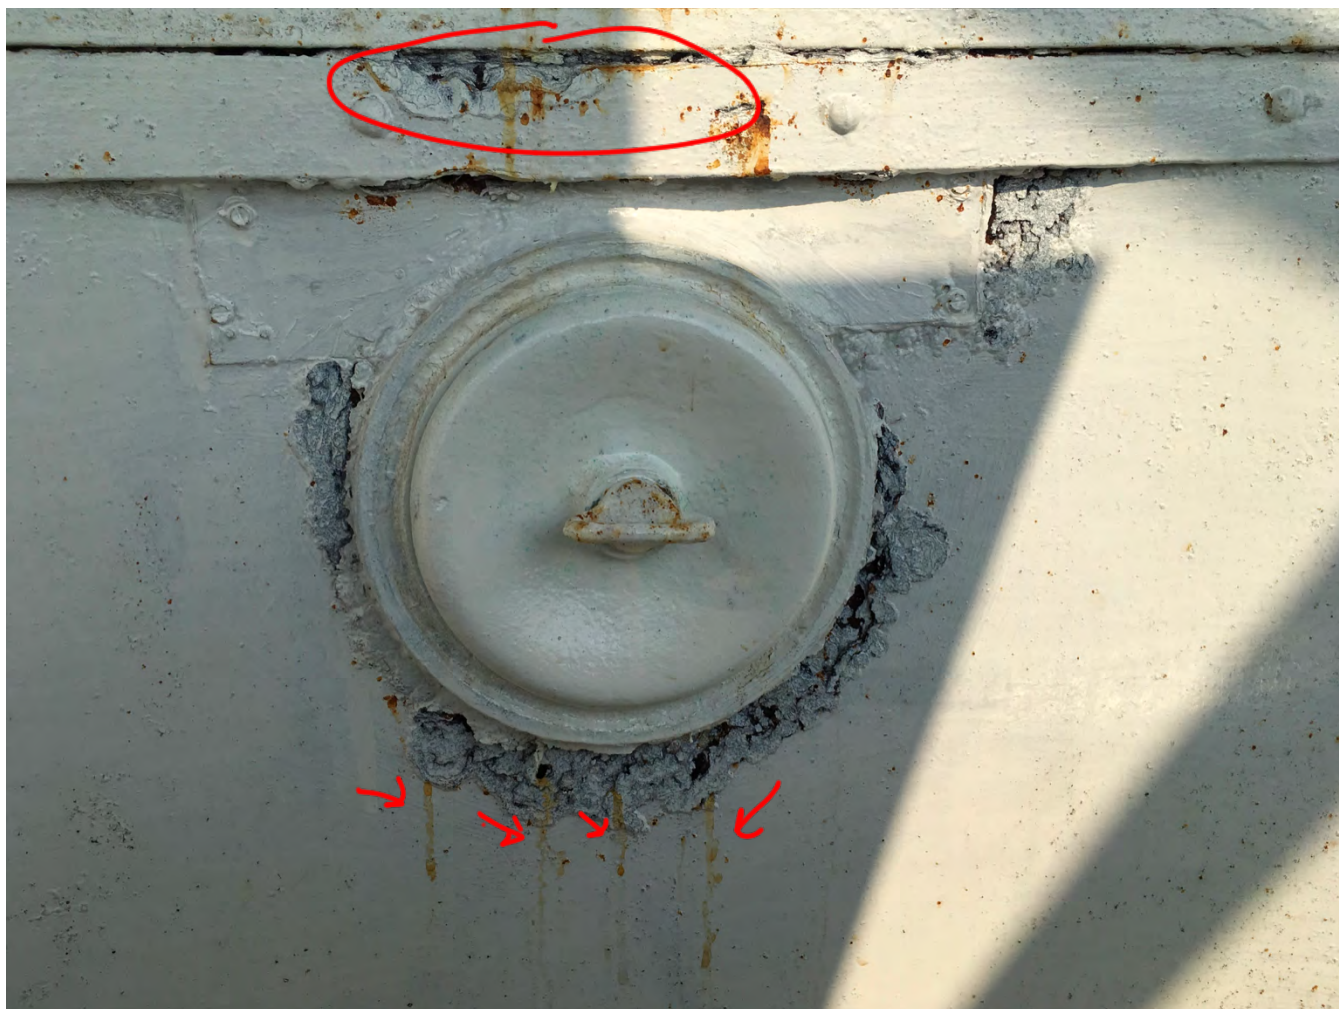
Section 3:

Top: Paint splatters and spilled oil on concrete floor inside lantern room. Evidence of iron corrosion penetrating through paint coating. Bottom: Localized corrosion due to water infiltration around vent and staining from iron corrosion drips.

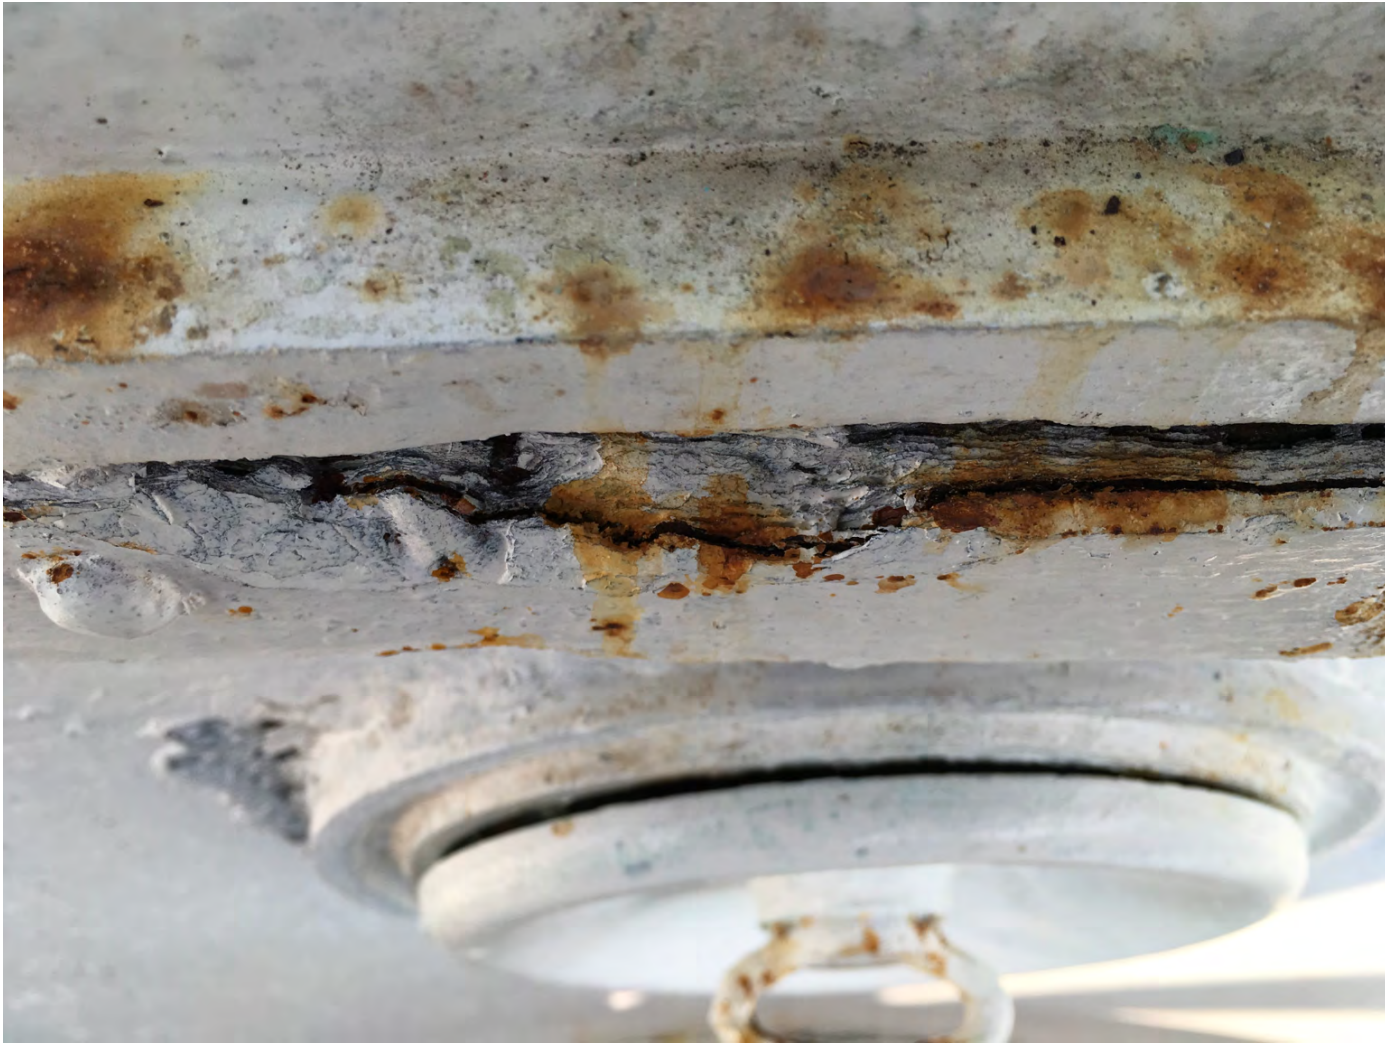
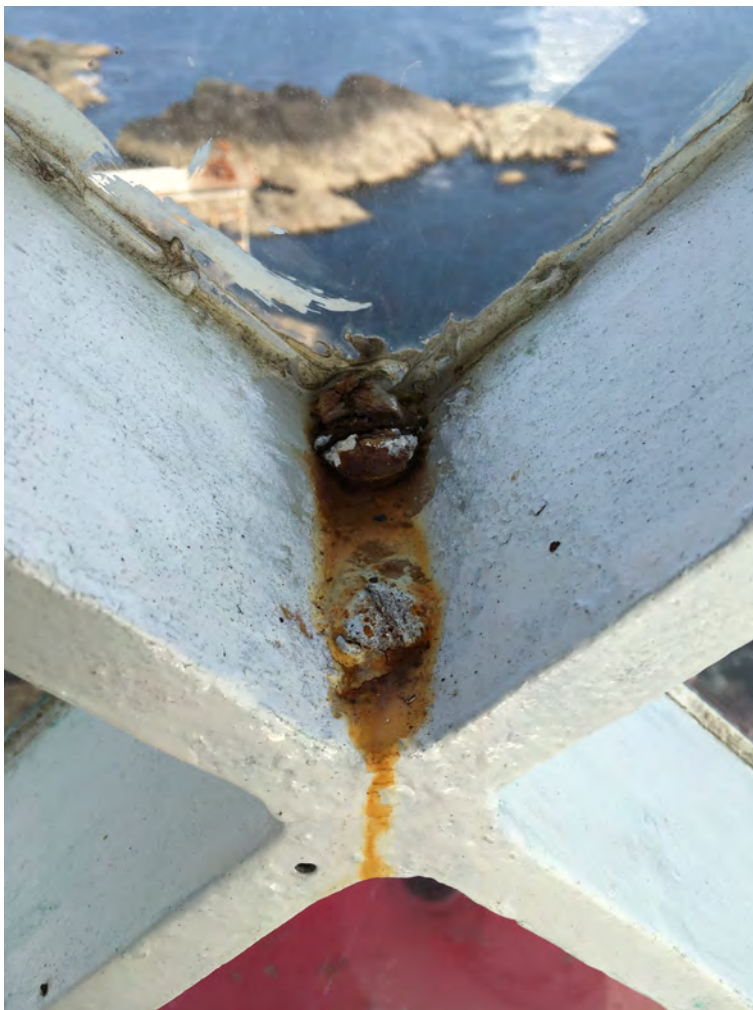
Section 3 (cont):

Details of iron corrosion staining and penetration through paint coating due to exposure to water and galvanic corrosion.

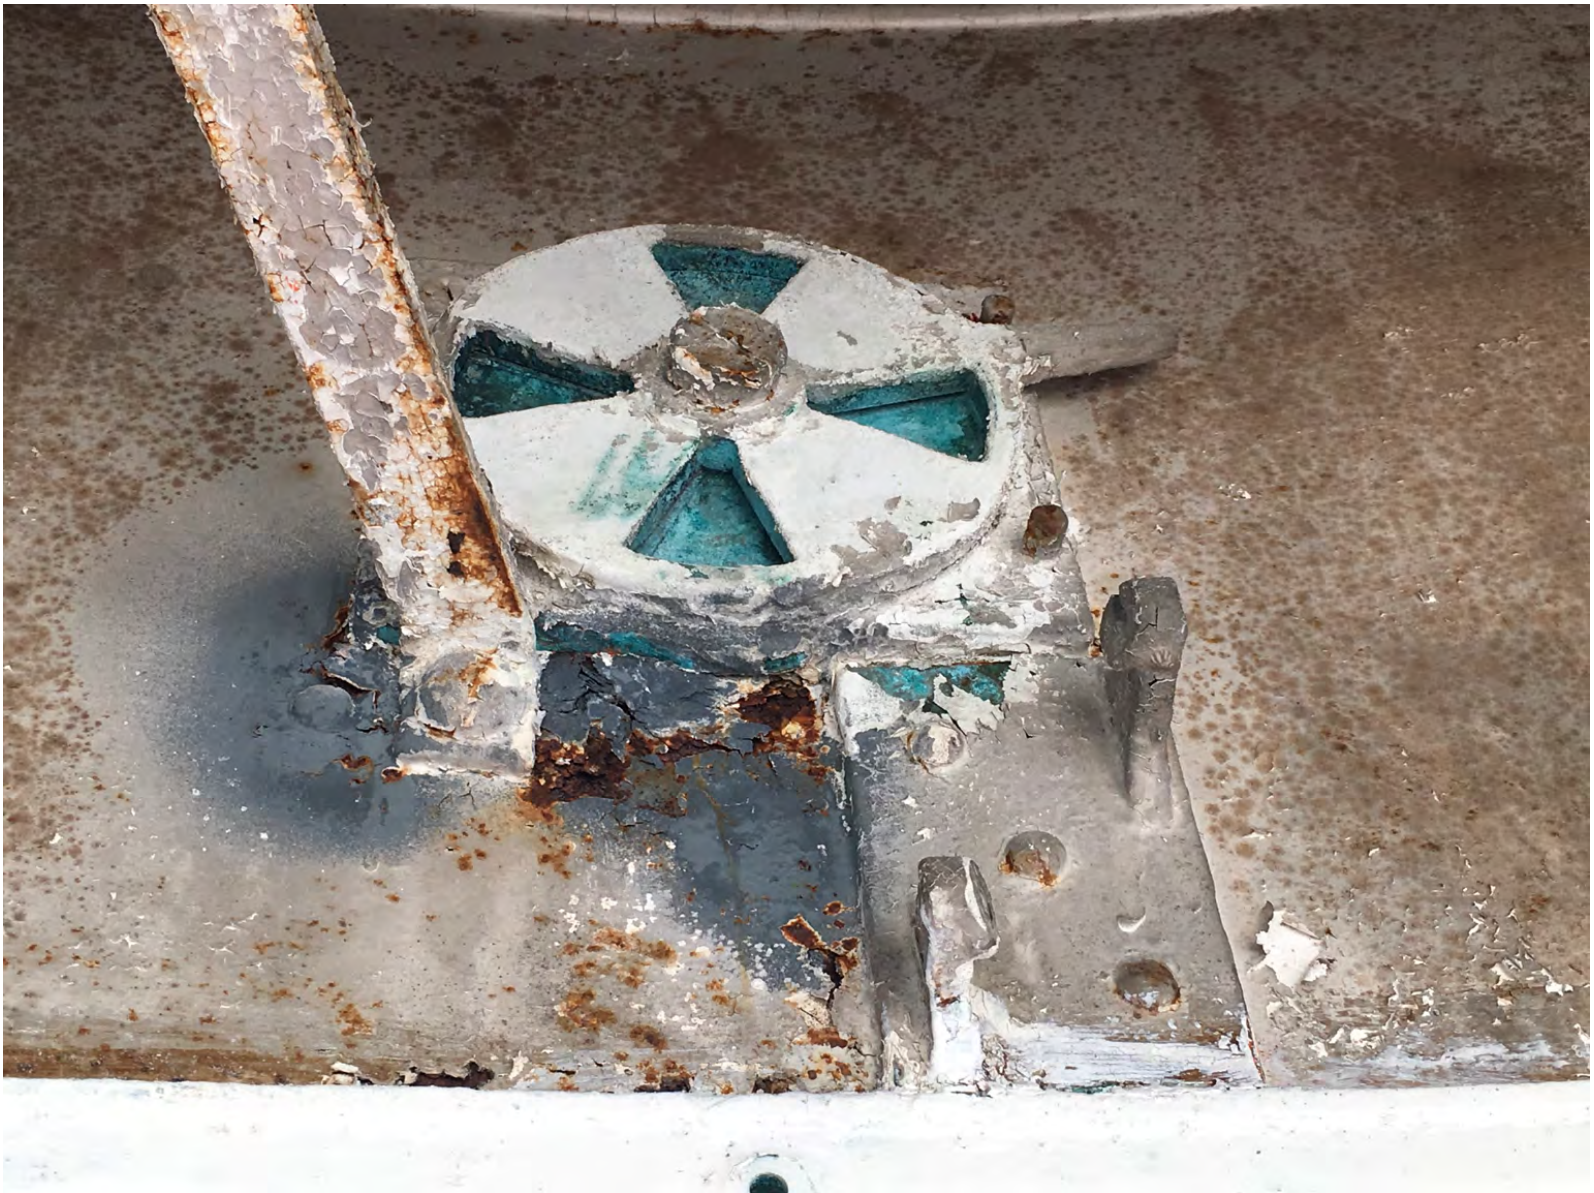
Section 3 (cont):

Detail of the vent in section 3. Rust-oleum(?) application, flaking paint system, advanced cuprous corrosion, delaminating and flaking of ferrous metal.
