CAPE DECISION LIGHTHOUSE SOCIETY (CDLS)

CONSERVATION CONDITION ASSESSMENT OF THE
CAPE DECISION LIGHTHOUSE
CUPOLA AND LANTERN ROOM

JULY 07-10, 2019

REPORT BY:
NICOLE PETERS, CONSERVATOR
PETERS ART CONSERVATION SERVICES, LLC

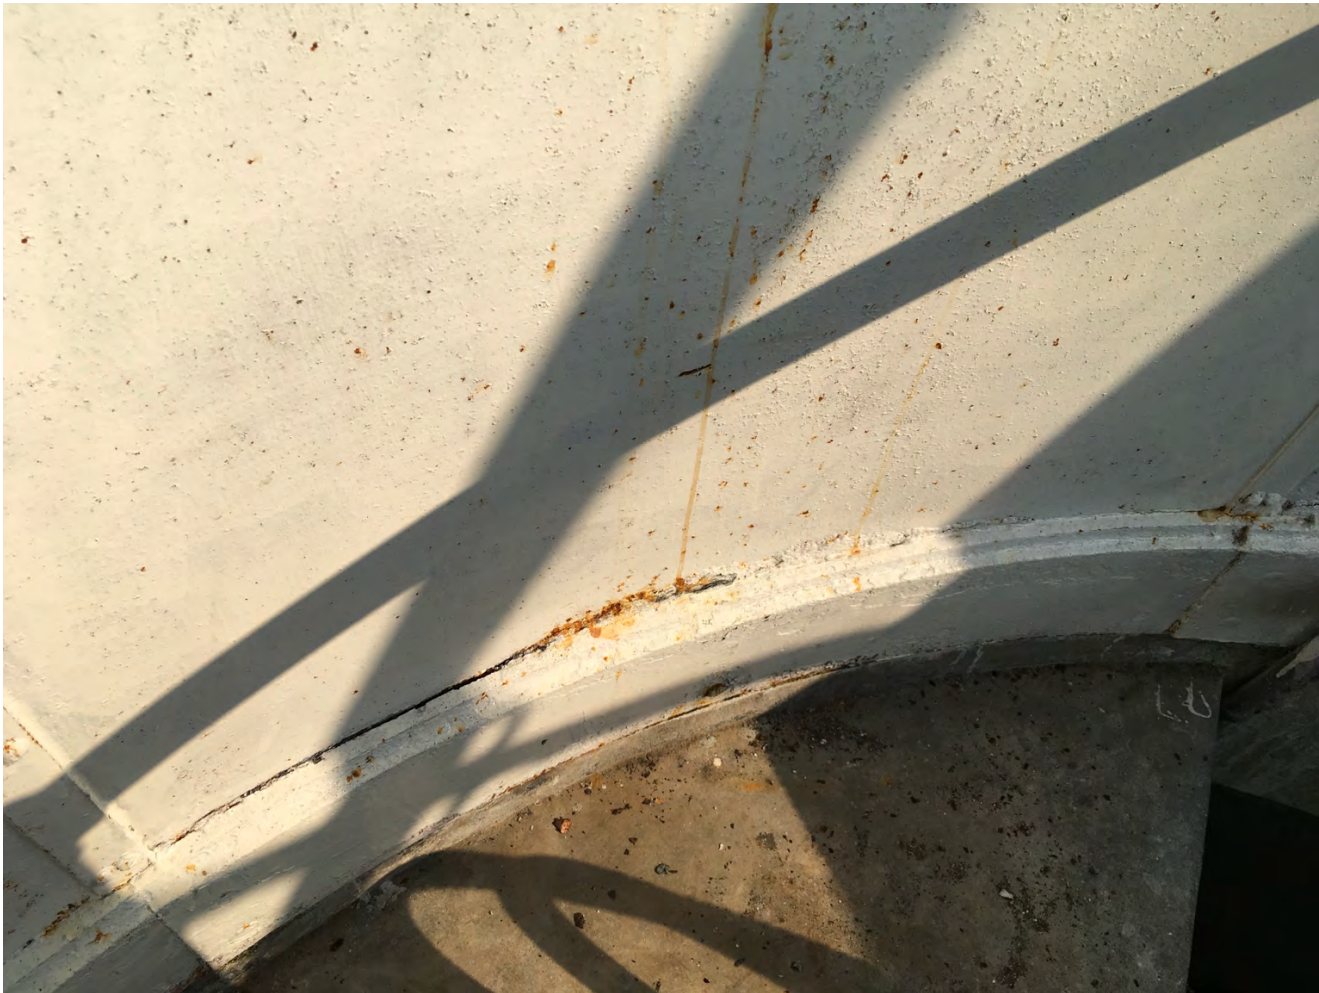
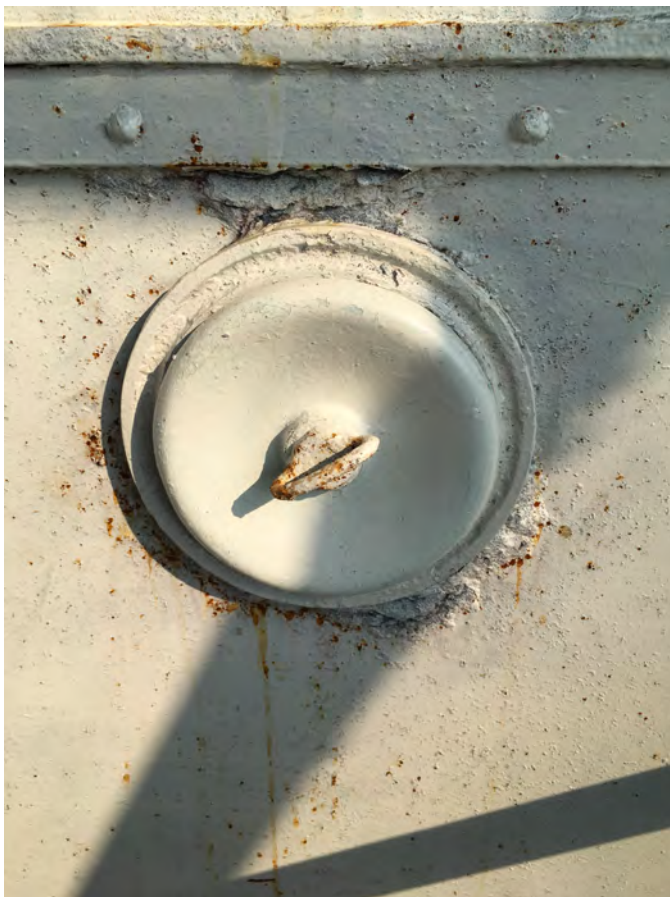
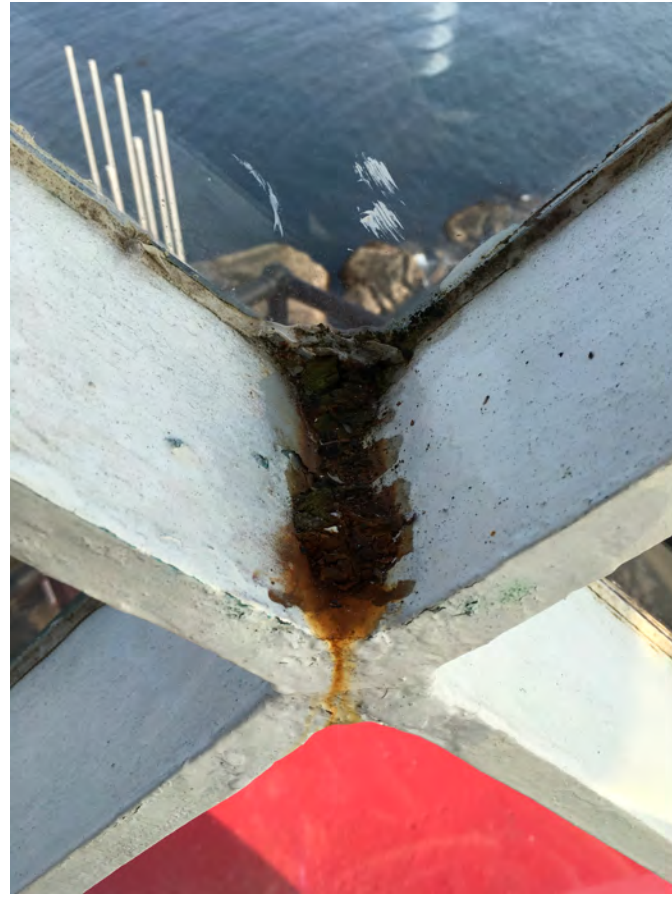
Section 4

Top: Iron corrosion spots penetrating through paint coating. Bottom right: Advanced galvanic corrosion of ferrous hardware. Bottom left: Iron corrosion staining from water infiltration around vents.

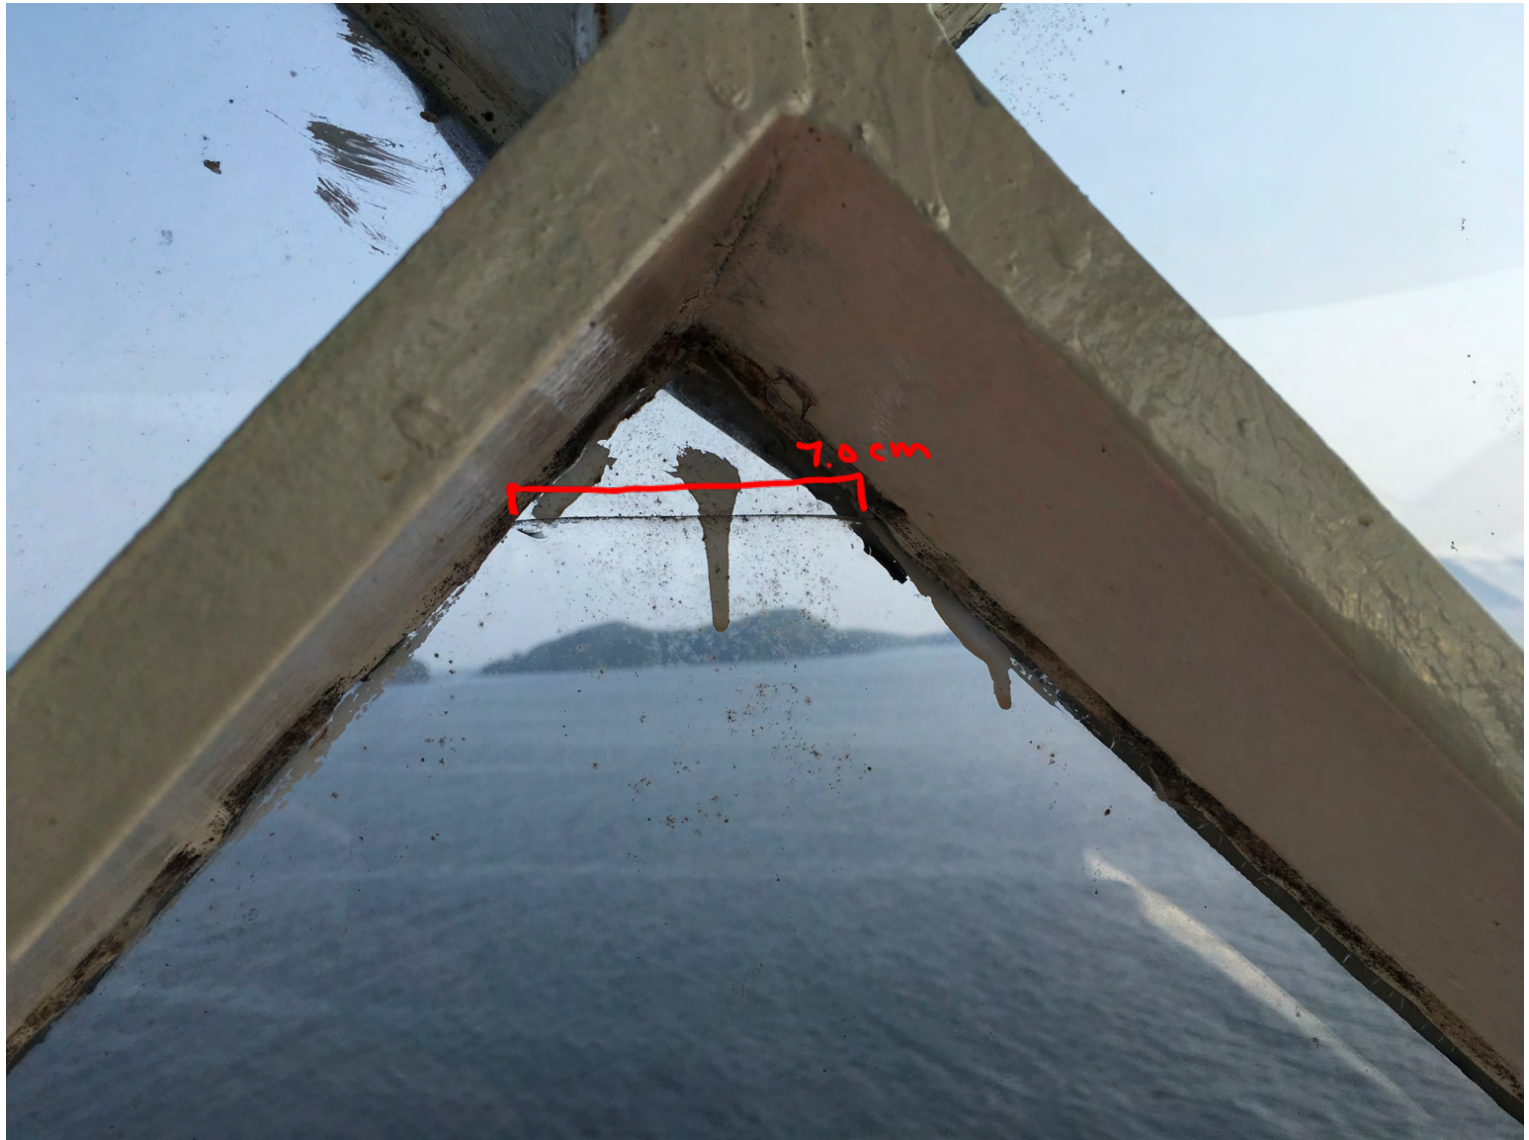
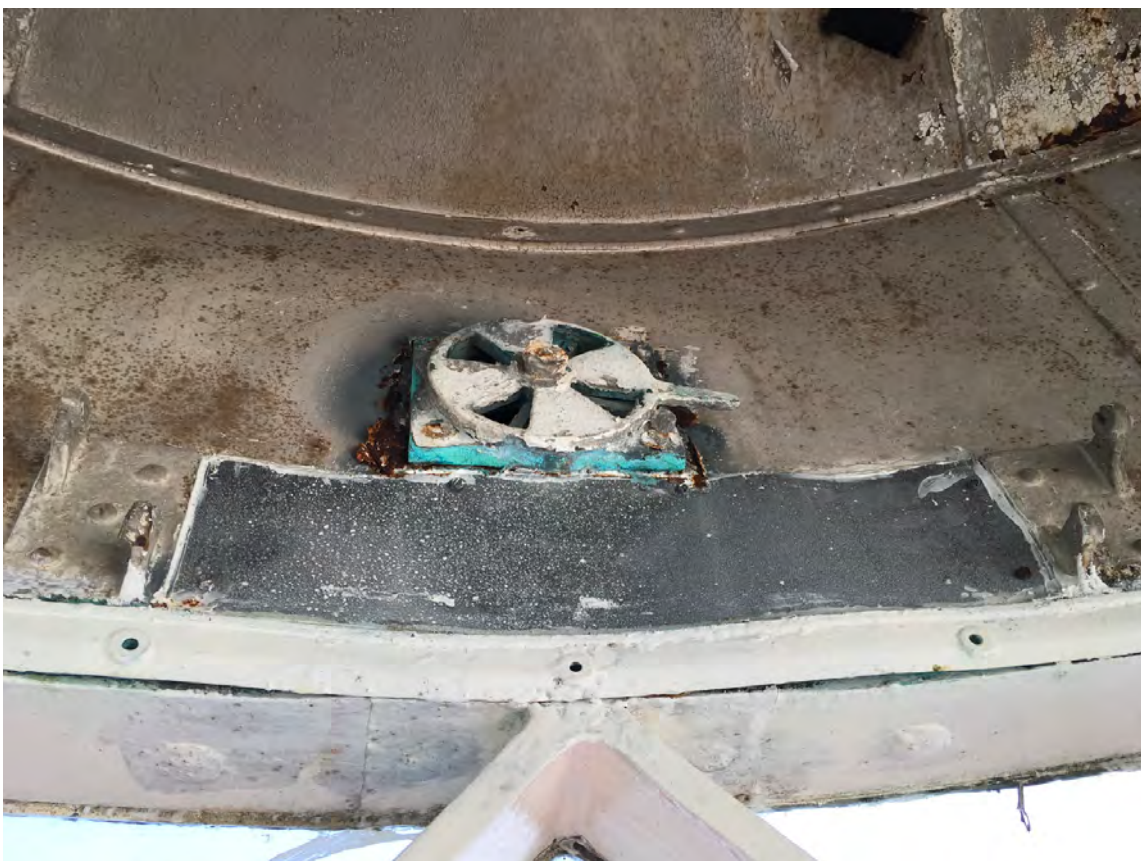
Section 4 (cont):

Top: Detail of crack in window pane. Crack currently spans the width of the pane in that area- approximately 7 centimeters. Bottom: Detail of severe condition of vents and replacement patch(?) just below. There are no records of this restoration.

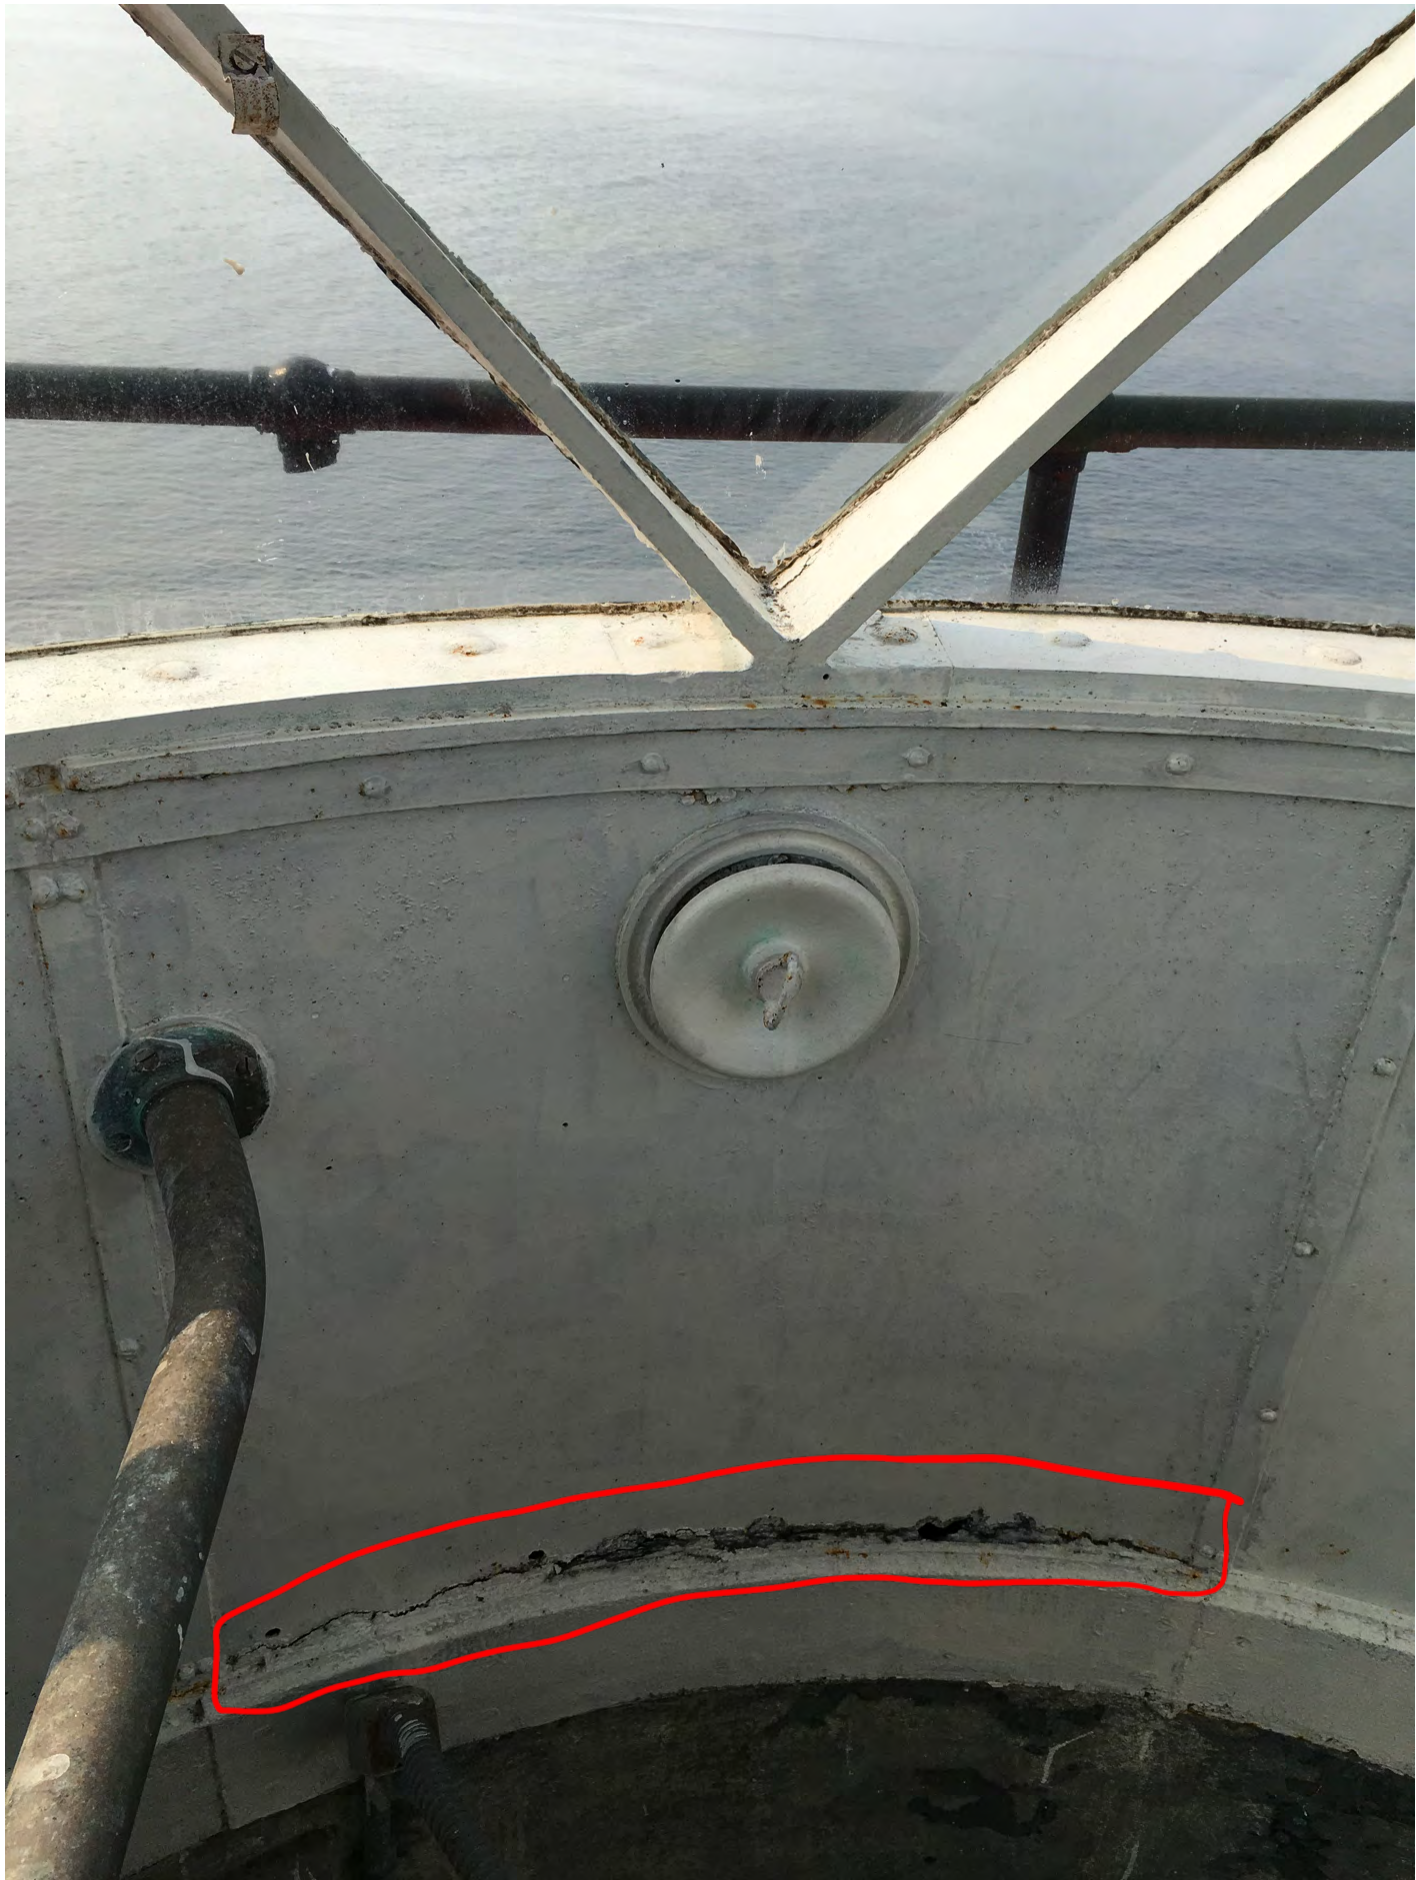
Section 5

Detail of advanced corrosion resulting in loss of structure. Area requires patch/sealing.

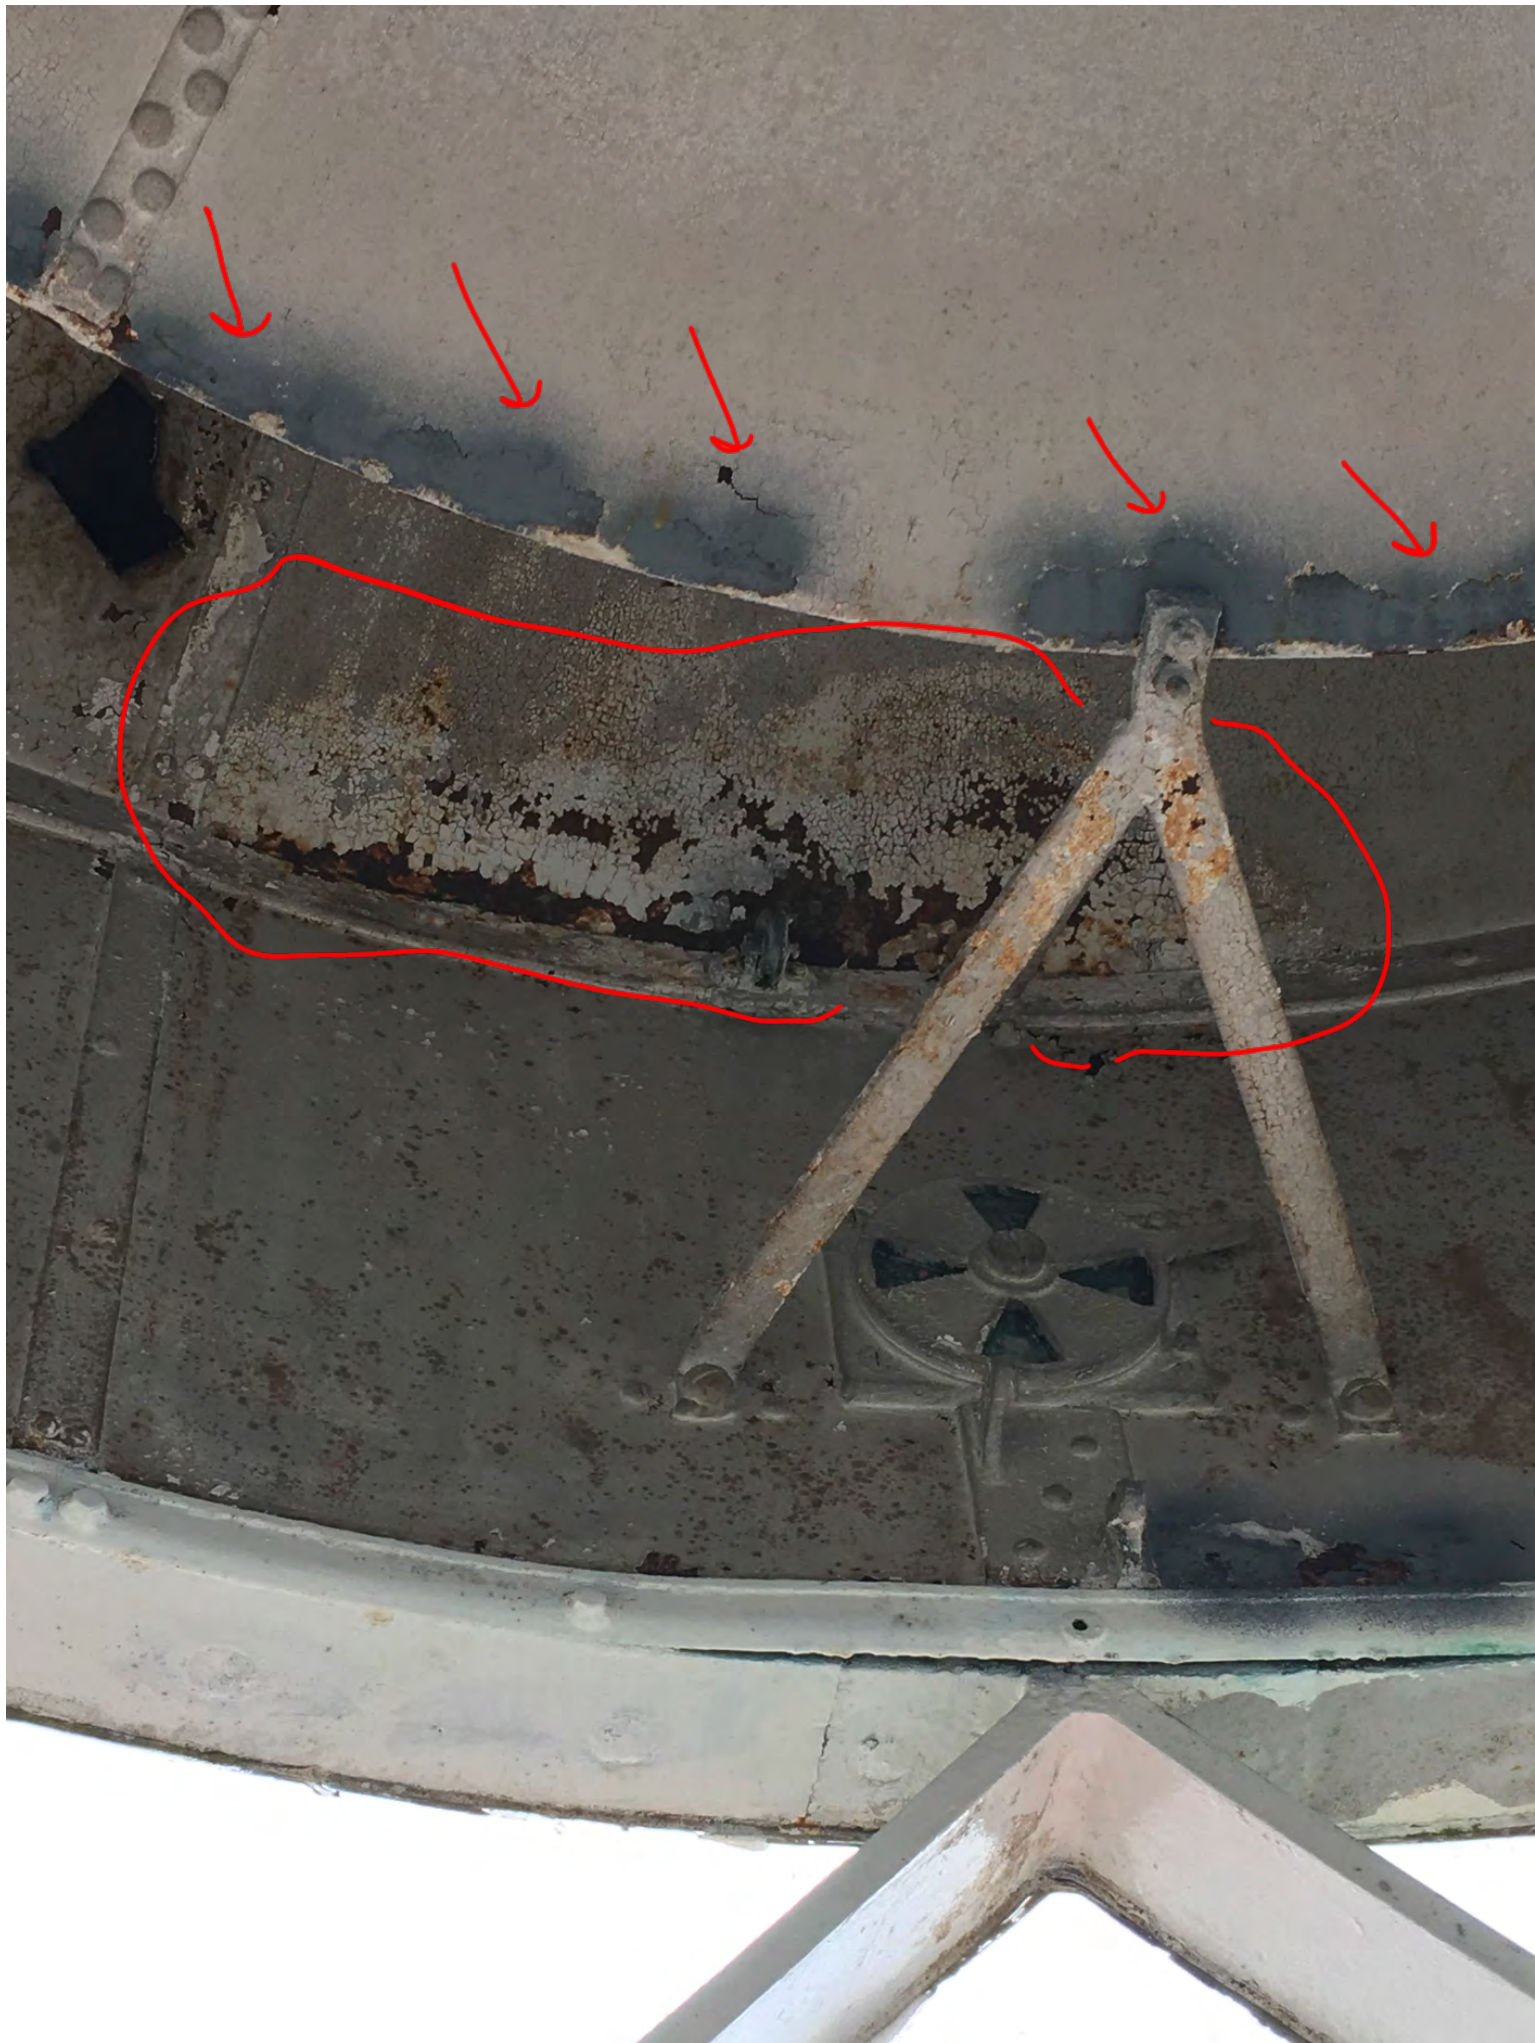
Detail of Rust-oleum(?) application and flaking paint system along upper ferrous panels.

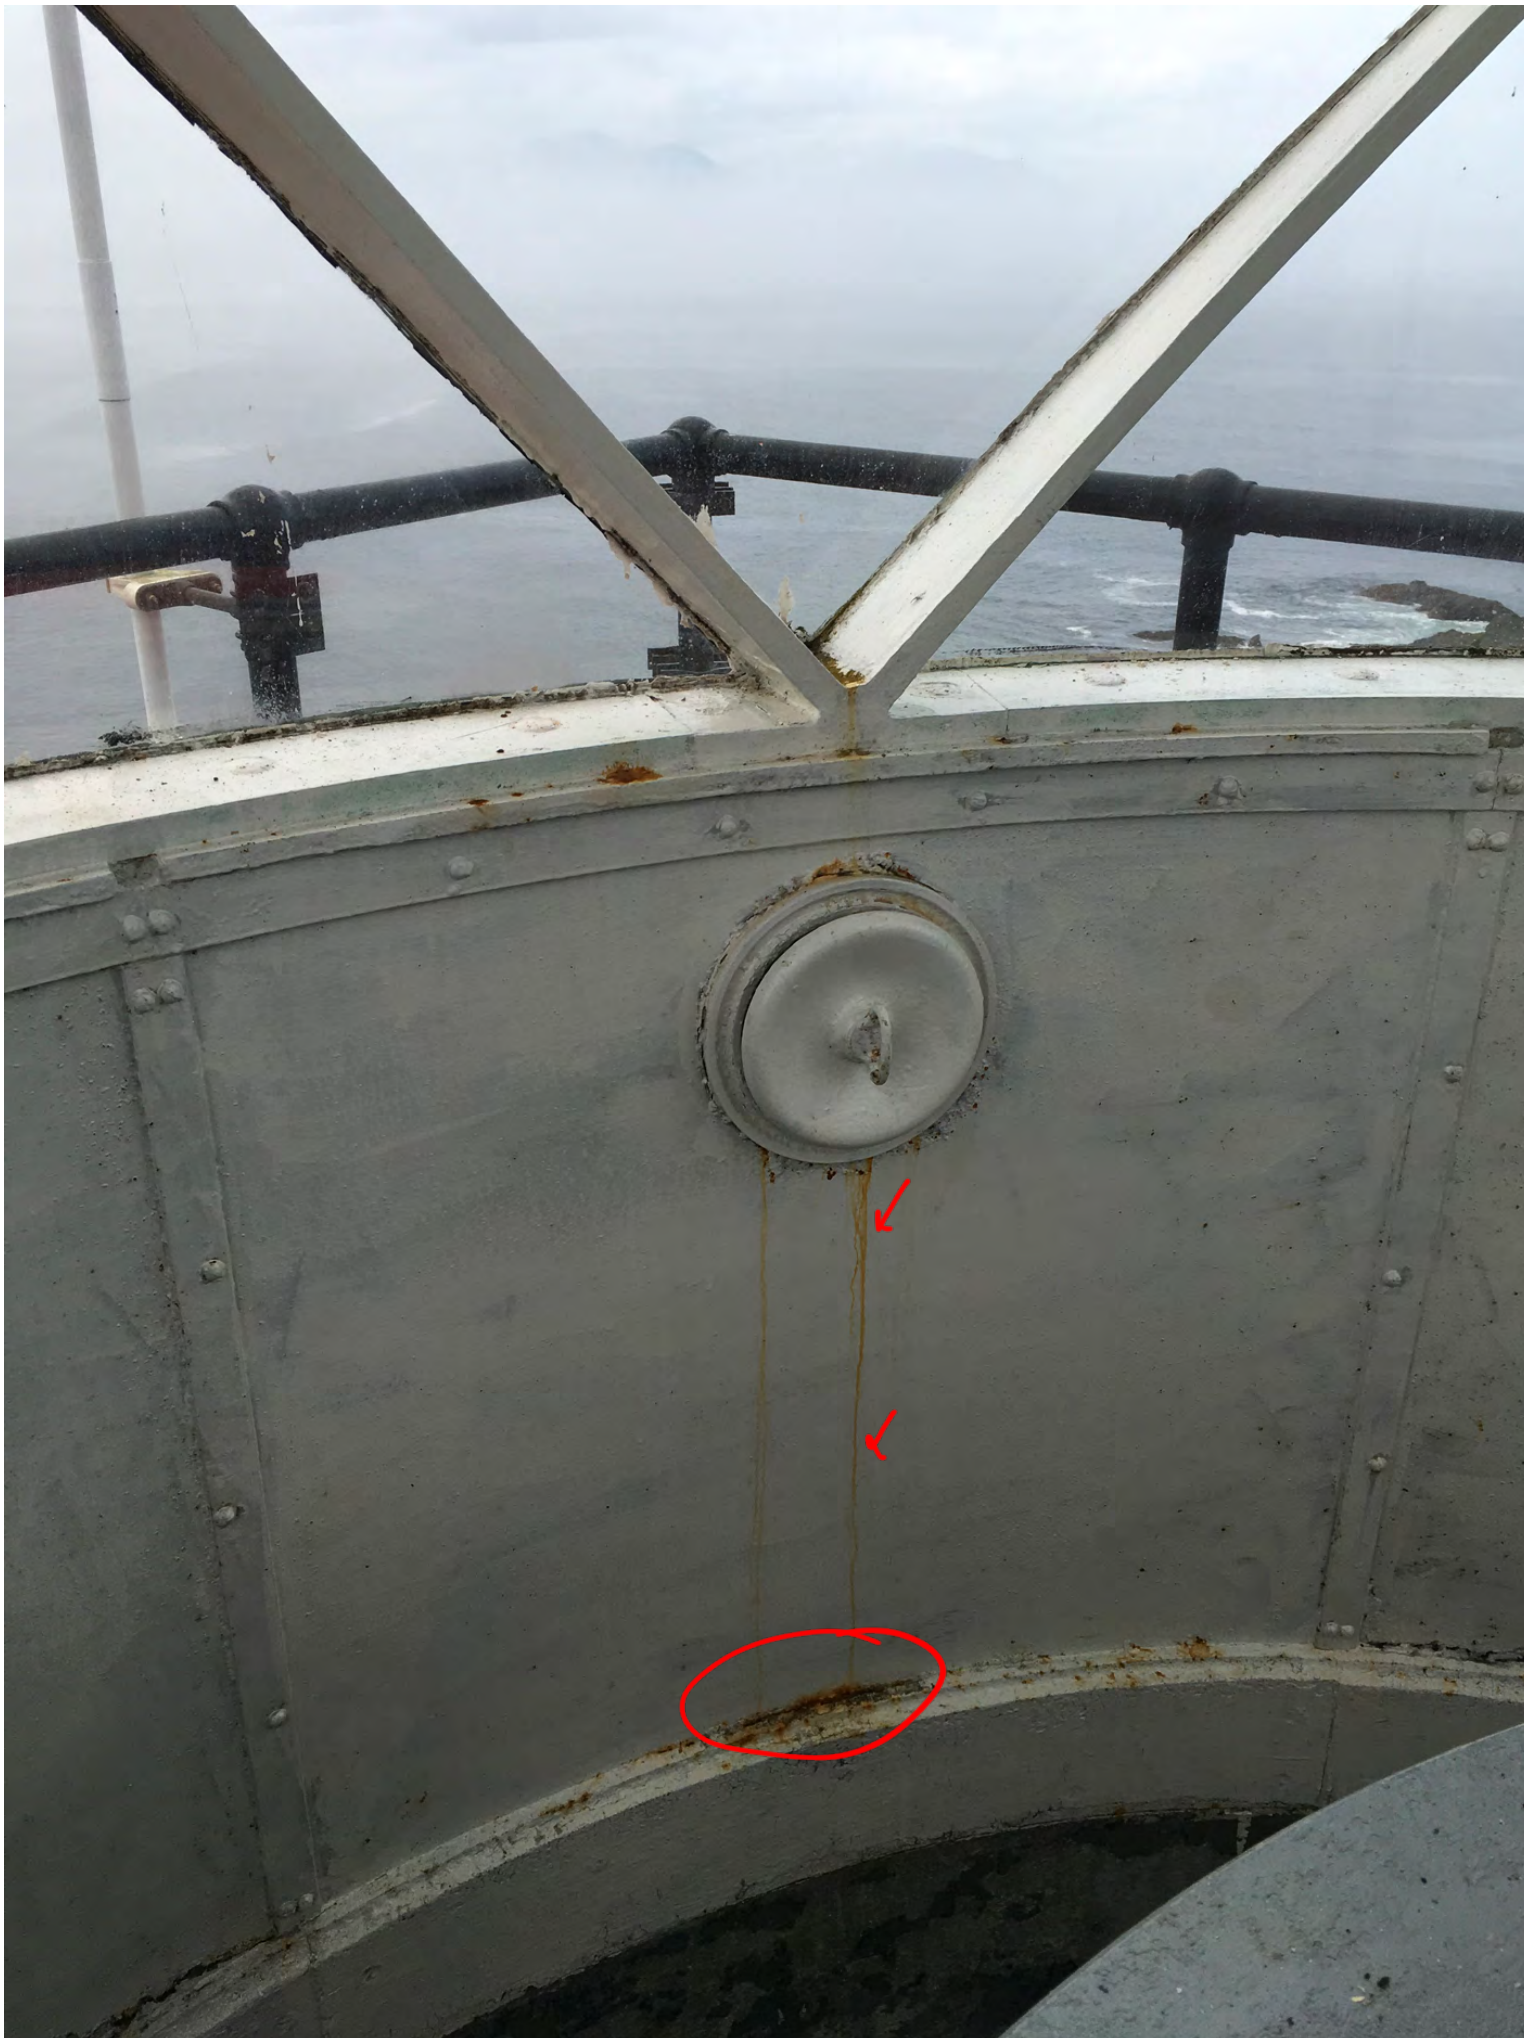
Section 6

Evidence of water infiltration through vents, resulting in iron corrosion staining and water puddling along bottom panel.

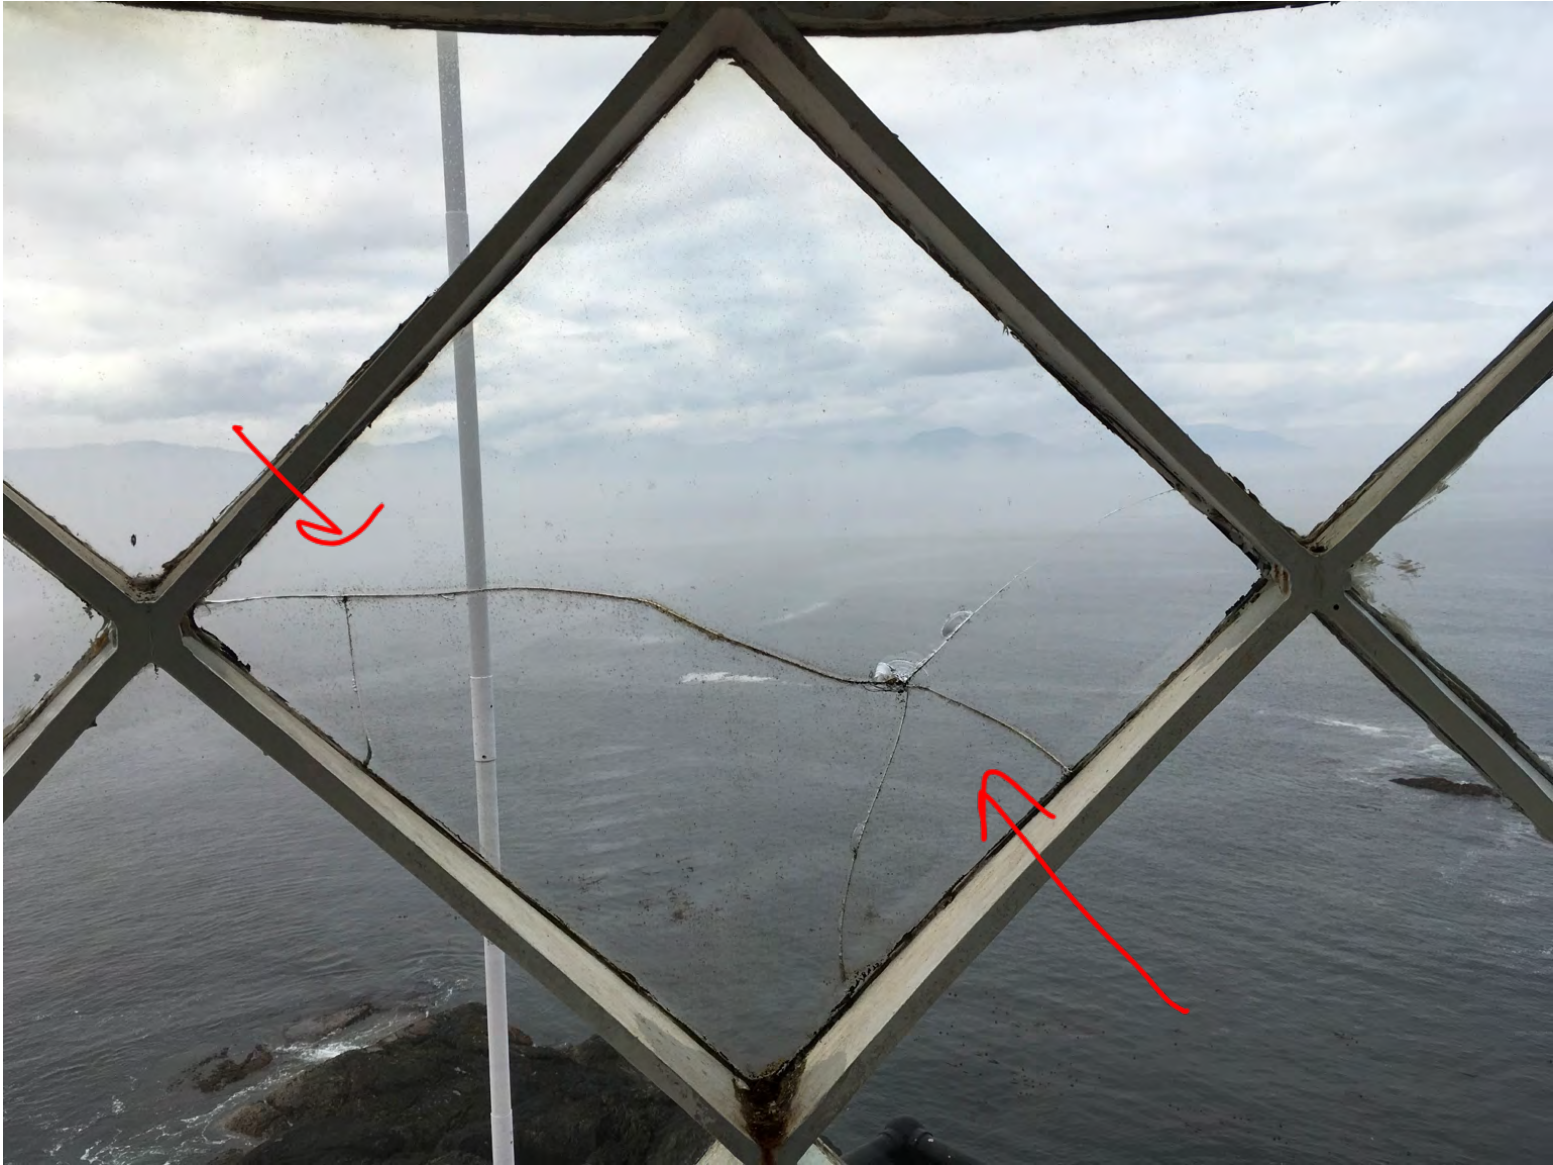
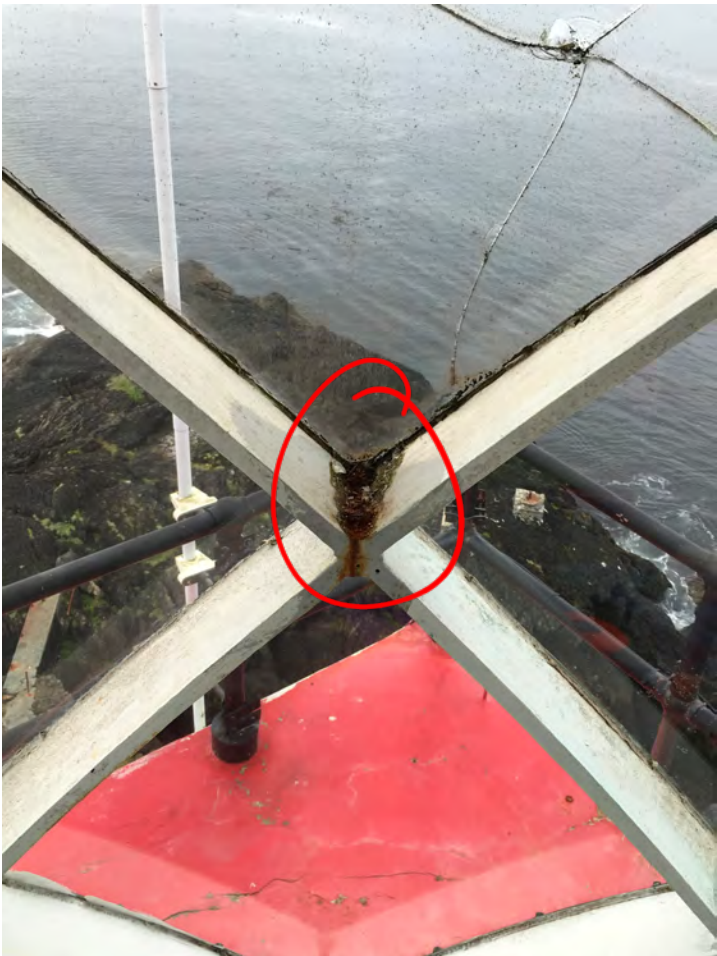
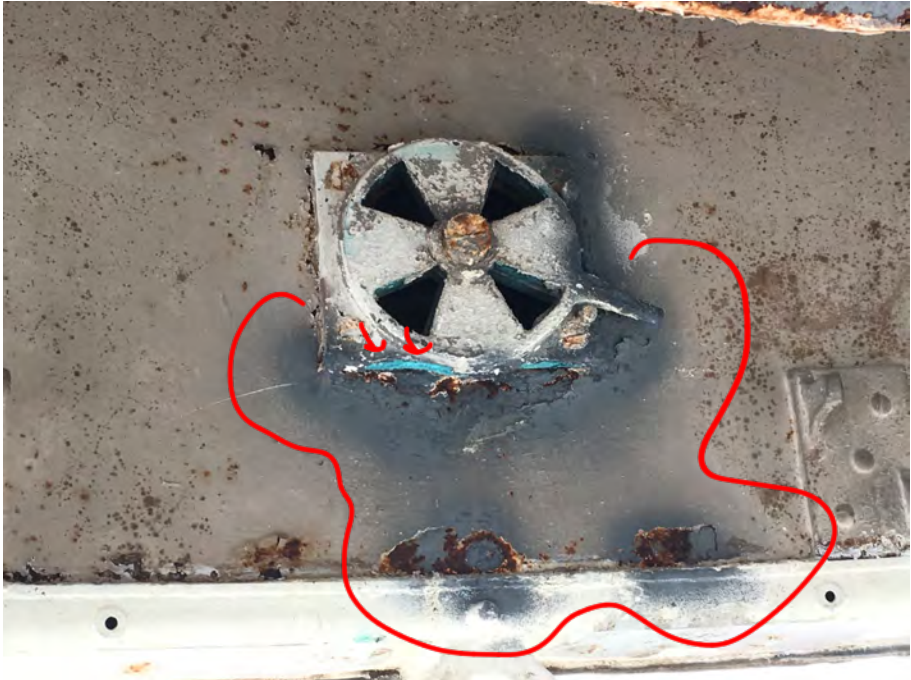
Section 6 (cont)

Detail of cracked glass pane on S/SW facing side. Damage is thought to have been caused by a bullet. It has been noted that damage has become worse over the years.

Top: Detail of cracked window pane and the multiple fissures extending from impact point. Bottom right; detail of vent in severe condition. Bottom left: detail of advanced galvanic corrosion of ferrous hardware.

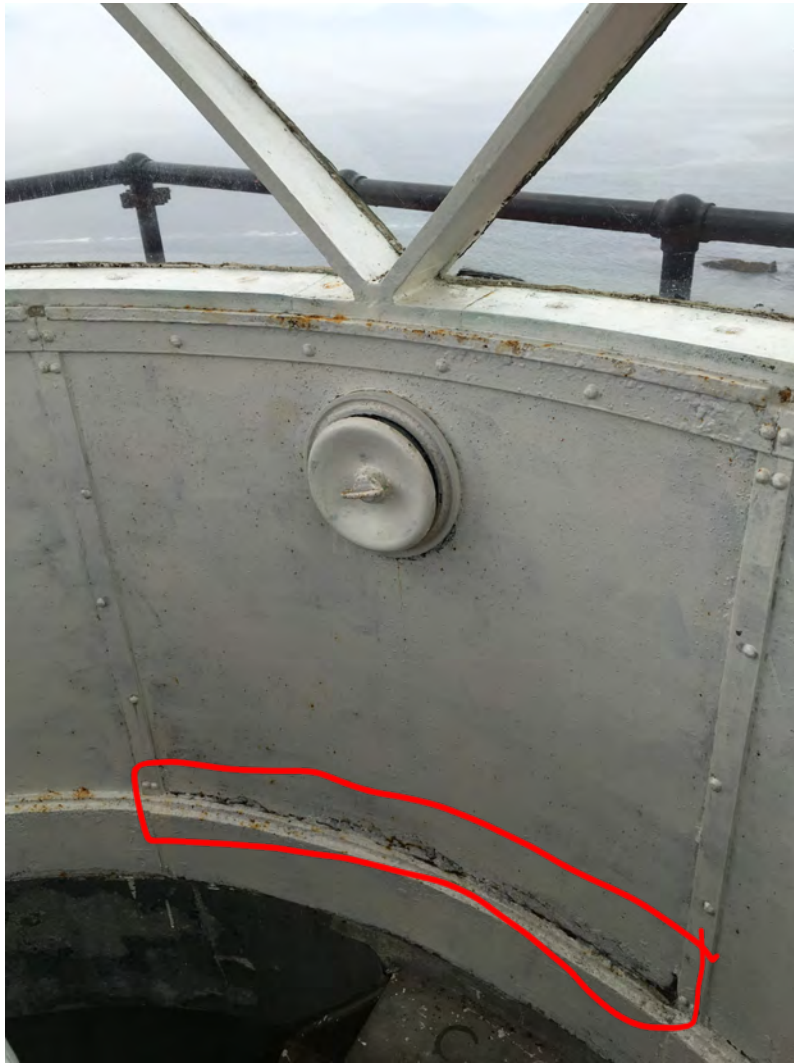
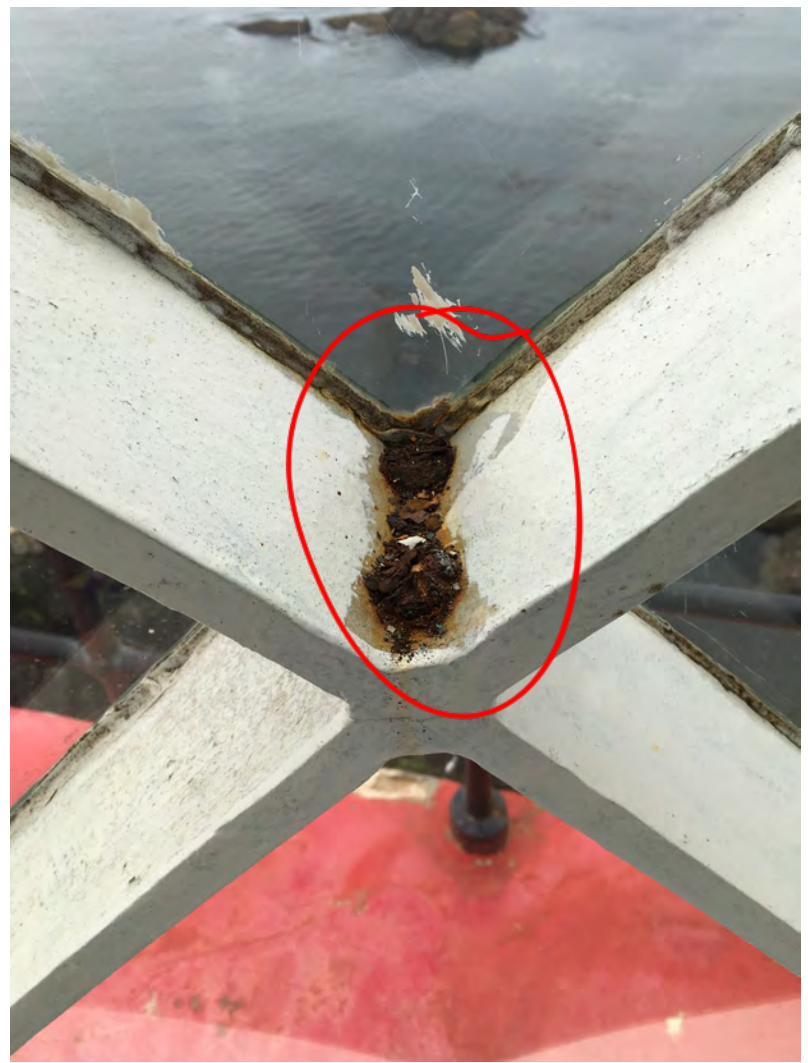
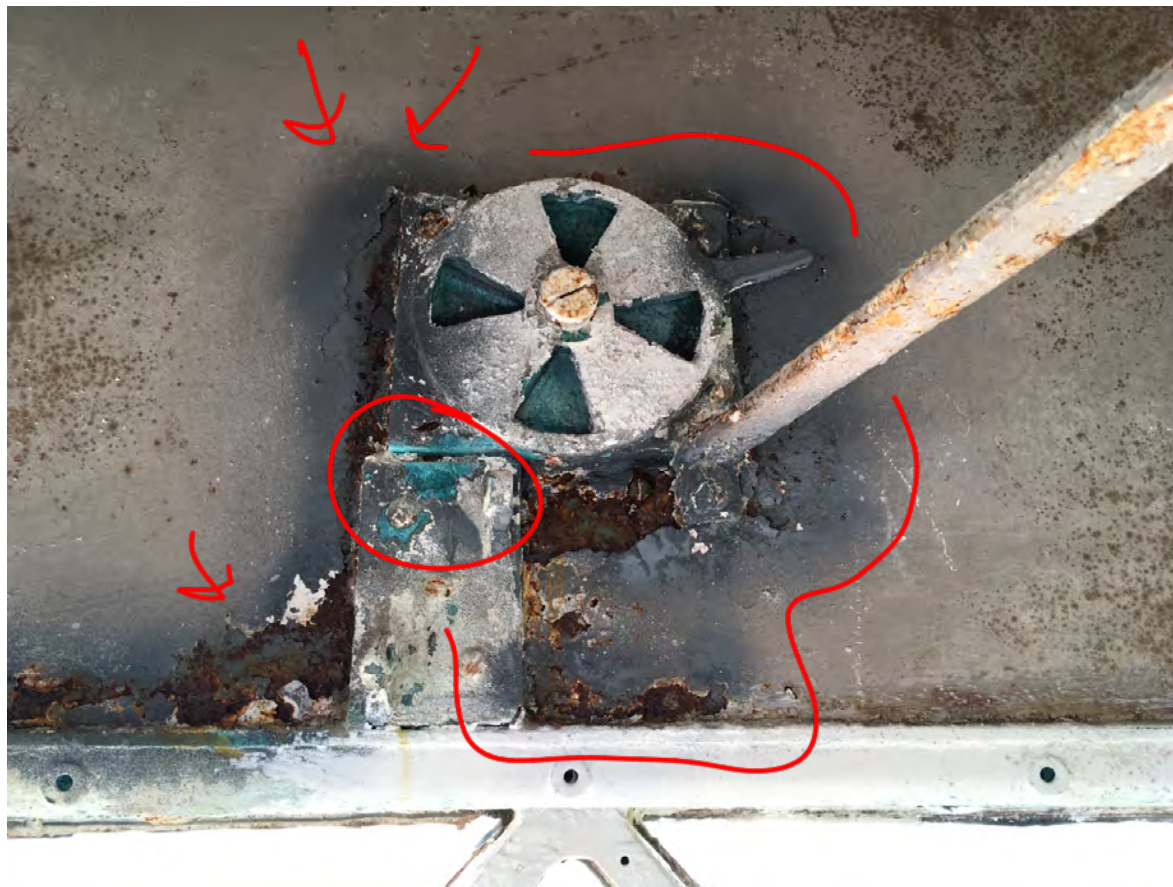
Section 7

Top left: Detail of advanced corrosion resulting in loss of structure. Area requires patch/sealing. Top right: Advanced galvanic corrosion of ferrous hardware. Bottom: Severe condition of vents (same issues noted on the other vents in lantern room.)
