CAPE DECISION LIGHTHOUSE SOCIETY (CDLS)

CONSERVATION CONDITION ASSESSMENT OF THE
CAPE DECISION LIGHTHOUSE
CUPOLA AND LANTERN ROOM

JULY 07-10, 2019

REPORT BY:
NICOLE PETERS, CONSERVATOR
PETERS ART CONSERVATION SERVICES, LLC

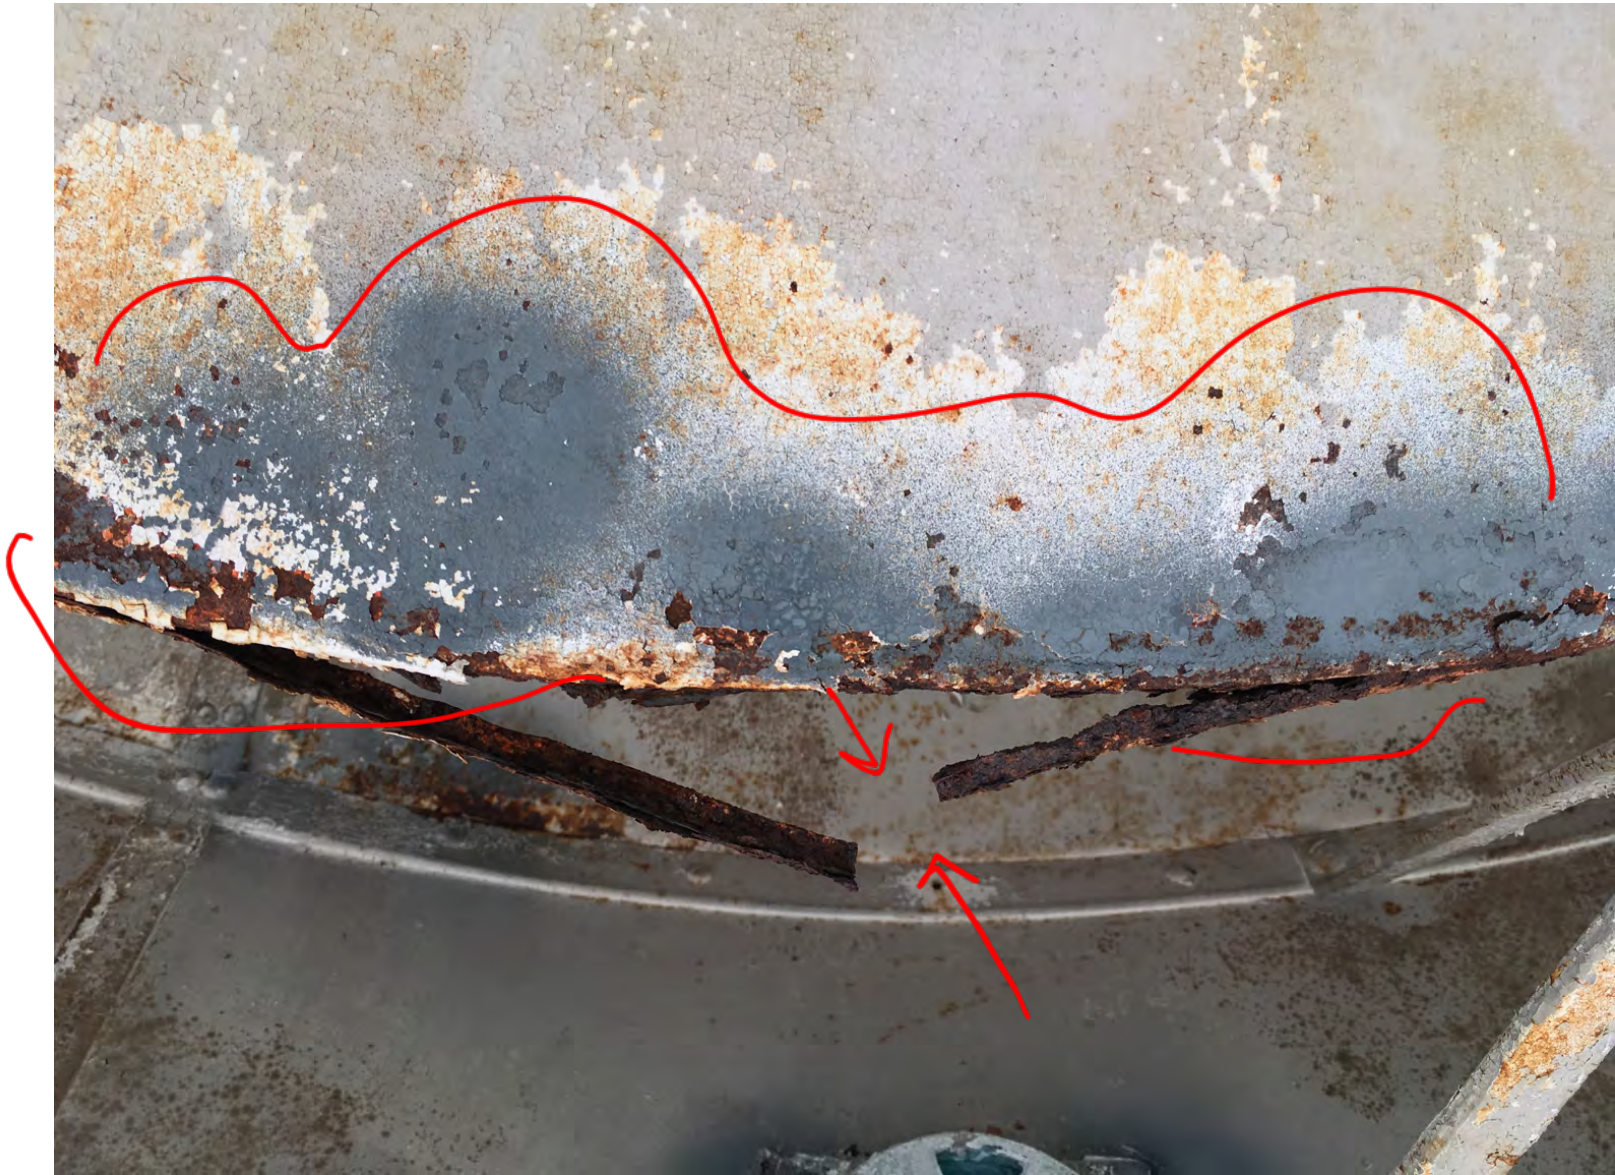
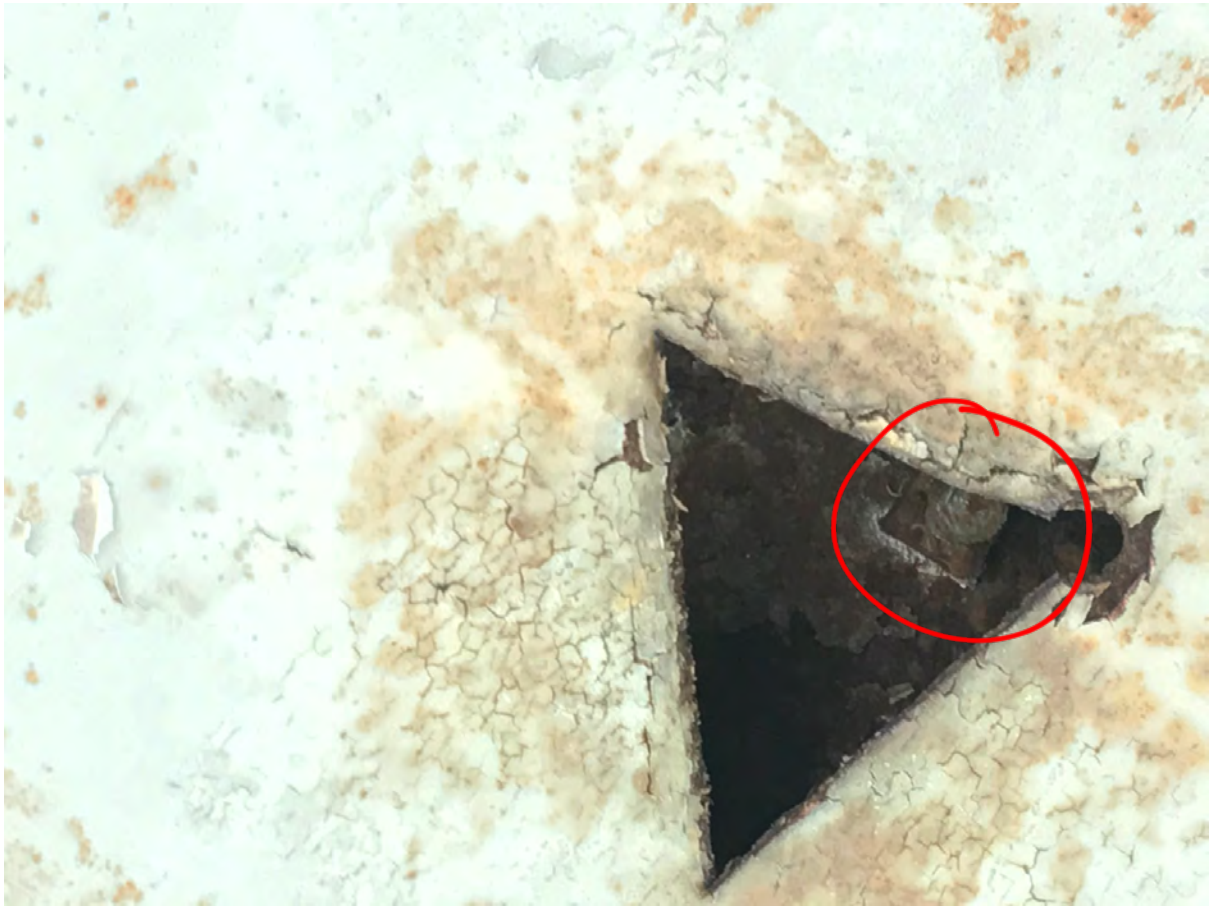
Section 7 (cont)

Top: Broken liner component due to advanced corrosion and degradation of structure. Rust-oleum(?) application and flaking original paint. Bottom: Attempted photographic documentation of the bolts in the top of the ceiling. These may be auxiliary hardware supports for the exterior cupola railing.

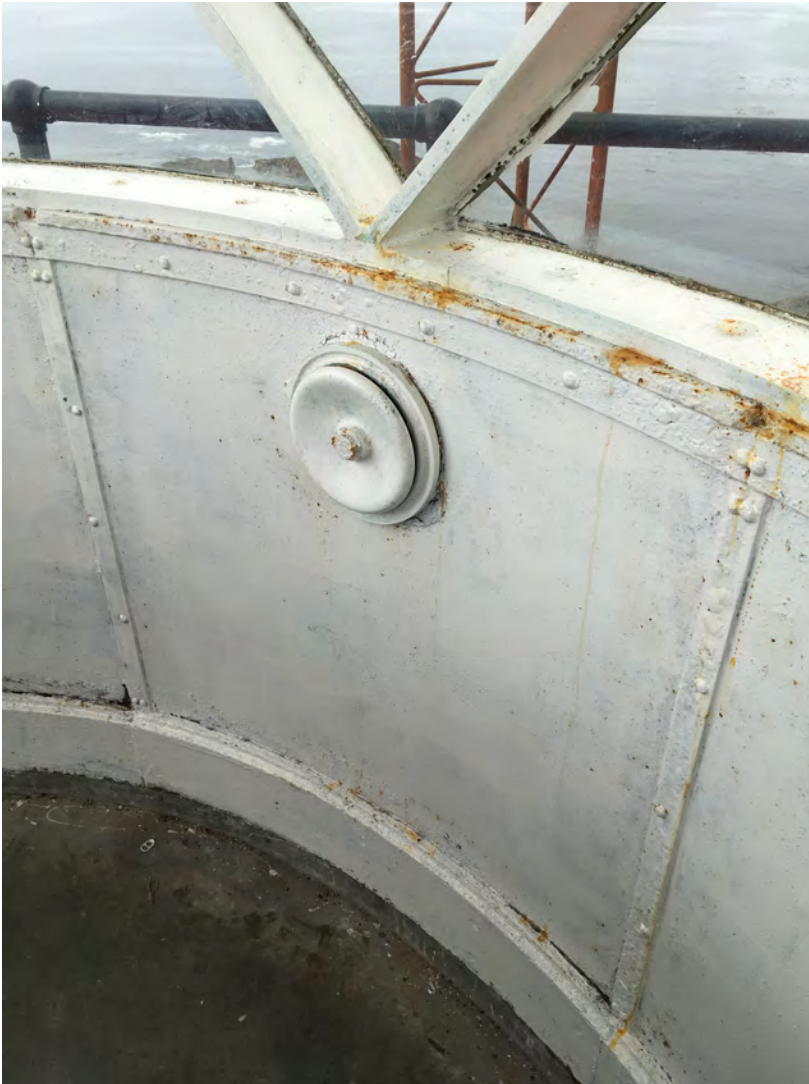
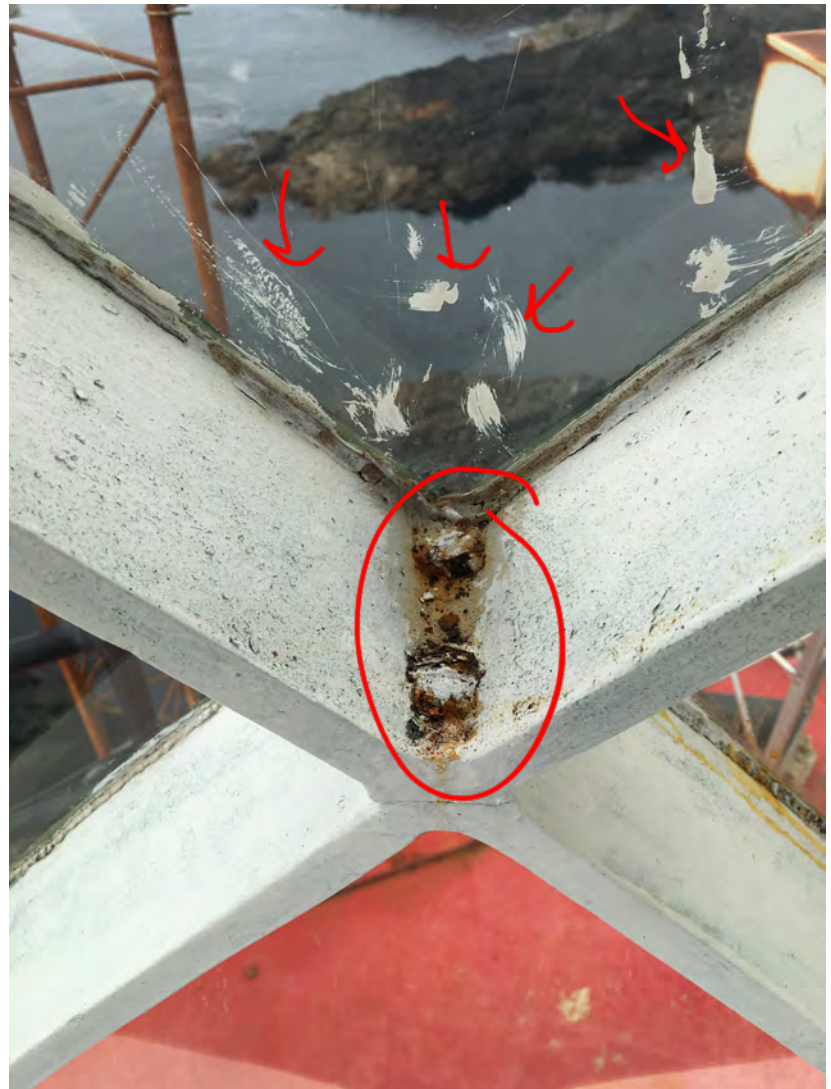
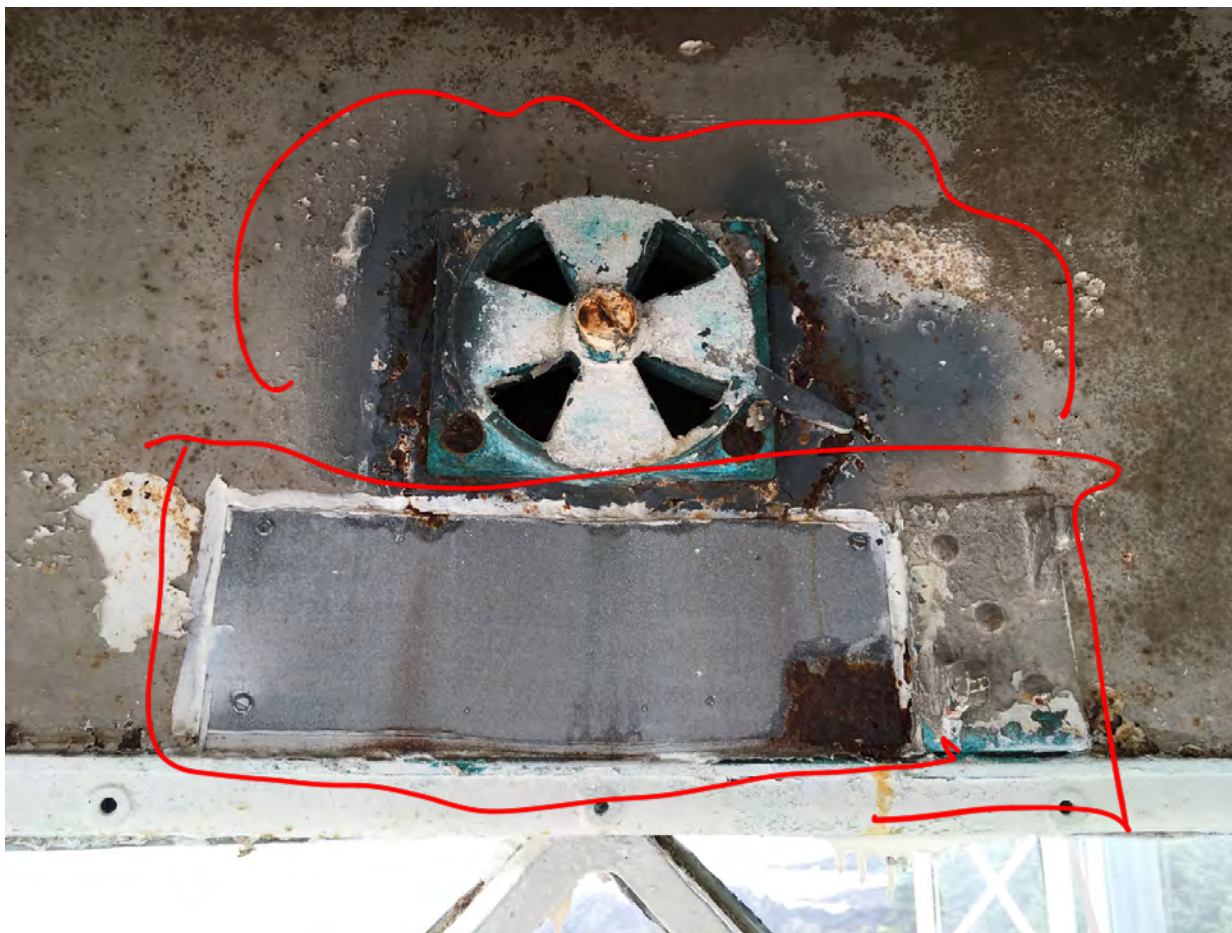
Section 8

Top left: Iron corrosion penetrating through paint coating. Top right; Galvanic corrosion of ferrous hardware and paint splatters on window. Bottom: Severe condition of vent and previous undocumented restoration/patch along upper panel.

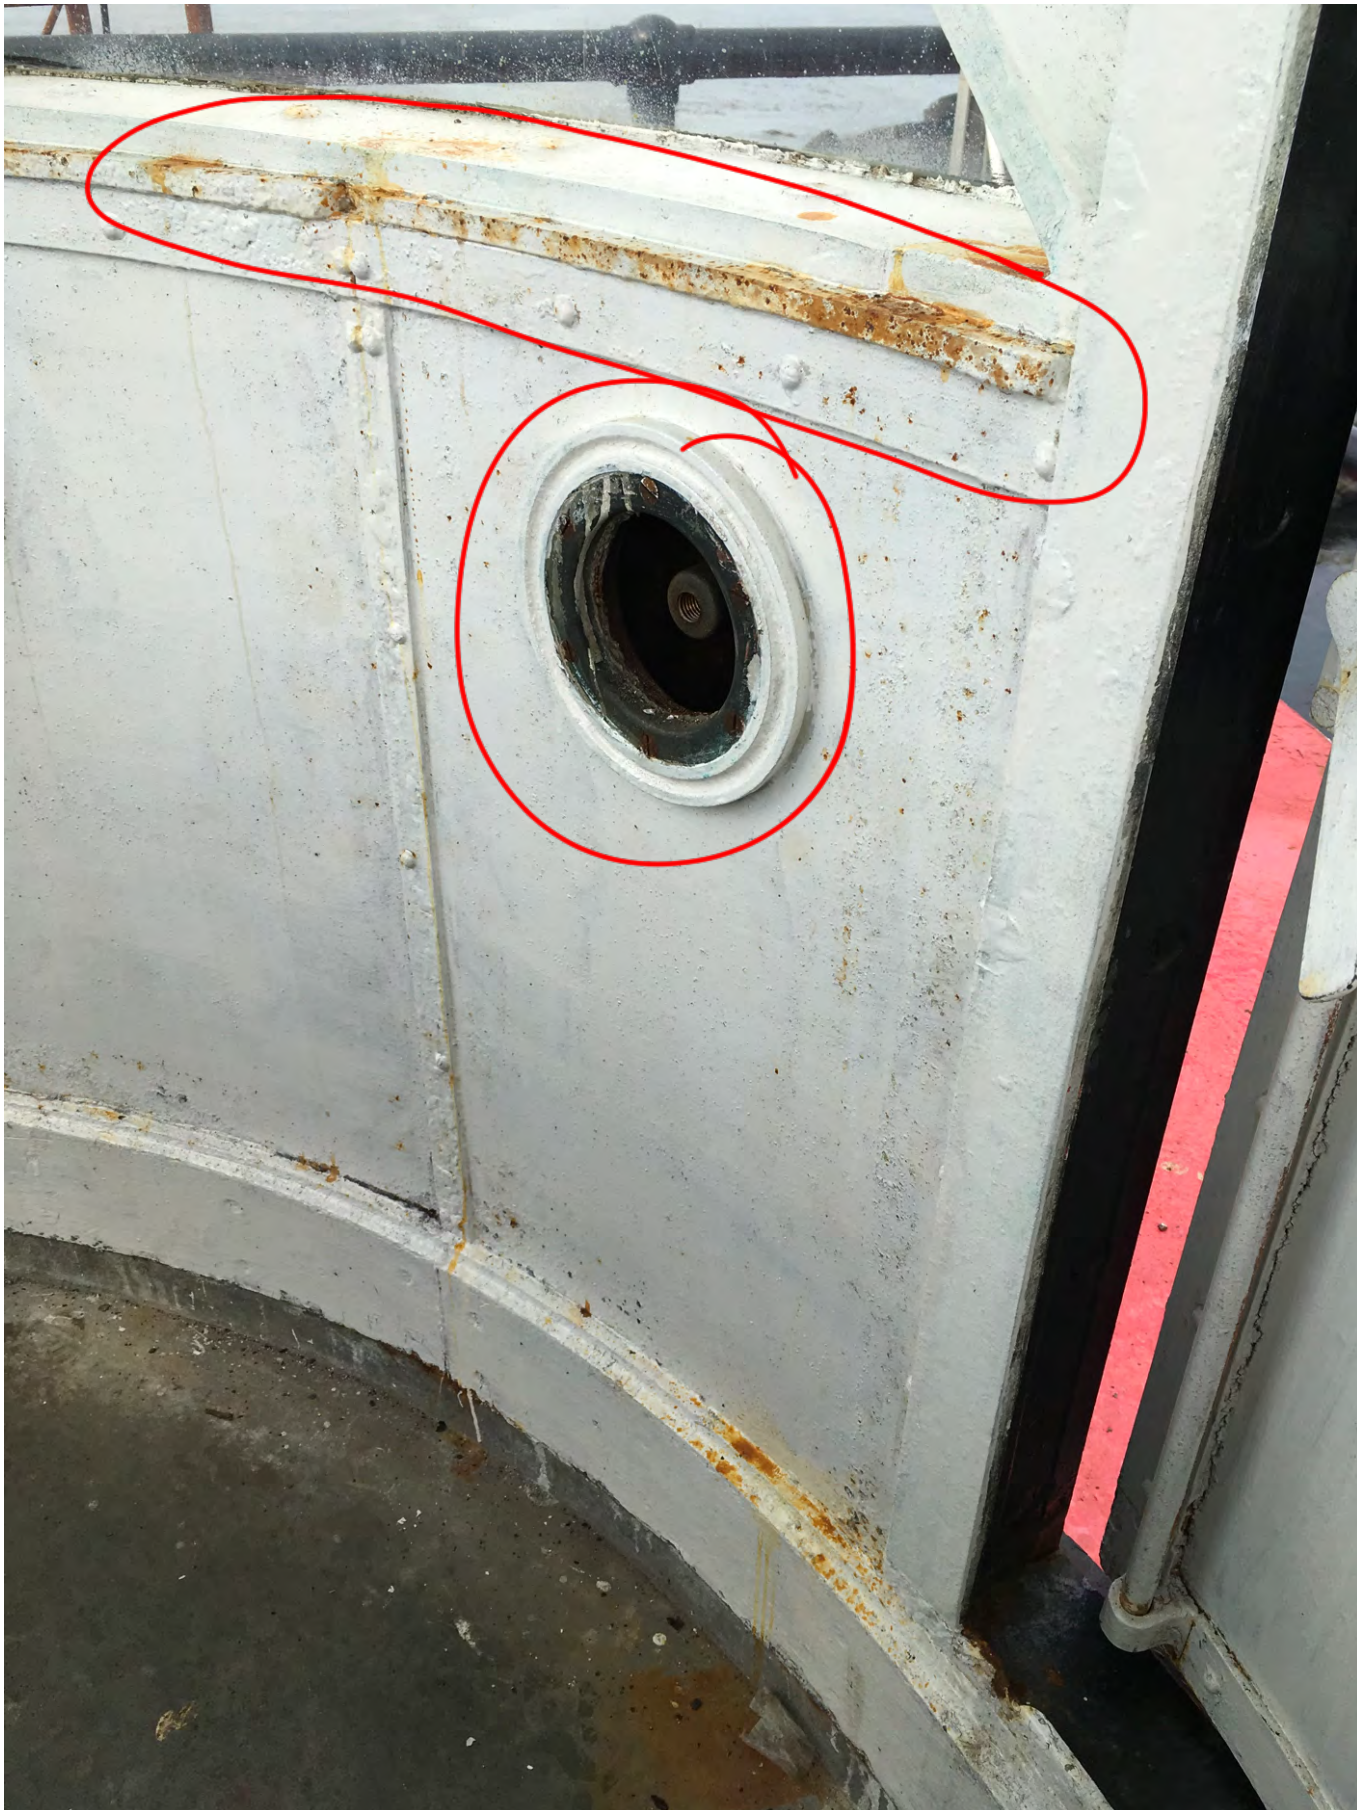
Section 9

Detail of iron corrosion penetration through paint coating. The missing vent plate has been recovered and was installed onto the vent after this picture was taken.

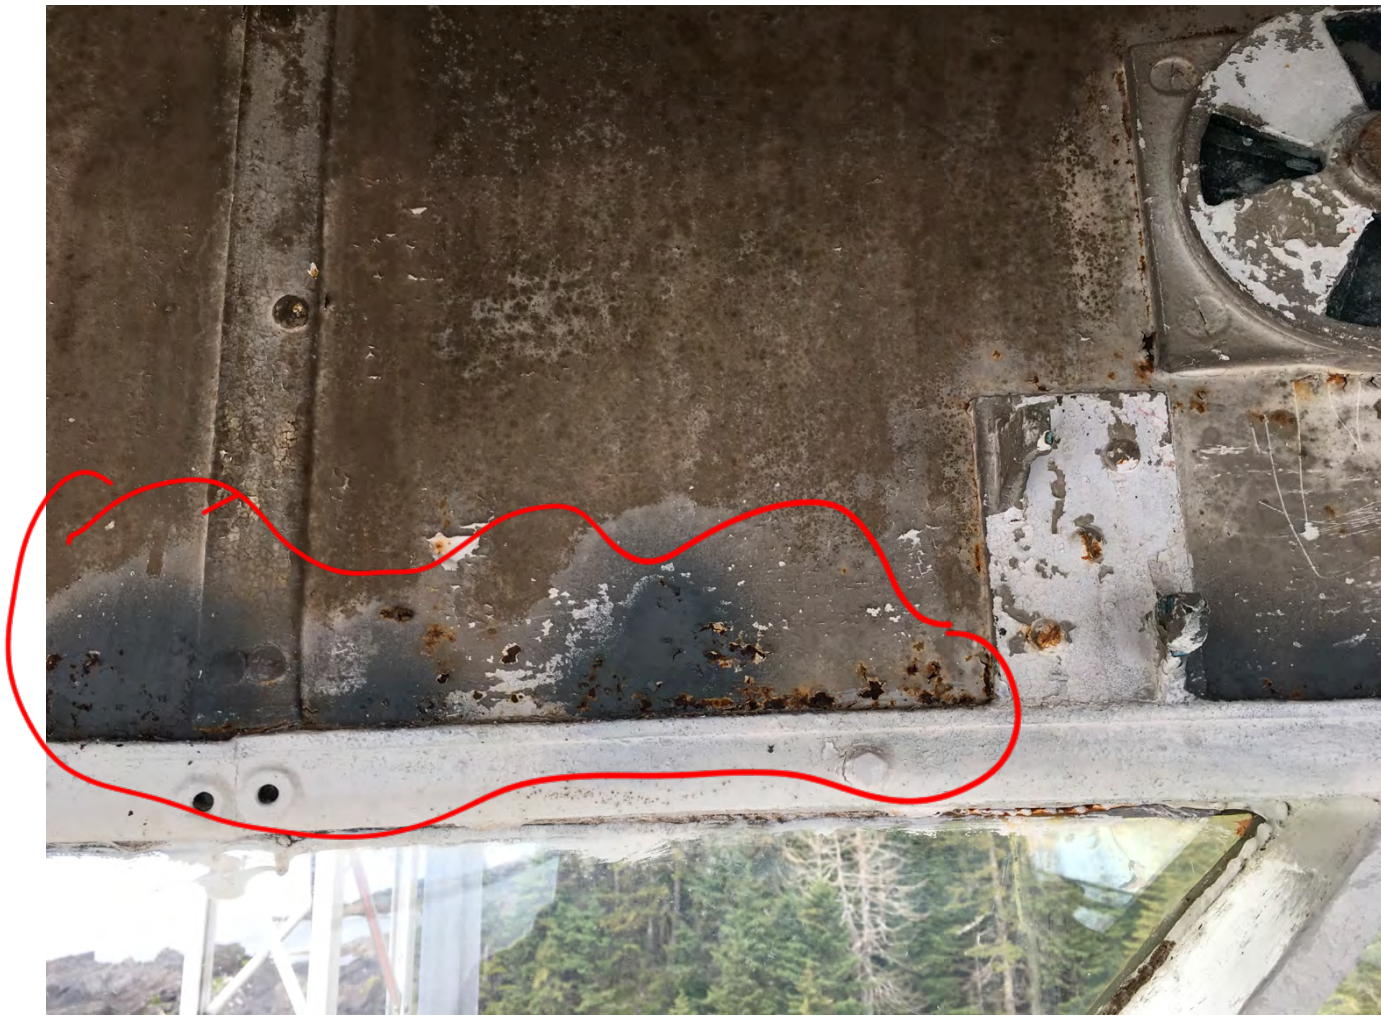
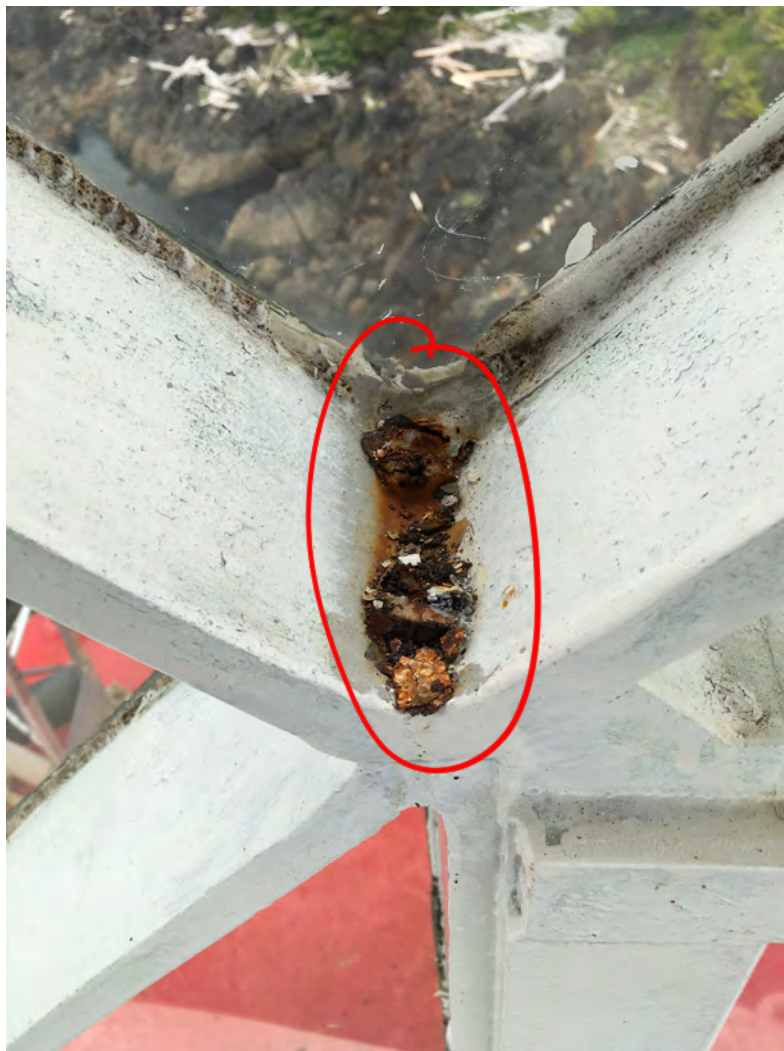
Section 9 (cont)

Top: detail of Rust-oleum(?) application on top panel. Bottom: Galvanic corrosion of ferrous hardware.

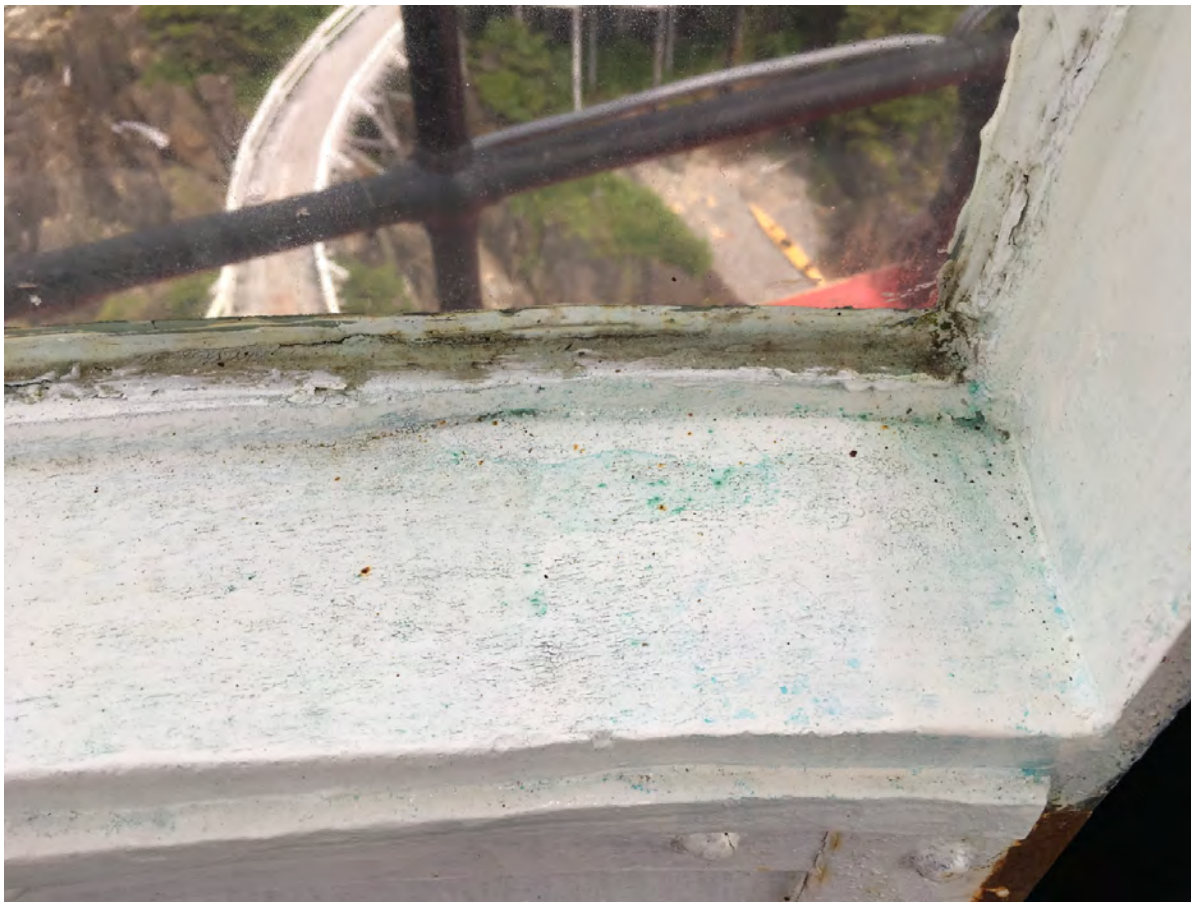
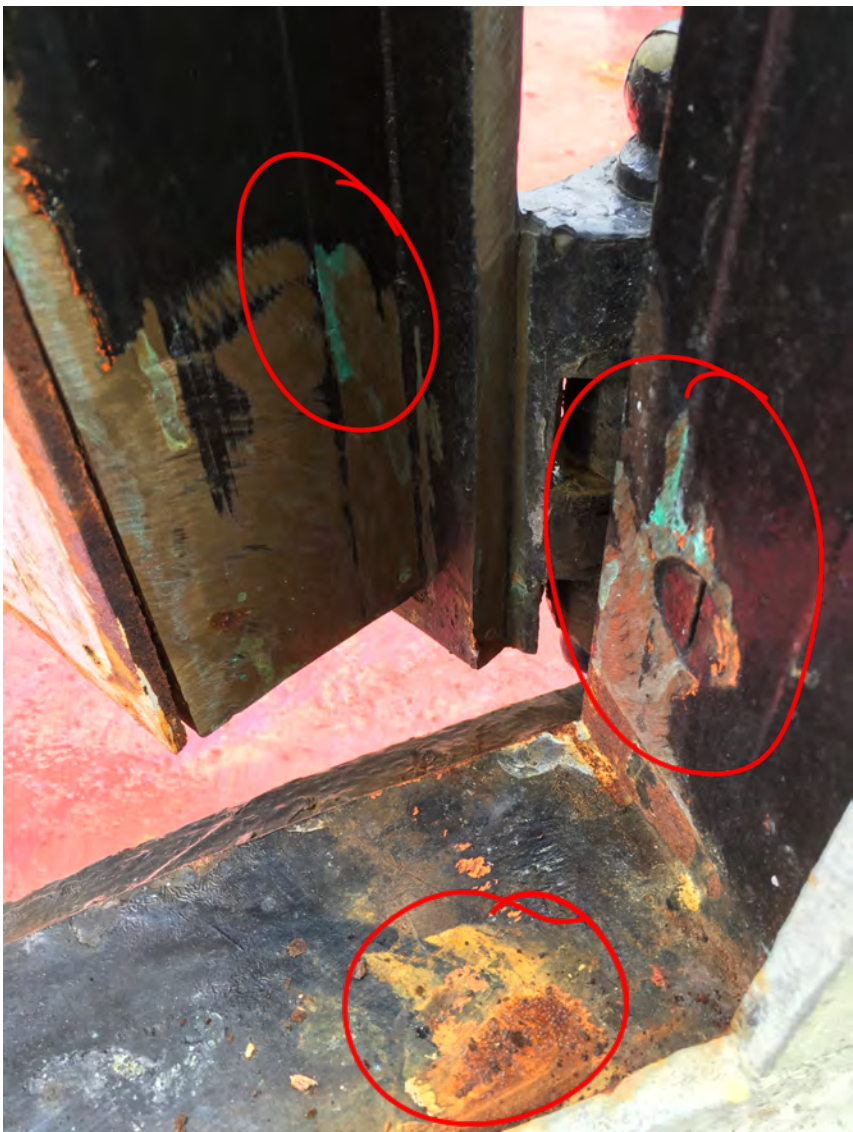
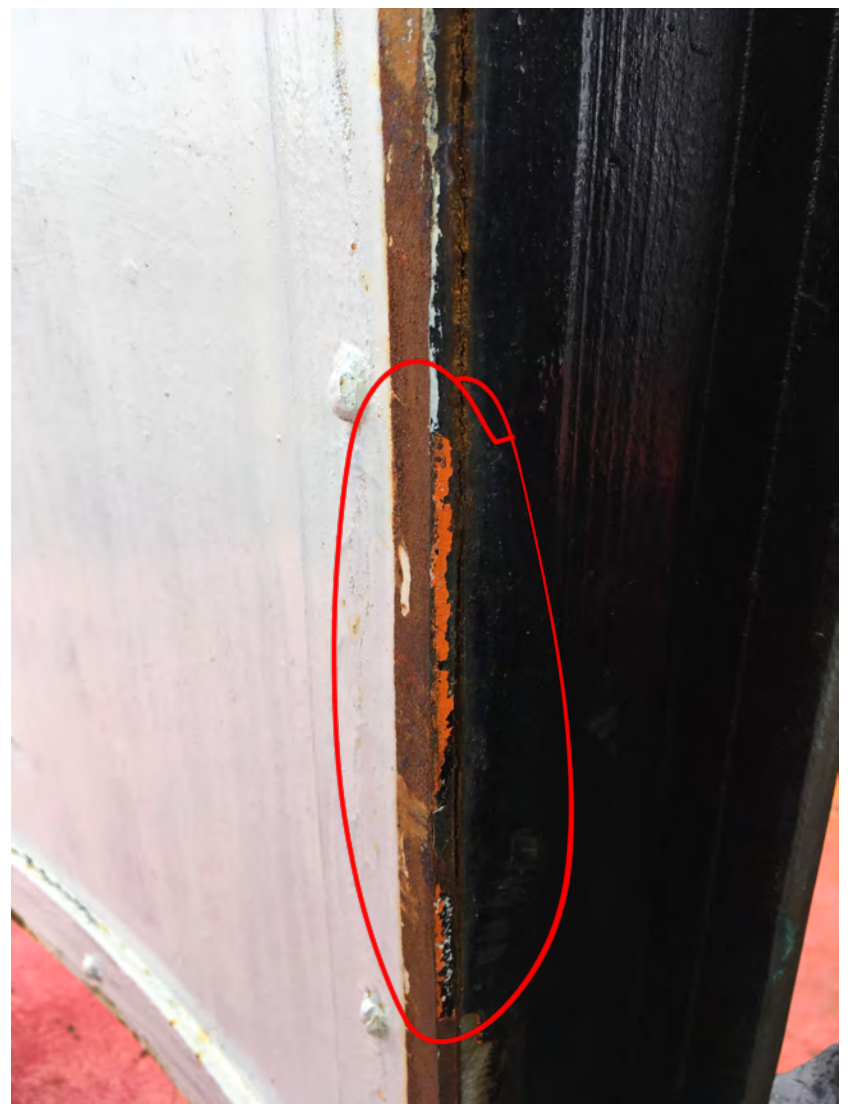
Top left: cuprous corrosion deposits along metal bars.
Bottom right: bright orange paint exposed. Bottom left: active cuprous and ferrous corrosion along bottom of bronze door hinges and bottom jamb.

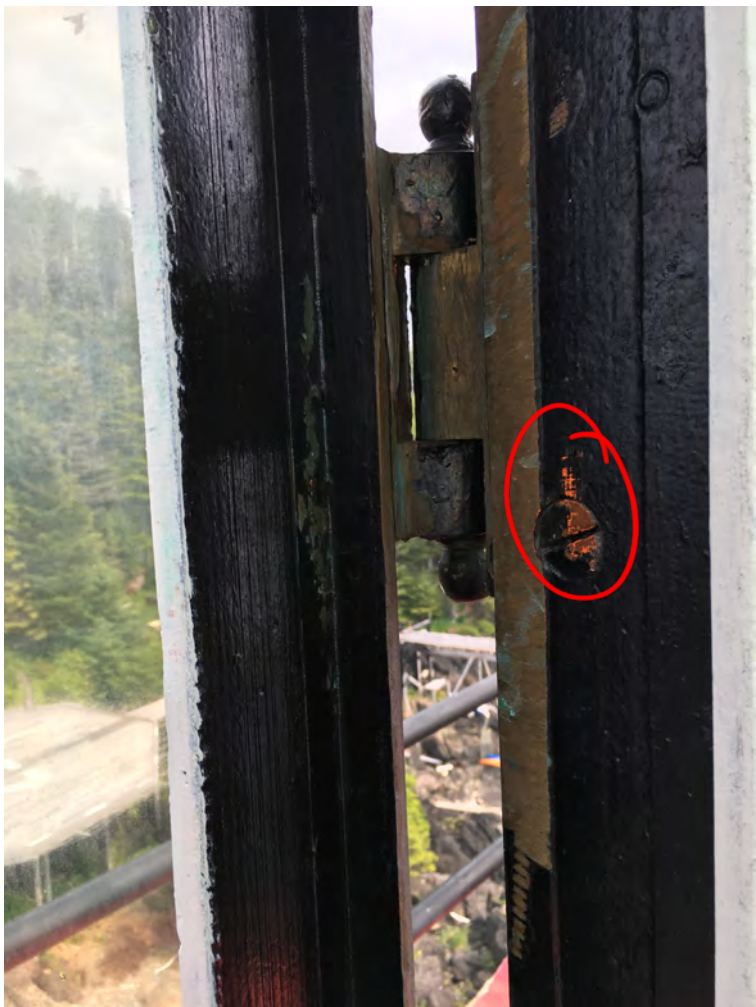
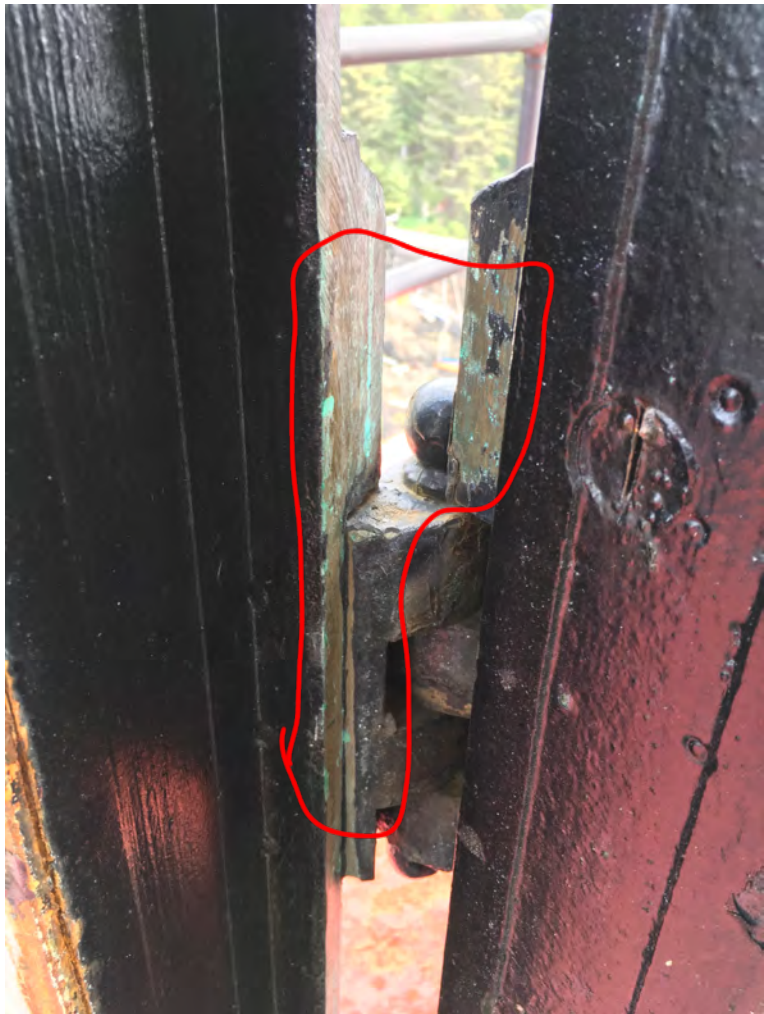
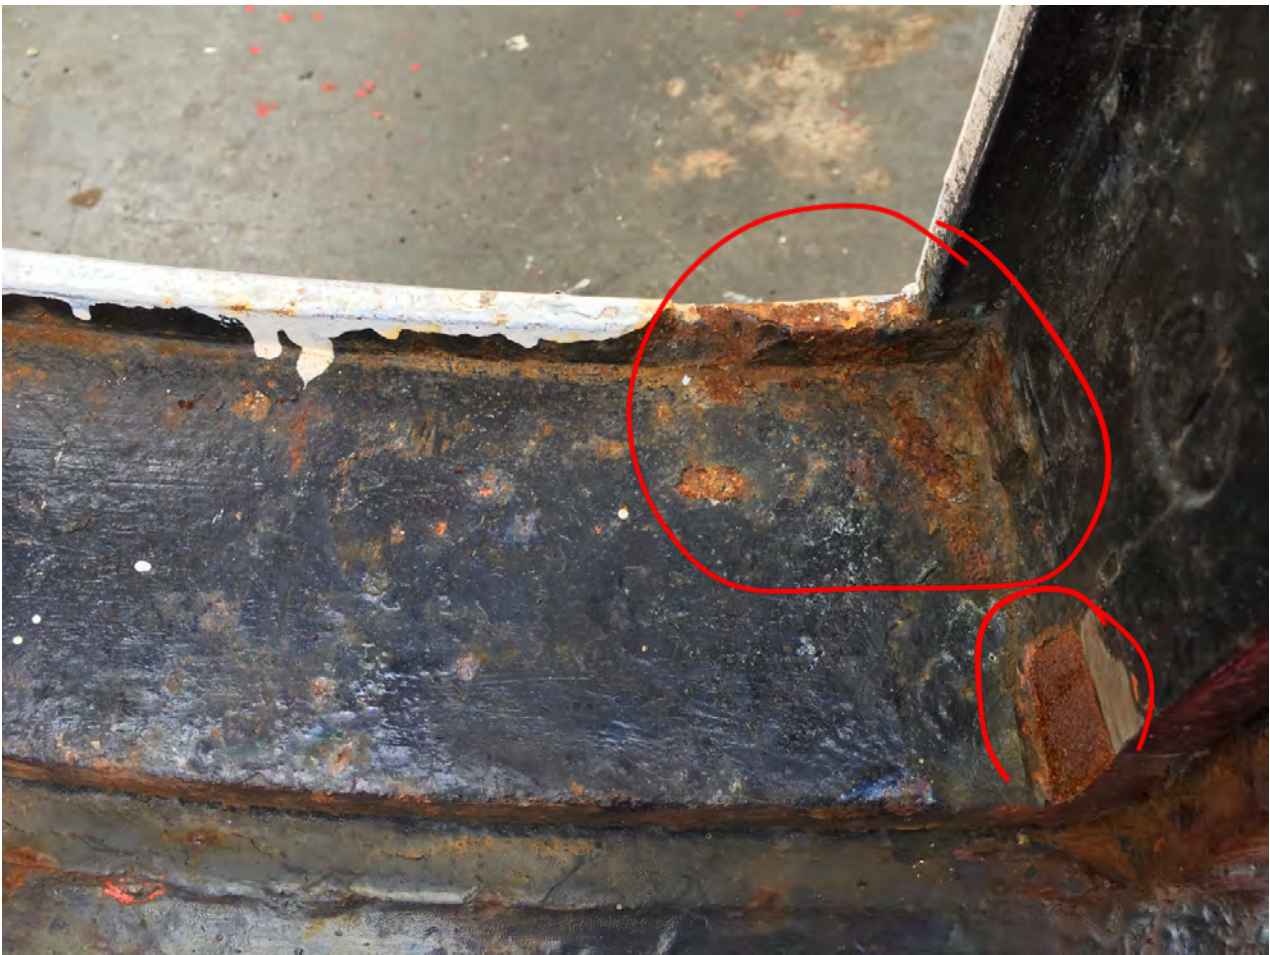
Section 10 door (cont)

Top left: Bright orange paint exposed. Top right: active corrosion (potential bronze disease) along bronze hinges. Bottom: Active and weeping iron corrosion along bottom jamb.

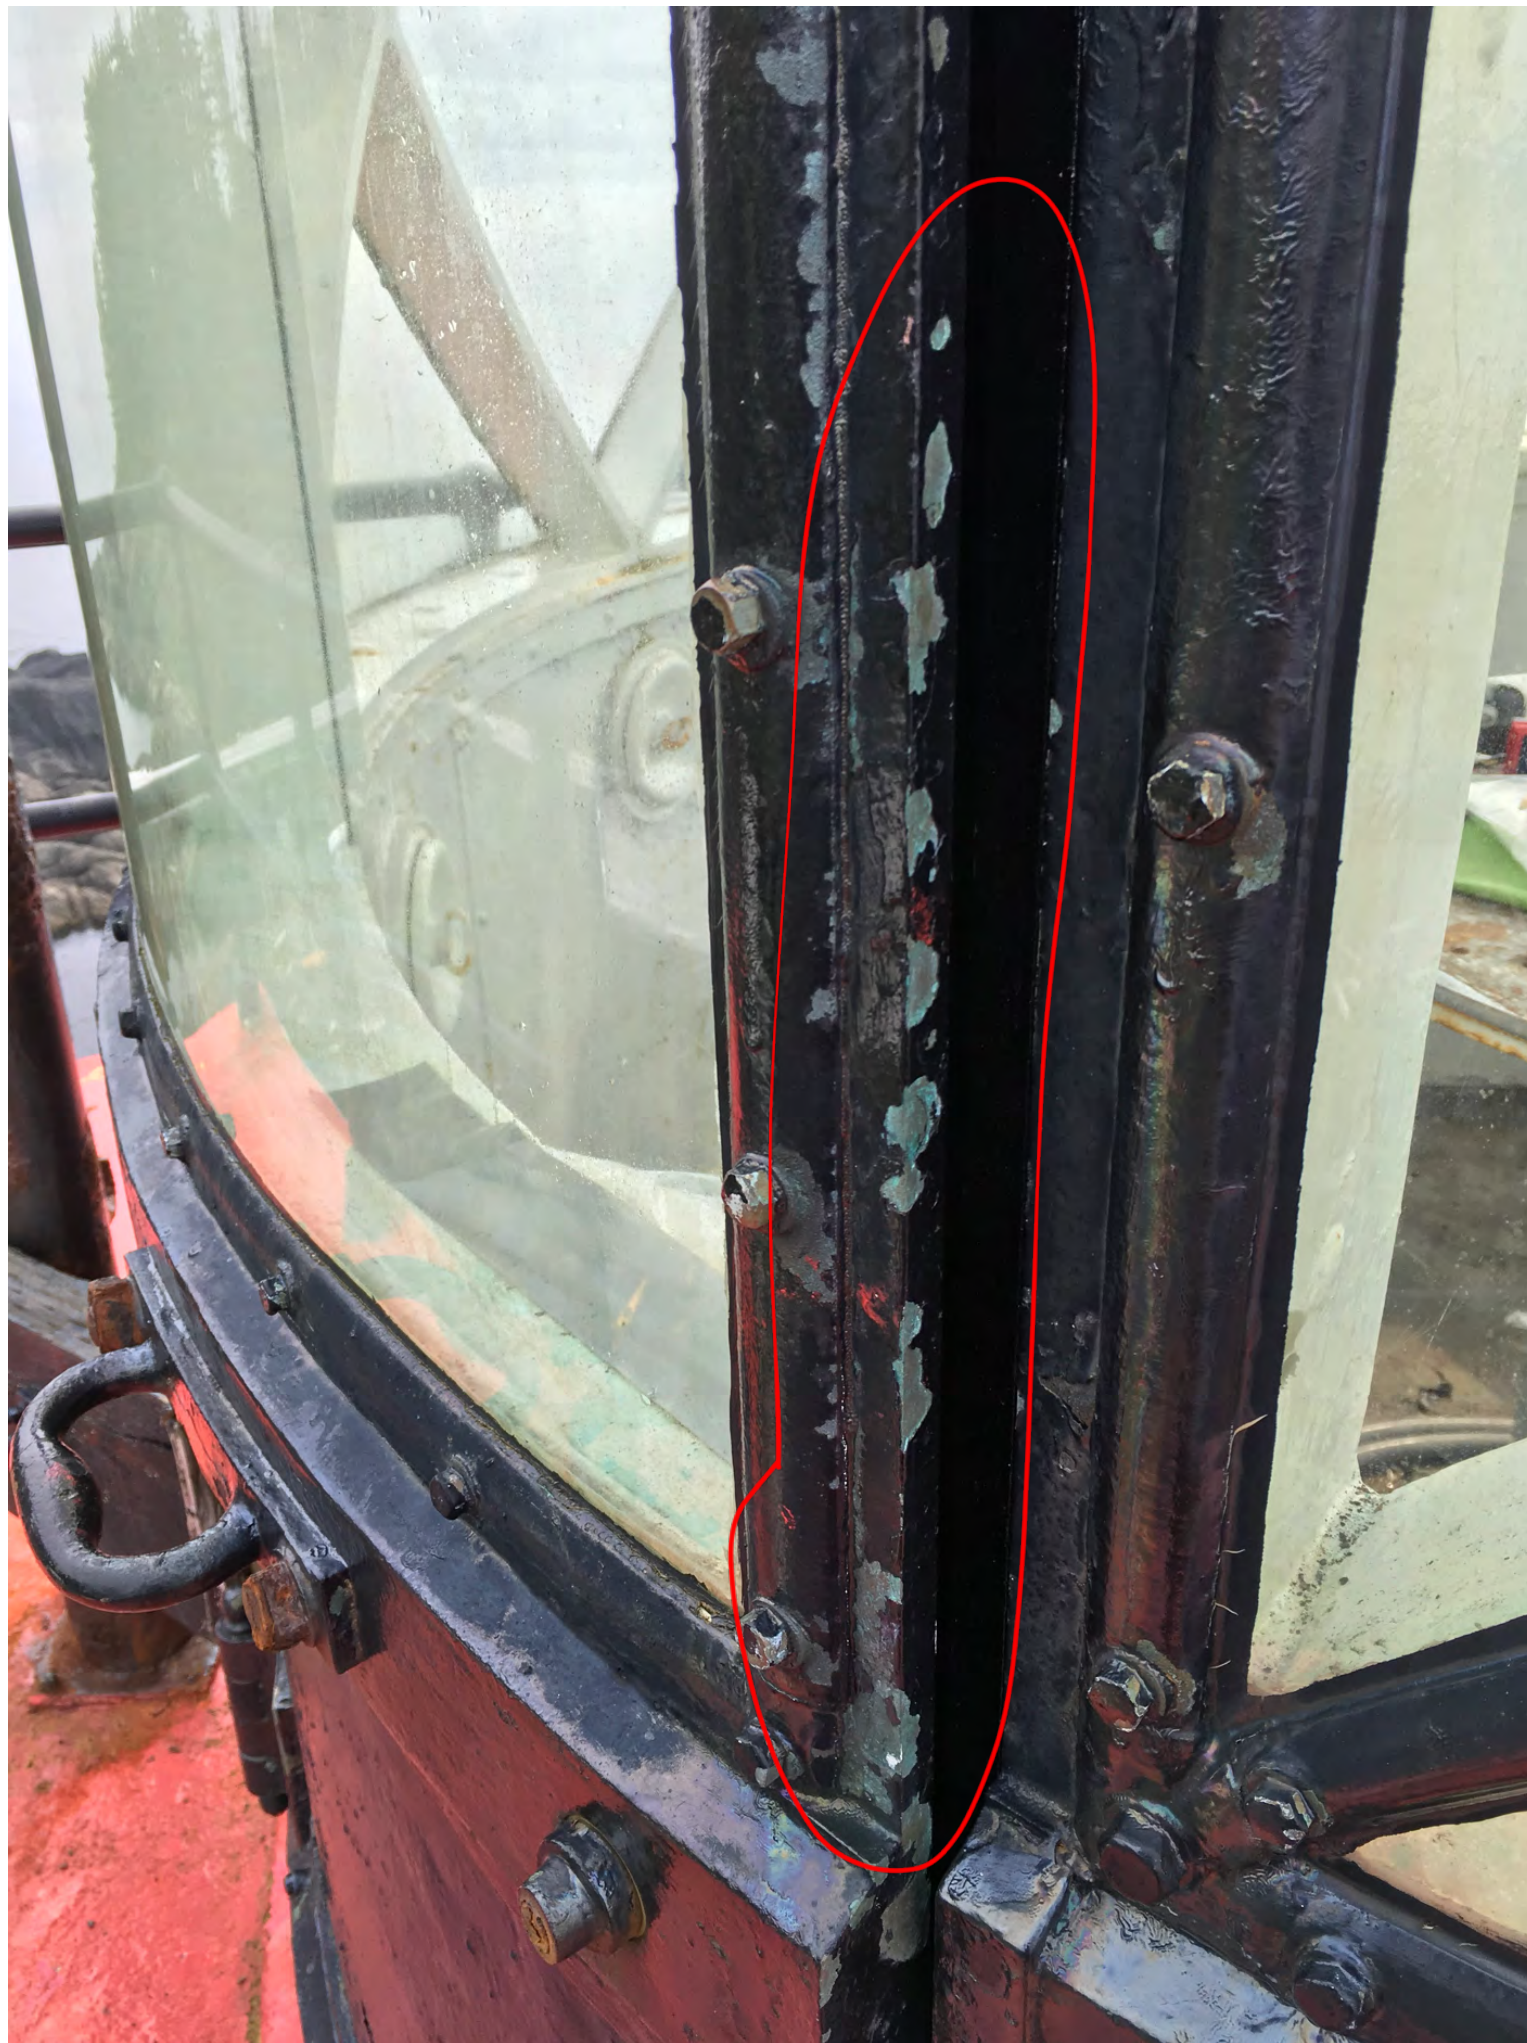
EXTERIOR OF LANTERN ROOM

Areas of paint loss where cuprous correction products are forming. Corrosion removal and reapplication of coating is recommended for 2020 season.

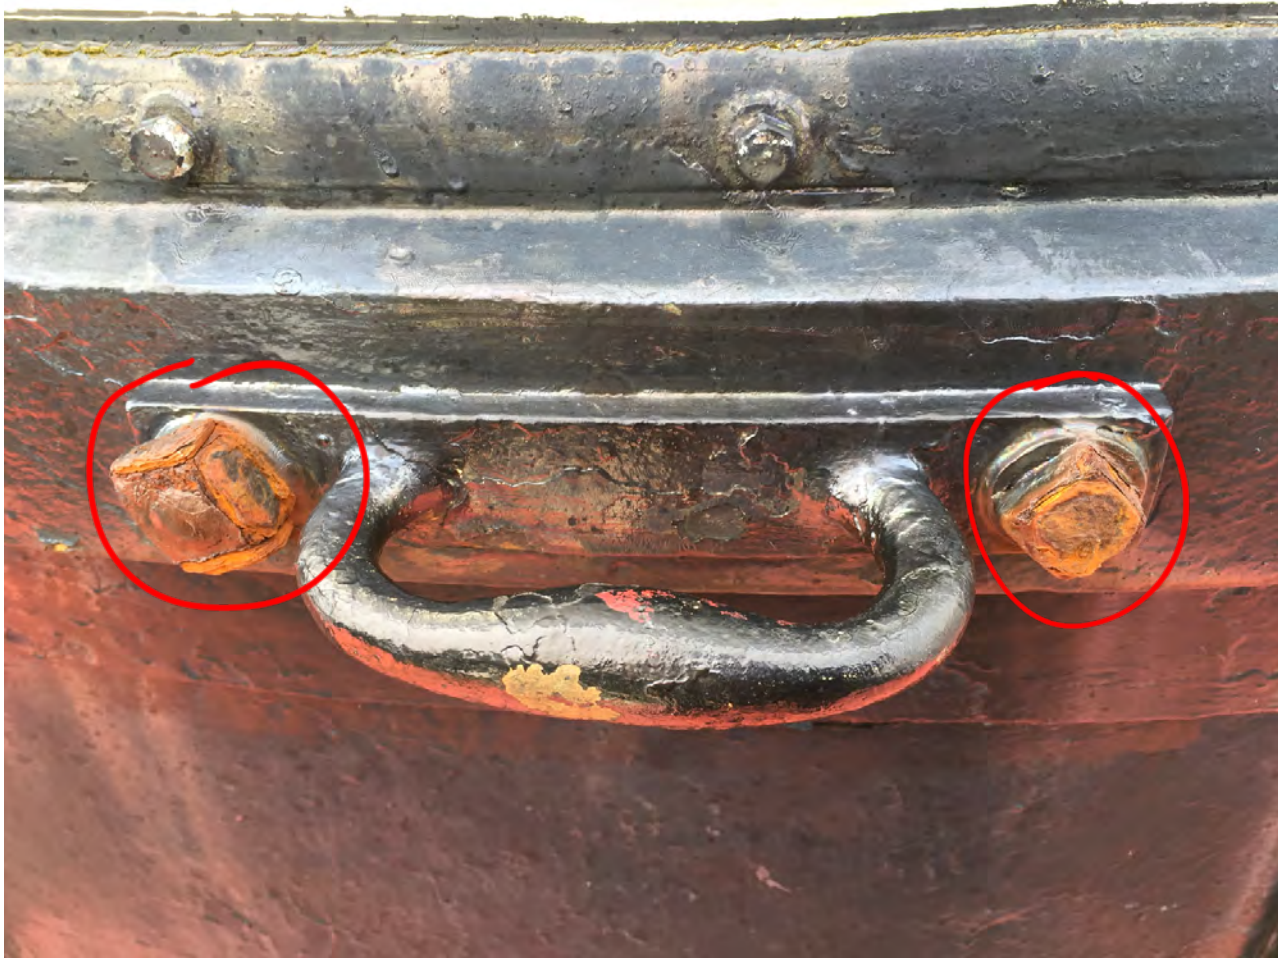
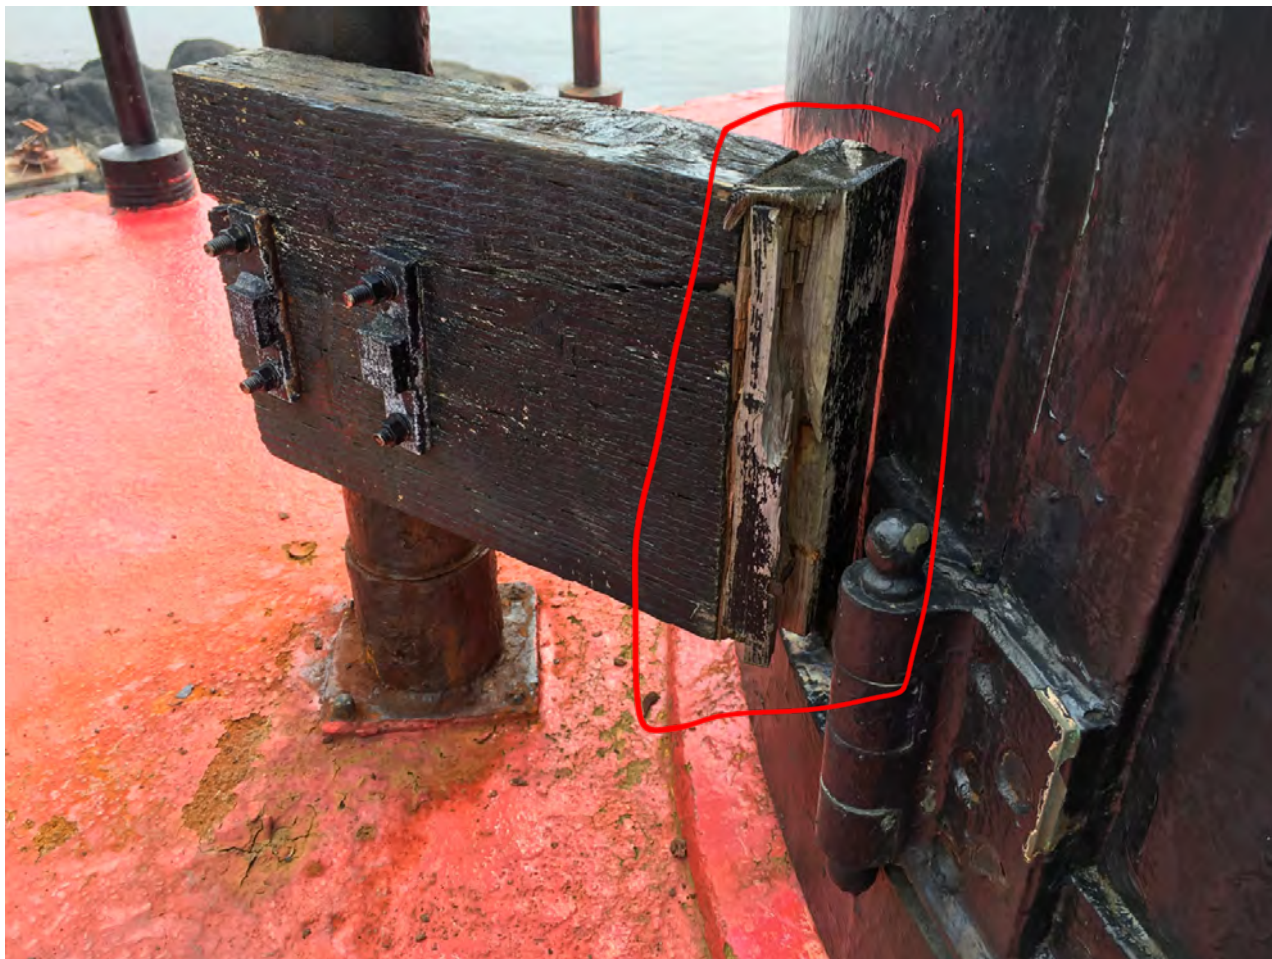
EXTERIOR OF LANTERN ROOM

The only wood component is the wooden door stop on the exterior of the lantern room. The stop is affixed to the pole ladder with steel bolts. The wood is cracked, rotted, and punky in texture and is no longer serving its purpose of preventing the door from hitting against the pole ladder. It is believed this component became damaged at some point when the heavy lantern door caught wind and slammed against the stop. Now, if the door is opened all the way, it touches the pole ladder. To prevent this while the door is open (for either work purposes or for ventilation), a temporary solution of tethering a rope to the inside of the door attached to the interior lantern table has been implemented. It is recommended this component be replaced with in-kind material in order to protect the door.

Top: Detail of galvanic corrosion of ferrous hardware. Bottom: detail of damage to wood door stop.
