CAPE DECISION LIGHTHOUSE SOCIETY (CDLS)

CONSERVATION CONDITION ASSESSMENT OF THE
CAPE DECISION LIGHTHOUSE
CUPOLA AND LANTERN ROOM

JULY 07-10, 2019

REPORT BY:
NICOLE PETERS, CONSERVATOR
PETERS ART CONSERVATION SERVICES, LLC

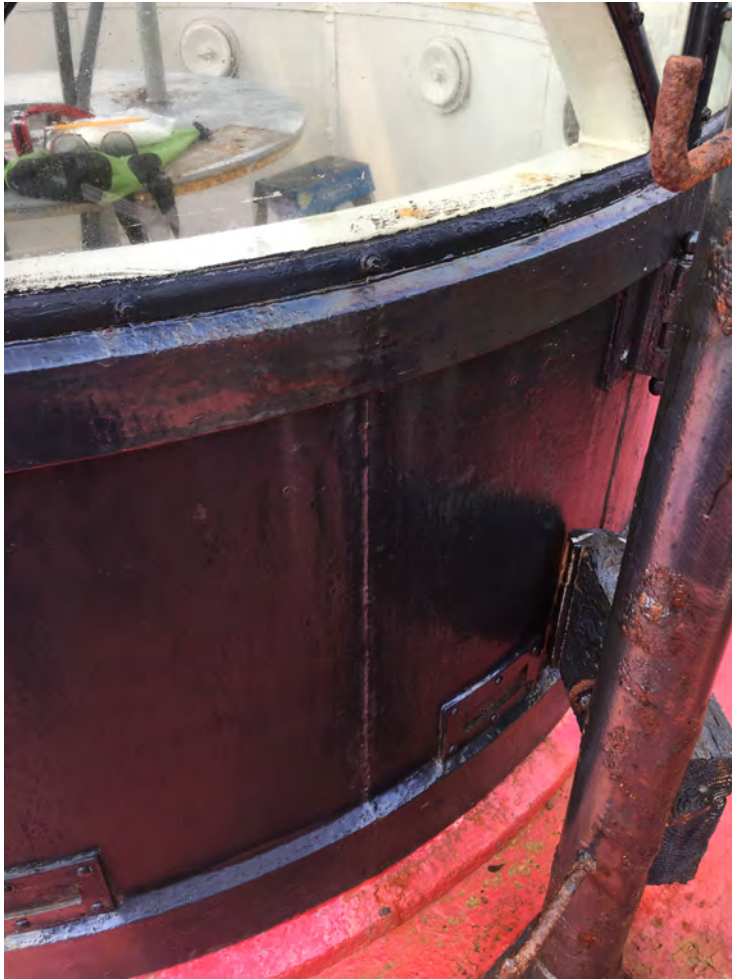
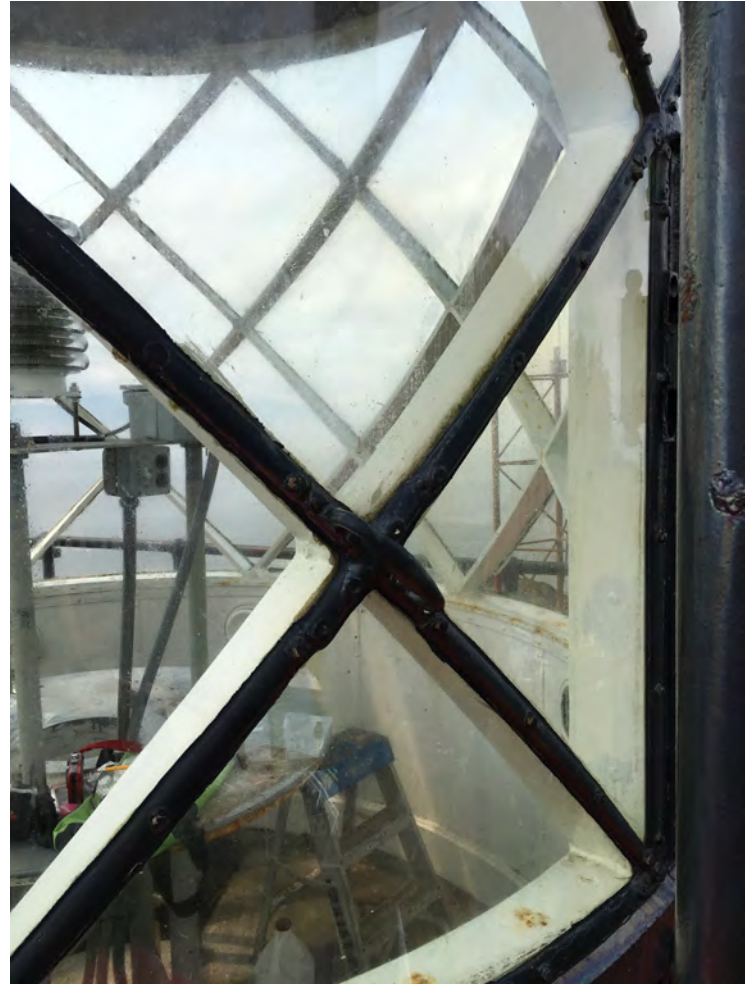
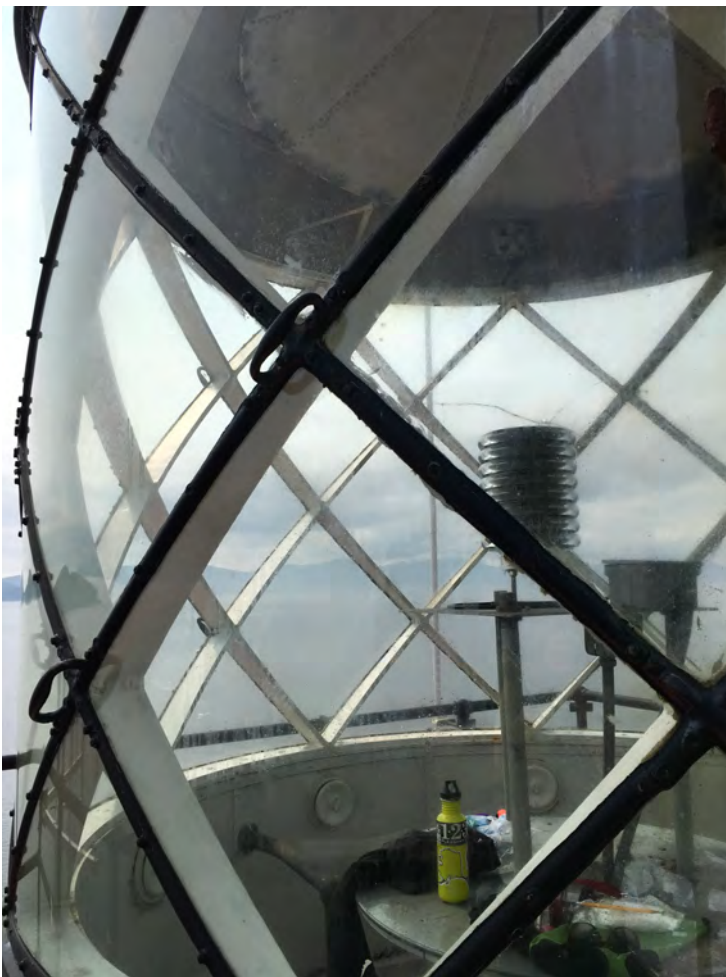
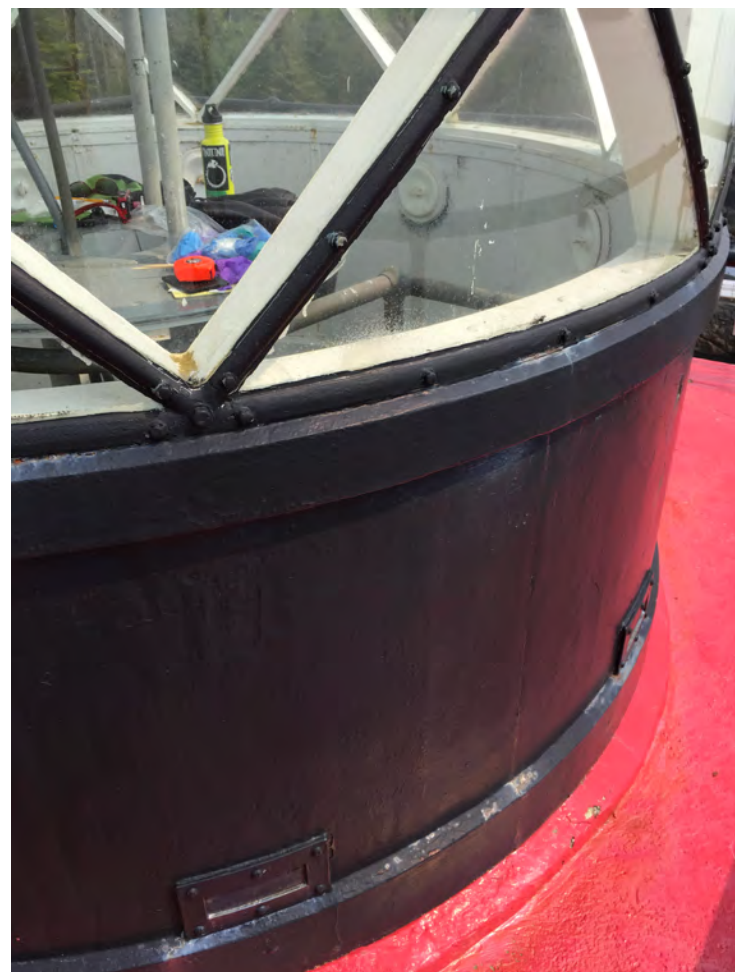
EXTERIOR OF LANTERN ROOM

Images of good/fair condition of exterior paint and coating systems. Minor touch-ups are recommended as necessary.
