CAPE DECISION LIGHTHOUSE SOCIETY (CDLS)

CONSERVATION CONDITION ASSESSMENT OF THE
CAPE DECISION LIGHTHOUSE
CUPOLA AND LANTERN ROOM

JULY 07-10, 2019

REPORT BY:
NICOLE PETERS, CONSERVATOR
PETERS ART CONSERVATION SERVICES, LLC

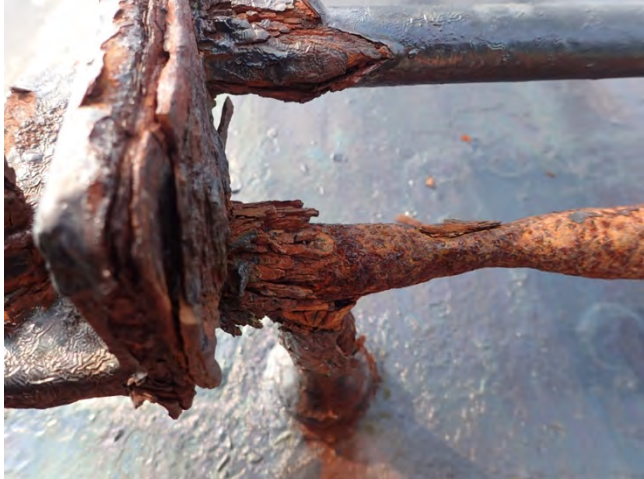
Detail of advanced corrosion on structural beam of upper ladder on top of cupola.

The upper ladder and platform on top of the cupola are not suitable for use. Similar to the railing, these components are heavily corroded and are actively delaminating and flaking. It was noted that some of the structural beams on the upper ladder have corroded to approximately 1/8" thickness with areas of flaking material around the thinned area. As mentioned earlier in the Key Recommendations section, the possibility of collaborating with the USCG for the restoration or replacement of the upper ladder and platform in exchange for permission to install monitoring equipment may be a mutually beneficial project. This prospect should be discussed amongst CDLS board members and SHPO.

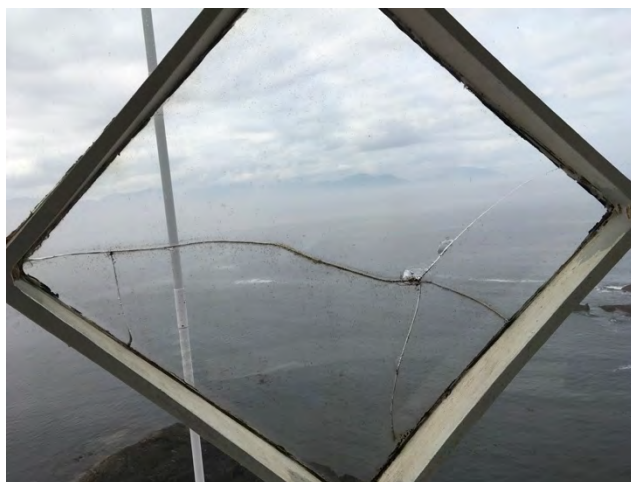
There are three cracked glass panes in the lantern room: 2 panes each containing a small, traveling fissure. One pane is located on a N-facing window and one is on a S-facing window. The third damaged glass pane faces S/SW and is thought to have been caused by a bullet. Several cracks have grown out from the initial impact point, traveling to the edges of the pane. Lantern glass and frames must be weathertight. To minimize water infiltration, the damaged glass (at least the “bullet damaged” pane) should be replaced if possible, using glass (either tempered or laminate) because of its superior weathering qualities. Acrylic or polycarbonate are not suitable replacement materials because they are easily scratched by airborne sand and will fog with time. The glass panes must be sized for code-required wind loads and code requirements for glazing next to or above walking surfaces. Depending on the location and environmental conditions at the lighthouse site, often times only laminated glass is acceptable. There has been ongoing consultation with colleagues in the historic preservation field who specialize in glass repair. For the two cracked panes and as a temporary measure for the bullet-hole pane, a low-viscosity UV-activated epoxy resin with a refractive index akin to glass can be carefully wicked into the cracks in order to mitigate further fissure growth. Options for resins include: Sunglue, windshield-glass repair epoxy (obtained from mechanic shop), HXTAL, or CCS330. Prior to treatment, four mockups of broken glass panes should be assembled with each epoxy inserted into the cracks. The mockups should be subjected to outdoor elements similar to that experienced at Cape Decision. (This may involve merely placing the mockups outside in Alaska for the winter/spring exposed to full visible light and ultraviolet radiation, and periodically spraying the surfaces with salt water).

Detail of cracked glass pane on S/SW facing side. Damage is thought to have been caused by a bullet. It has been noted that damage has become worse over the years.

3. There are three cracked glass panes in the lantern room: 2 panes each containing a small, traveling fissure, and 1 pane containing substantial damage and cracking thought to have been caused by a bullet. Lantern glass and frames must be weathertight. To minimize water infiltration, the damaged glass (at least the “bullet damaged” pane) should be replaced as soon as possible, using glass (either tempered or laminate) because of its superior weathering qualities. Acrylic or polycarbonate are not suitable replacement materials because they are easily scratched by airborne sand and will fog with time. The glass panes must be sized for code-required wind loads and code requirements for glazing next to or above walking surfaces. Depending on the location and environmental conditions at the lighthouse site, often times only laminated glass is acceptable. For the two cracked panes and as a temporary measure for the bullet-hole pane, a low-viscosity UV-activated epoxy resin with a refractive index akin to glass can be carefully wicked into the cracks in order to mitigate further fissure growth.

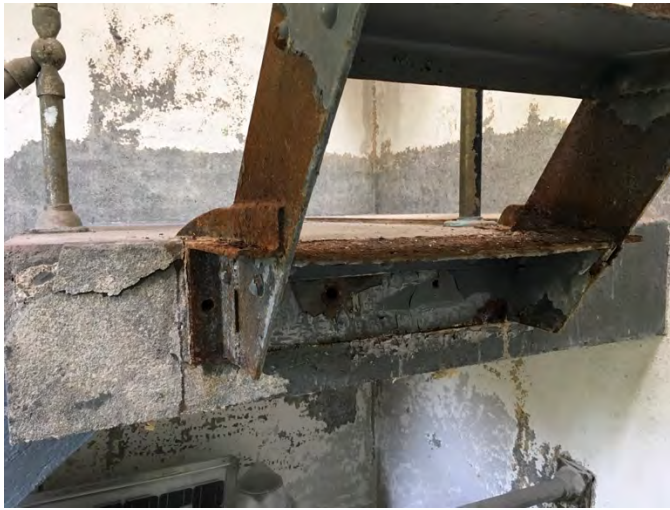
Detail of cracked concrete which is supporting ladder leading up to lantern room.

and the curing of the patch. The stairs and concrete support leading up to the lantern room also require stabilization. The concrete is cracked where the hardware penetrates into the structure; this is a result of expansive ferrous corrosion and delamination of metal structure, likely induced by prolonged moisture exposure or catalytic corrosion due to close contact with alkaline concrete fabric. Given the critical utility of this structural element, consultation and collaboration with a structural engineer is recommended in order to gather data on load-bearing parameters of both the original materials and repair materials.

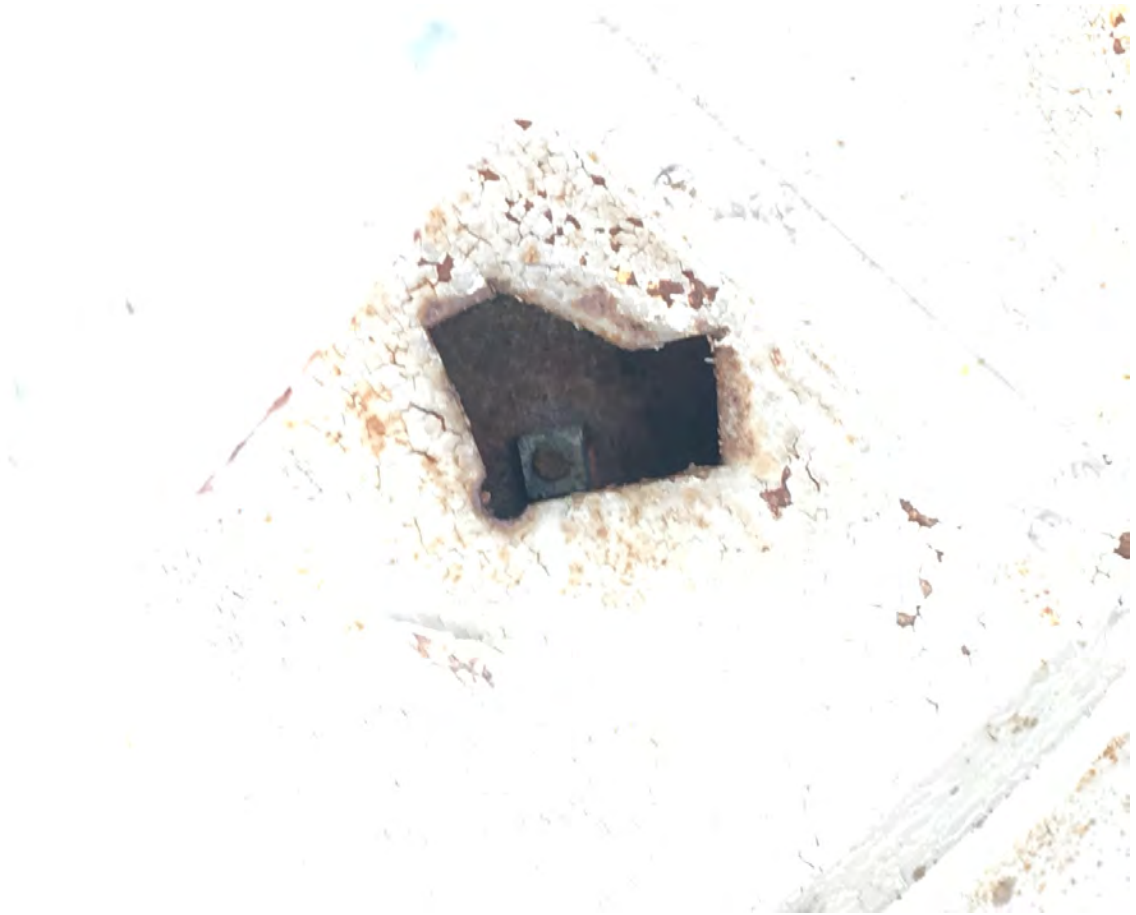
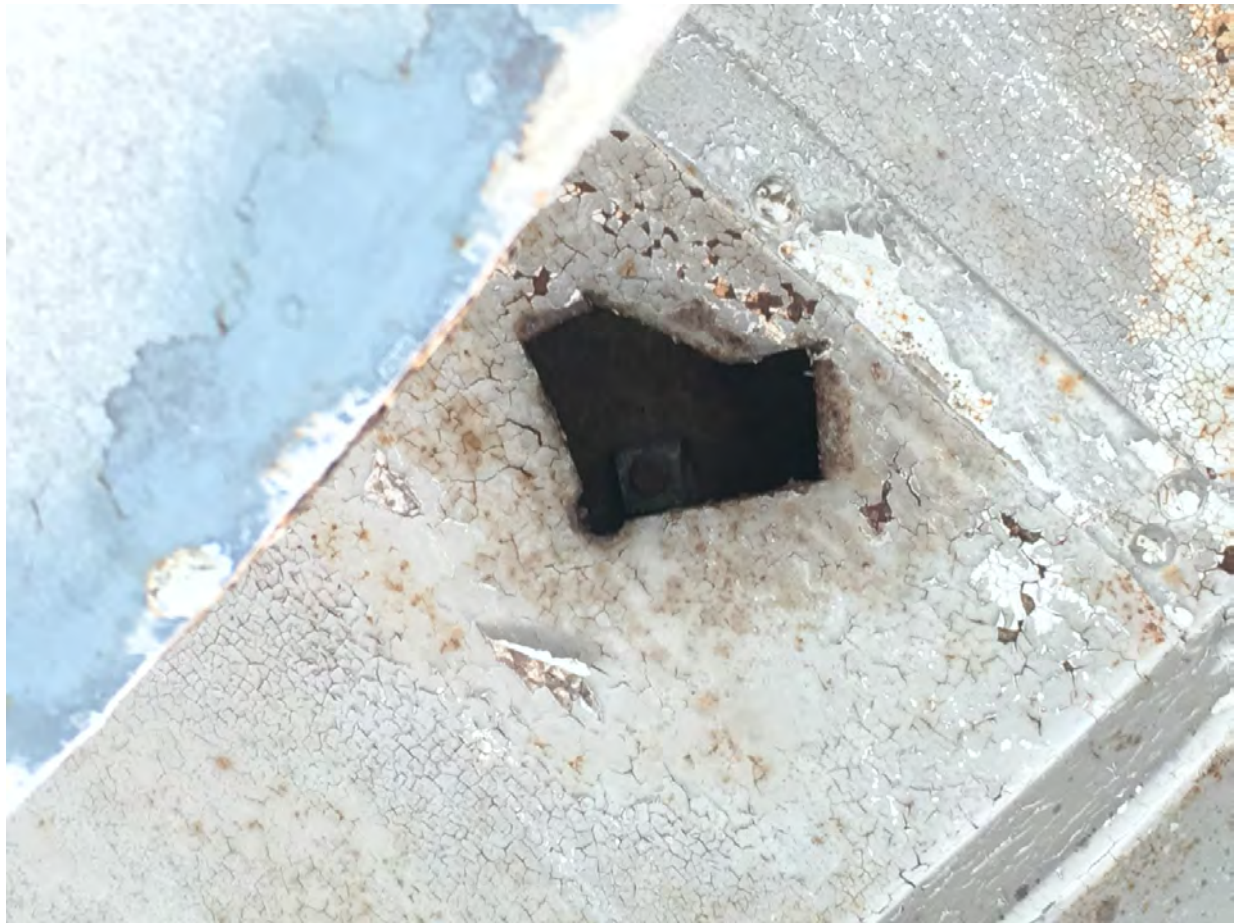
Section 4 (cont):

Attempted photographic documentation of the bolts in the top of the ceiling. These may be auxiliary hardware supports for the exterior cupola railing.

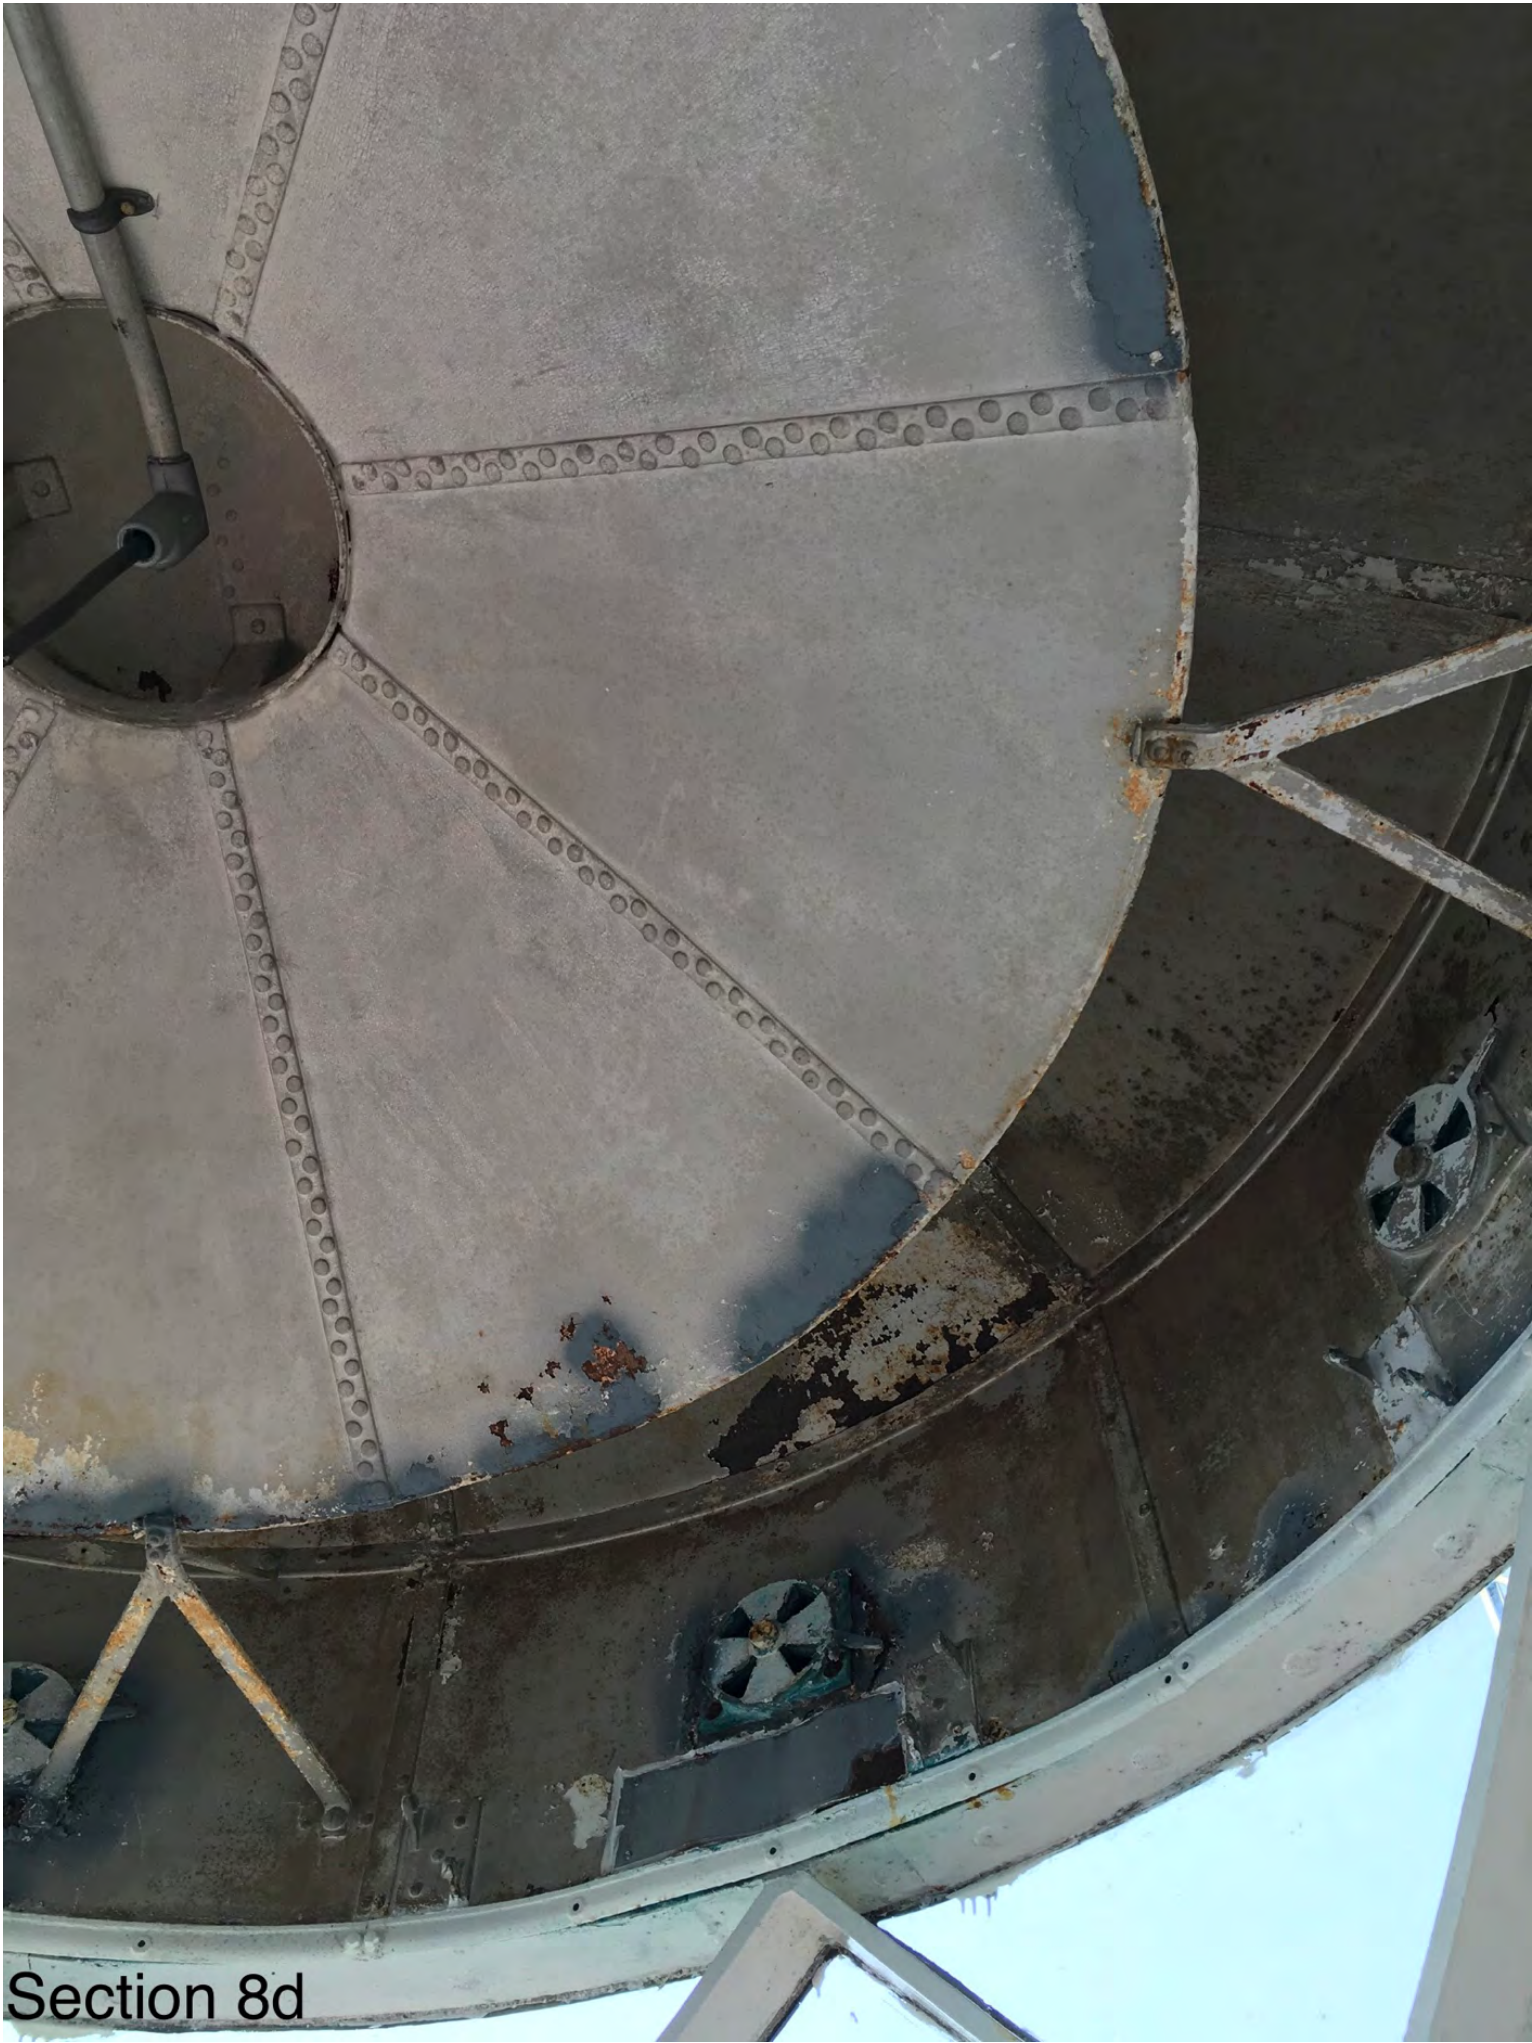
SECTION 8d

Top left: Iron corrosion penetrating through paint coating. Top right; Galvanic corrosion of ferrous hardware and paint splatters on window. Bottom: Severe condition of vent and previous undocumented restoration/patch along upper panel.

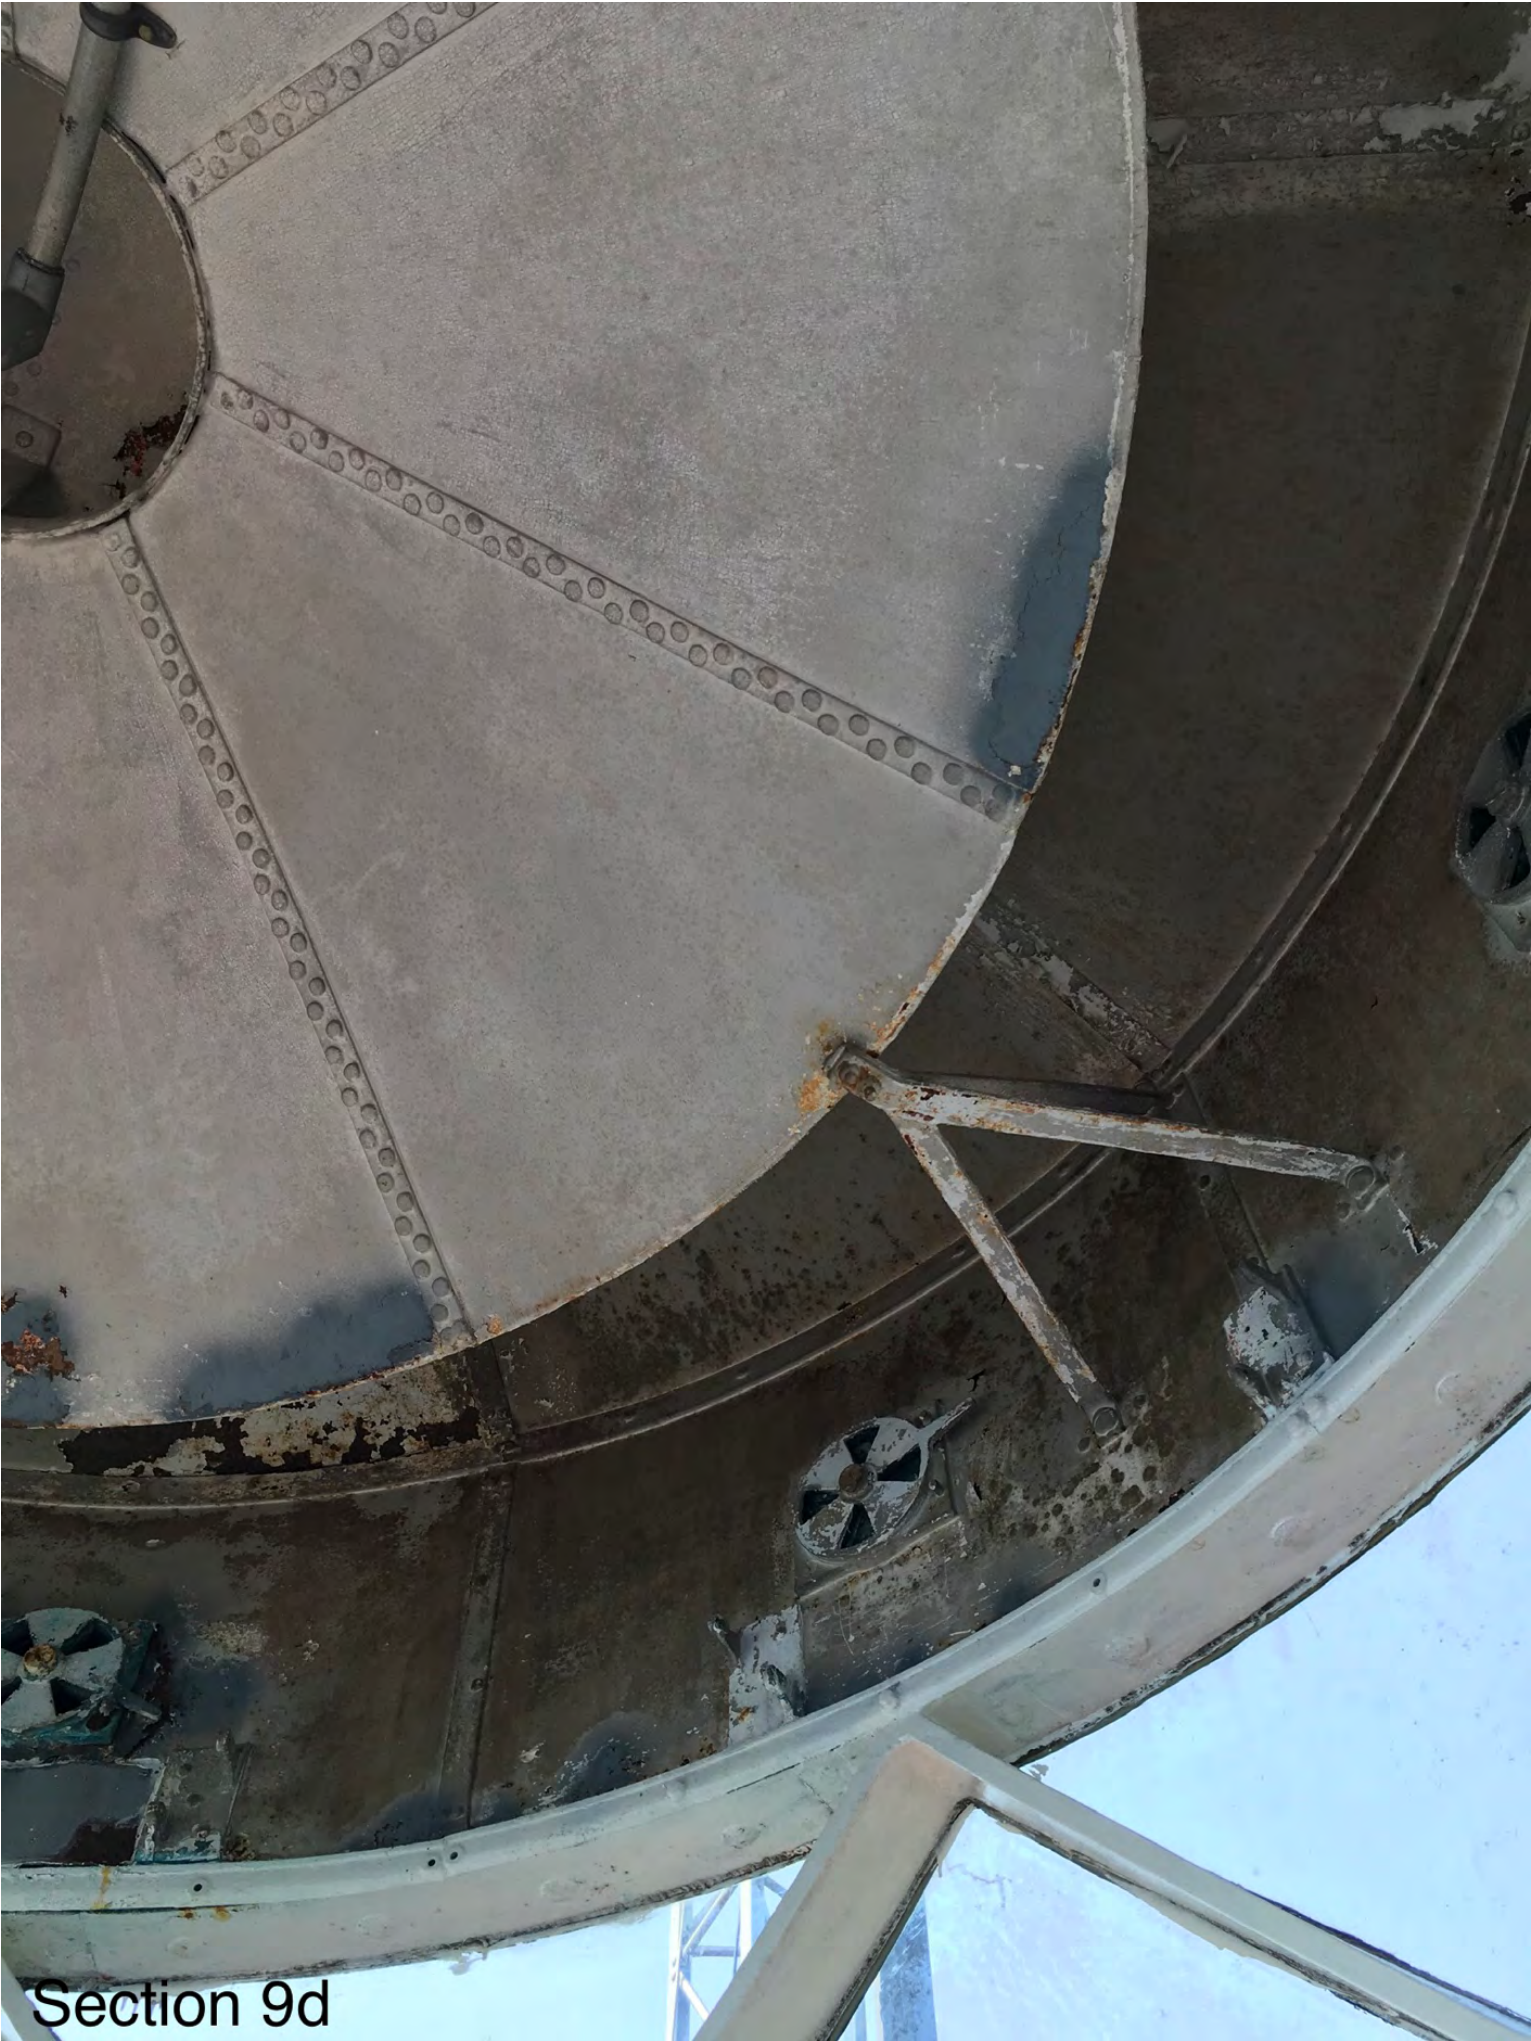
SECTION 9d

Detail of iron corrosion penetration through paint coating. The missing vent plate has been recovered and was installed onto the vent after this picture was taken.

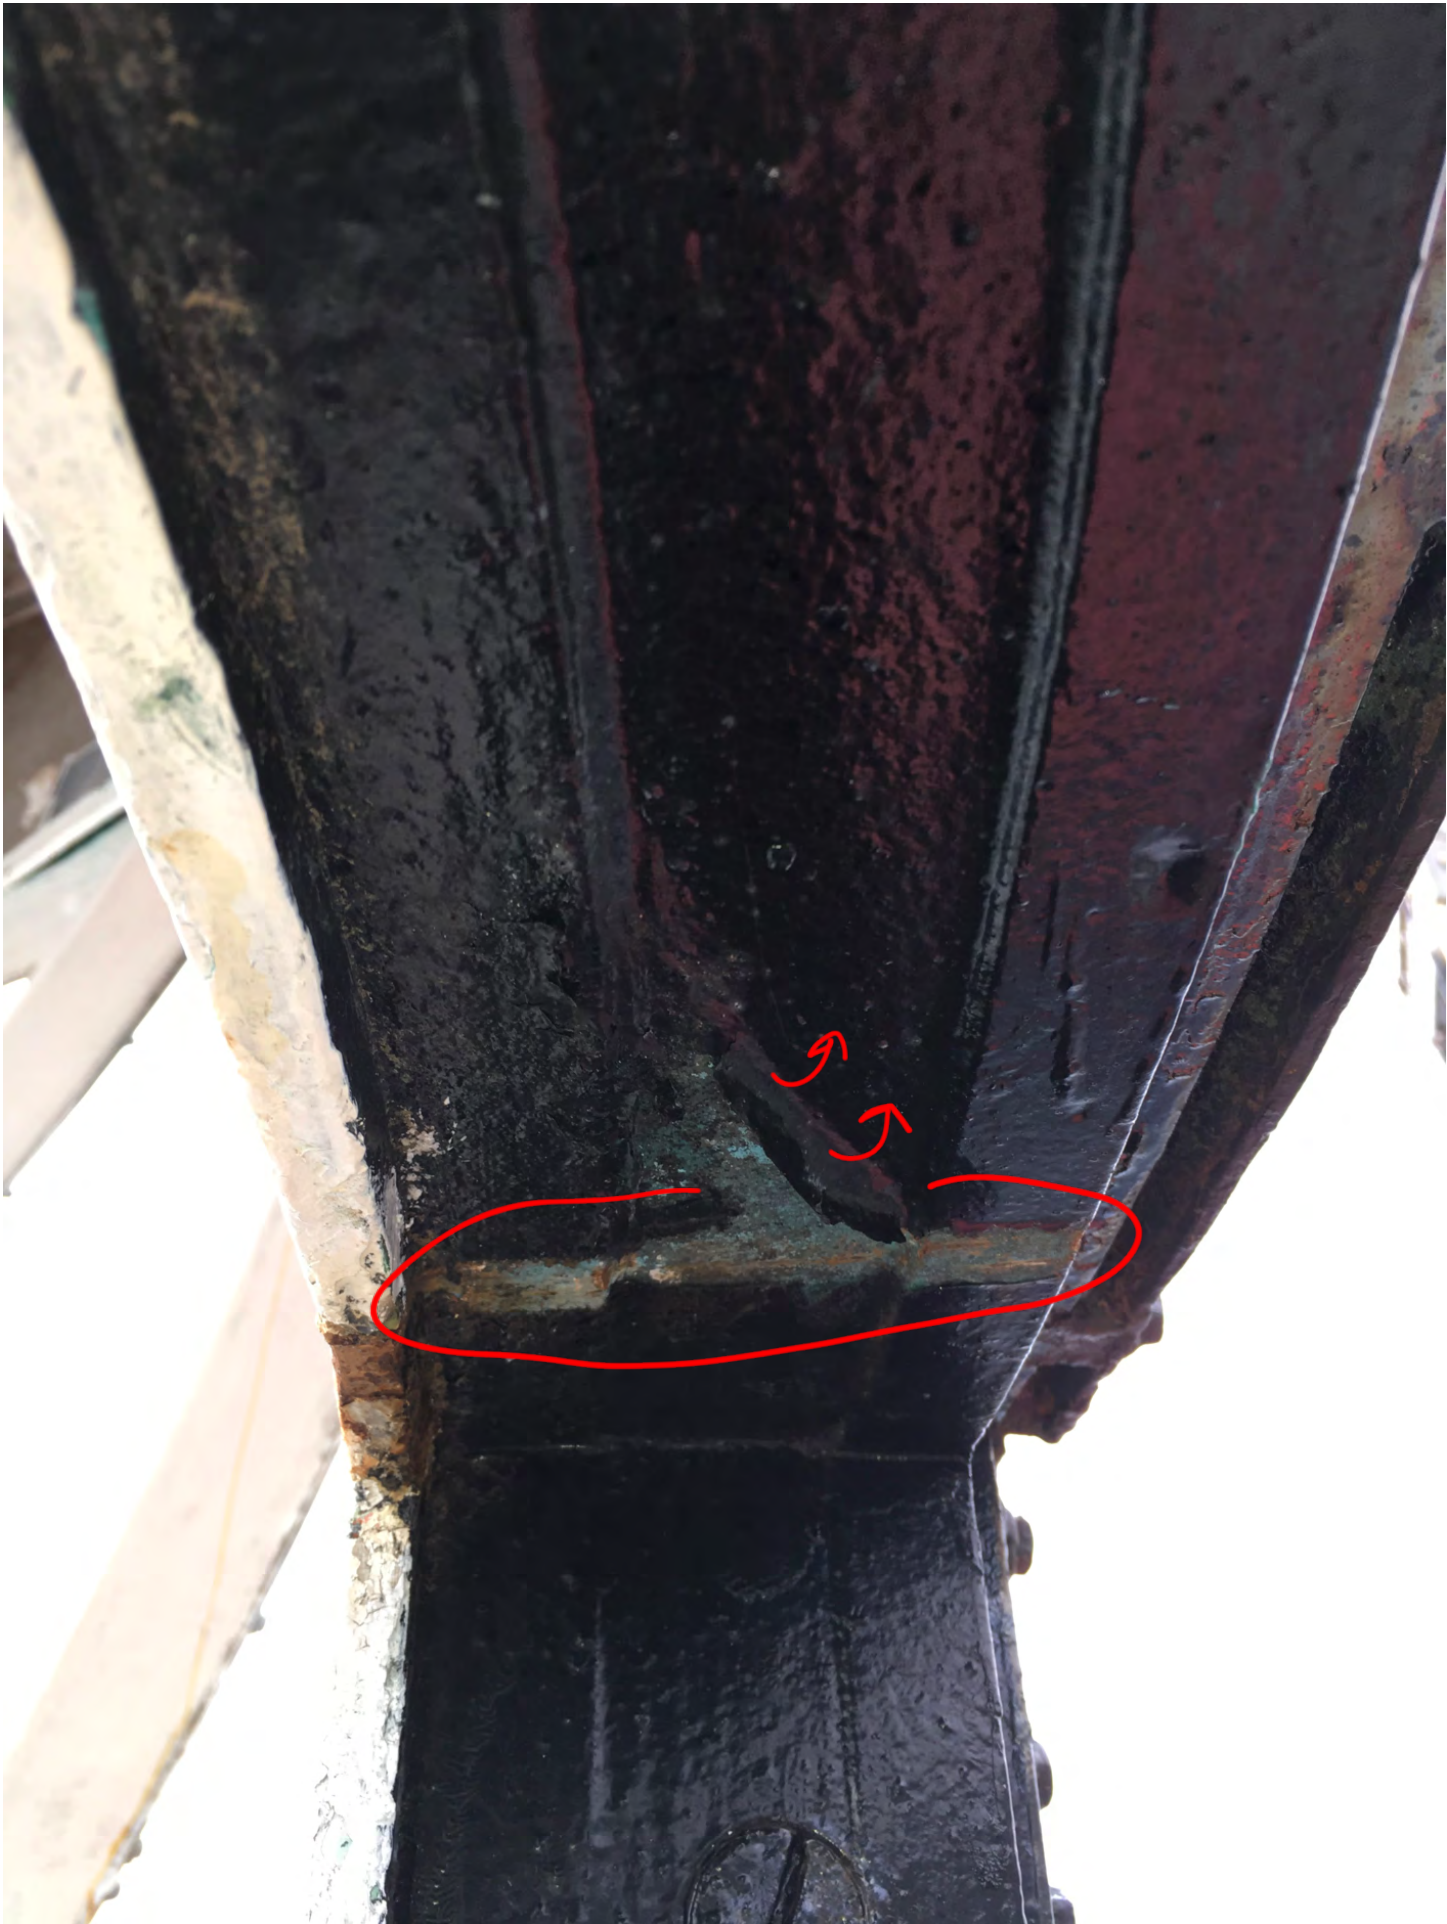
Section 10 door

Abrasion into metal surface on top jamb and coating disruption from opening and closing of door.

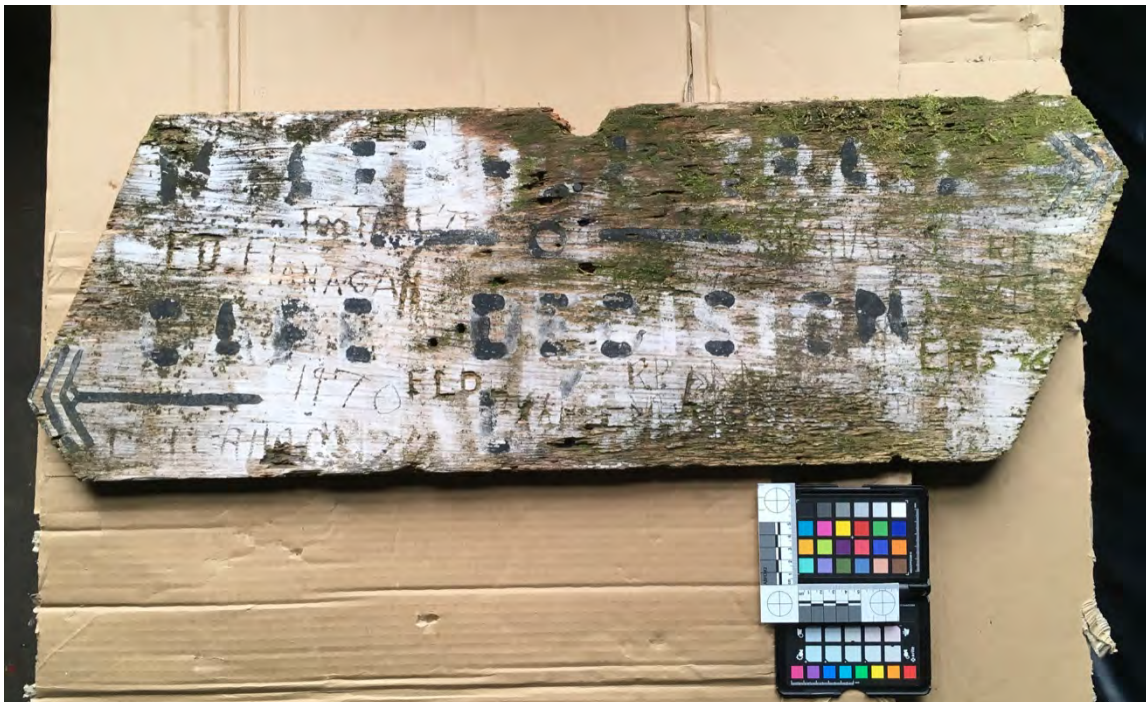
BEFORE TREATMENT (LARGER SIGN)

Both signs were in poor condition. The wood is rotted and punky in texture with heavy biological growth. Lichen colonies, moss, and mold were embedded into the wood surface, obstructing the original paint surface and text. The surfaces were cleaned using small brushes and bottled water. Areas of mold growth were treated with Q-tips and rubbing alcohol sachets acquired from a backpack emergency kit. After treatment, the signs were placed in the foyer to dry. Further biological growth removal can commence once the wood has dried.
